Improvisations in Traditional Lime Work, Punjab, India

The case for study is a traditional historic Havelli (Mansion) in Punjab restored by the author as site Conservation Architect under the guidance of CRCI, New Delhi. The project was completed in a span of 6 months in 2008. Many a restorative techniques used are non-conventional and help in giving a new direction to the traditional processes of restoration.

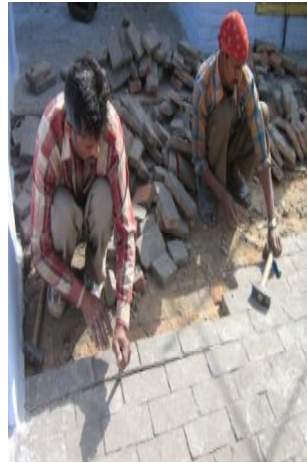
Removal of finishing
brick

- 2) *Removal of finishing layer of roof:* The top finishing layer of the roof was traditional bricks in mud mortar. These were carefully removed piece by piece and were neatly stacked after cleaning with water. In traditional restoration works the objective is to reuse traditional materials as much as possible so all process of removal and stacking of the older material are done with utmost care. Wastage during removal process is minimized.

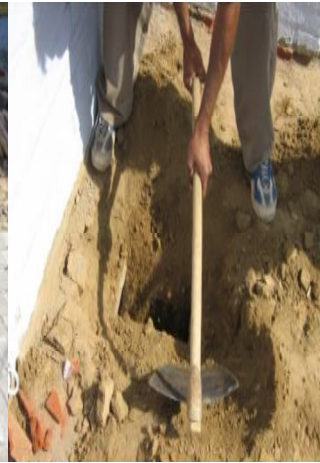
Removal of earth layer

- 3) *Removal of earth:* The earth filling is removed by ploughing all the earth to the room below
- 4) *Removal of brick layer:* The bottom most layer of the traditional bricks are removed. These again are done with care to reduce on breakage and wastage so that they can be reused at a later stage. The brick surface at the soffit of the roofing was white washed white; this shall be upturned and reused.

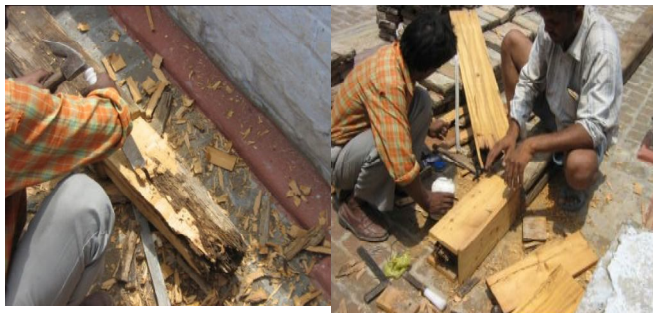
Removal of wood end

Deodar wood planks

The original wooden beam in one of the rooms was in a good state but the ends were deteriorated due to moisture content in wall. This end section of the wooden beam was consolidated. The weathered part of the beam was chiselled and removed. The end was encased within new planks of deodar wood 20mm thk. and the gap was filled with wood shavings mixed with resin of industrial bonding. This beam was then rested upon wooden wall pad.

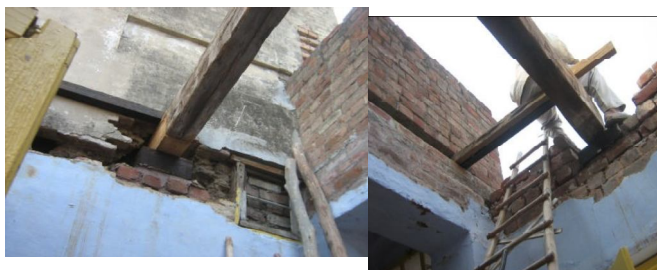
Insertion of wood pad

Wooden purlins laid

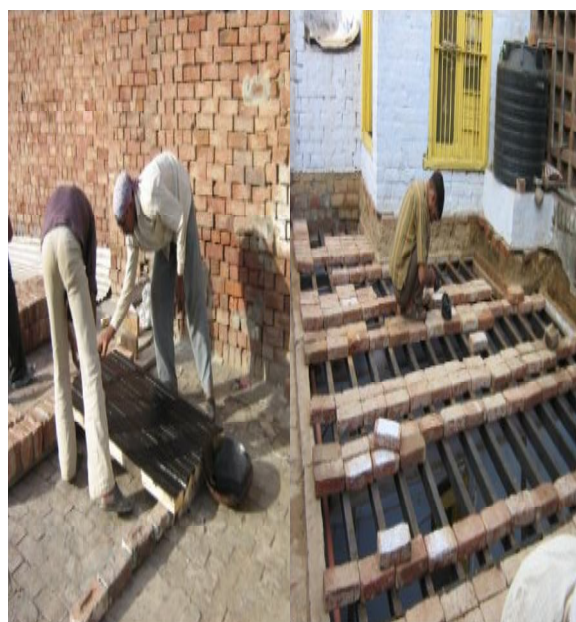
Anti-Termite treatment
of purlins

Wooden spacers for
purlin placement

- 1) *Laying of wooden purlins:* Wooden purlins were checked for any defects and those found structurally stable were reused. Others were replaced by purlins of same size as originals, 65mm x 50mm in cheer wood. Purlins were cleaned of any dirt and grime. Thereafter, all the purlins were treated with application double coat of termite proof mixture of burnt engine oil and turpentine oil in 1:2 proportions. The centre to centre distance between purlins was maintained at 230mm c/c. as wide as the brick length. The wooden purlins are fixed in position c/c by fixing small wooden batten pieces as spacers between two purlins. These spacers are positioned above iron girders and they help in avoiding the dislocation of purlins while placing the top layer of brick tiles.

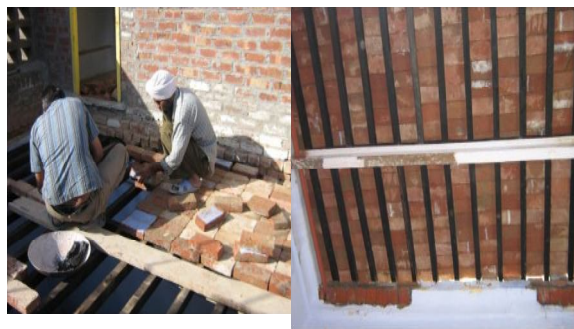
First layer of tile laid

Soffit of roof restored

- 2) *First layer of brick:* the first layer of brick was laid over the wooden purlins, reusing most of the original bricks and by inter changing the face of the brick. Whitewashed brick faces were laid facing the terrace as against their earlier positions when they were facing below.

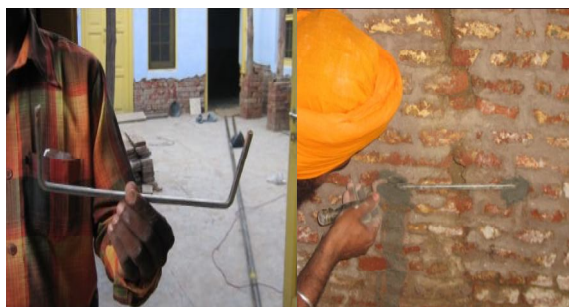
Mild steel C pin

C Pin Staple on wall crack

- 3) *Lime grouting*: lime pressure grouting was undertaken for consolidating a crack in masonry. The crack was first stitched with mild steel C Pins of 10mm dia. Thereafter, the crack was filled with lime grout forced into the fissures of the masonry through a grouting machine. The lime forced with pressure reaches the internal fissures of the masonry and fills in the gap. This operation though proved to be a failure in the said case and the wall in 24hrs time bulged out. After further investigation into the cause of the same, it was learnt that the wall so treated has internal mud mortar layer and the thus the mud after absorption of moisture from lime grout swelled up causing the bulging effect in the wall.

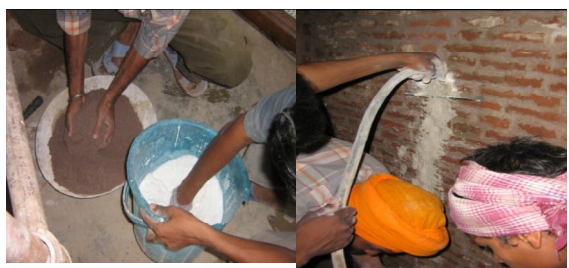
Lime grouting mixture

Lime grouting of crack

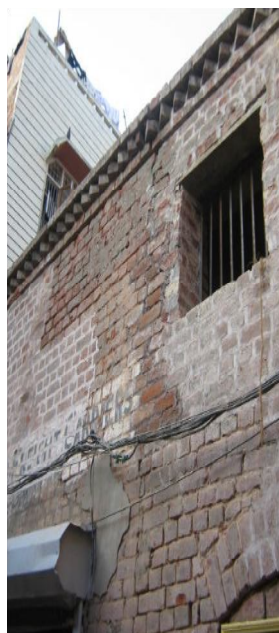
Consolidated restored wall

- 4) *Masonry consolidation through rebuilding*: Many cracks in the masonry which were only one course deep were restored by removing the bricks and re-laying the masonry in lime mortar, carefully building in interconnected joints between the new and old masonry. The important aspect to take into account though is that before consolidating the masonry the probable cause for crack was identified and the corrective measures were taken so that the restored masonry might not fall under stress.
- 5) *Plinth protection to walls*: plinth protection was provided to walls both from the inside and outside of the building. This ensured check of rising damp in case of traditional walls lacking the damp proof course.

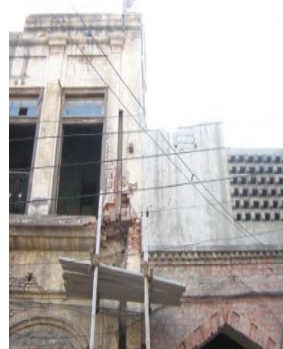
Vegetation removed

A Peepal plant had taken roots into the masonry of the Haveli, this could cause collapse of the wall if the plant was not removed. Plants if not carefully and completely removed have a tendency to regrow. The plant was injected with chemical compound which slowly dried up the plant. The masonry along the roots was removed to pull out the entire vegetation growth. Terracotta jaalis from the adjacent property belonging to the client were carefully removed and cleaned. These jaalis are rare as they are not casted anymore and have been replaced steadily by cement jaalis in the market.

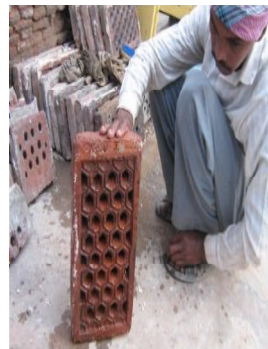
Terracotta tile restored
