Review of Failure Analysis of Ground Level Reservoir and Remedial measures

T.Vijila¹, N.Sakthieswaran², G.Shiny Brintha³, O.Ganesh Babu⁴

Abstract - *This paper presents failure analysis of ground level reservoir. During operation one side wall of the Ground Level Reservoir collapse. The detailed study involves preliminary assessment of structural conditions, detailed analysis of causes of failure. A major part of the civil Engineering infrastructure will need significant repairs. This innovative rehabilitation and strengthening method of reinforced concrete ground level reservoir can be done after assessing the failure reasons due to the stresses developed in extremely loaded condition.*

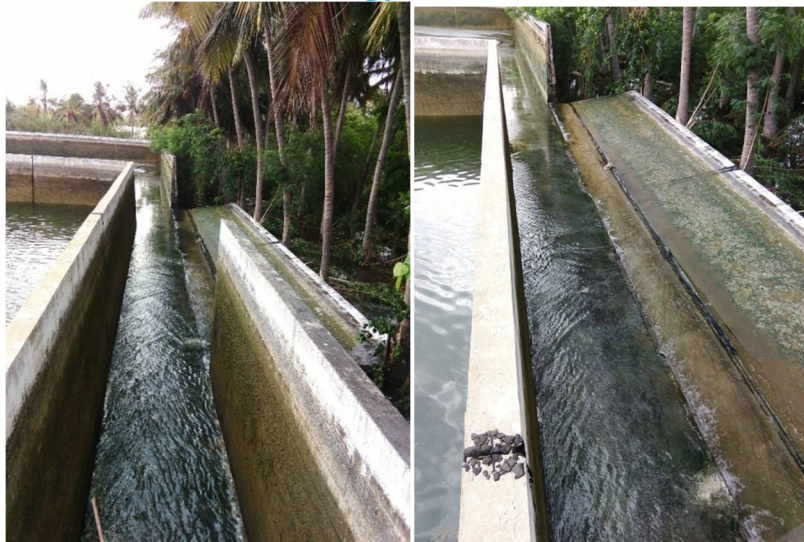
On 12.07.2015, a portion of the wall toppled as a rigid body near the beginning of diversion channel. The separation occurred at the raft and side wall connection. At the time of collapse, the level of water is approximately 90% of its capacity.

This indicates that the pressure all along the wall is higher than the design pressure at the time of failure. The higher pressure causes the shear failure of rods and the wall was collapsed. The photograph shows the collapsed wall and three places where the concrete and rod samples collected. The higher dynamic pressure may be due to the sudden drawl of water from the compartment.

Figure 1 : Collapsed Ground level reservoir Photos
