A Case Study on Reliability Improvement of New Bar Mill Stand Gearboxes

Ankush Sharma¹, Himangshu S Mandal², T Thirumurugan³, N Rajesh Kumar⁴, Md Perwaiz Kaiser⁵, Rajiv Garg⁶
 One Shared Services Technology Group, Tata Steel Limited, Jamshedpur, 831001, Jharkhand, India

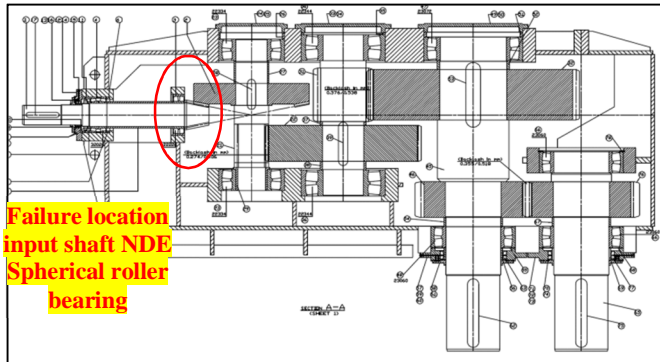
In all the failures of Mill stand gearboxes of NBM in recent past, it has been observed that input shaft bearing was failed and in some cases input shaft gear teeth were also damaged due to misalignment generated post bearing failures. On Spet'2020, NBM stand no 1 vertical gearbox input shaft Non-drive end (NDE) spherical roller bearing was found damaged as inspected through inspection cover after hearing abnormal sound coming from gearbox.

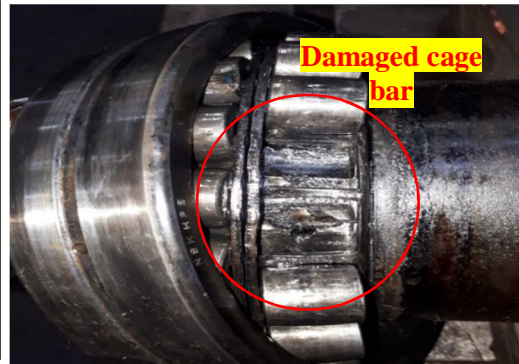
Heating marks were found on bearing rolling elements with cage breakage and few rolling elements came out from cage refer figure 2 & 3. This gearbox (overhauled) failed after giving service life of 1.1 year.

In all failure cases of mill stand gearboxes, failed bearings and its components metallurgical analysis was done in Sc Services Lab. No gross material abnormality with respect to chemistry, hardness and microstructure was observed in the bearing elements.

Such high impact torque load is detrimental for bearings cages & caused initiation of cage breakage.

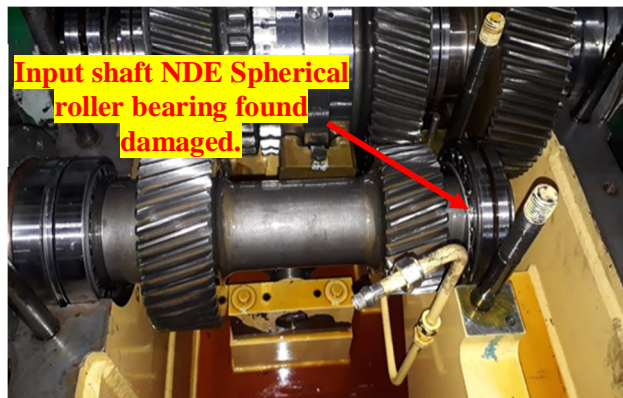
In past also in 2019 abnormal sound was observed during rolling from stand no 16 gearbox. Mill was stopped for inspection of stand no. 16 gearbox by opening the inspection covers and it was found that input pinion shaft NDE spherical roller bearing cage broken refer fig.4 & 5. Similarly, in 2018 Stand no 15-gearbox failed during service with same phenomenon of input shaft NDE bearing damaged & gear teeth damaged refer figure 6. In all the cases the gearbox was failed very prematurely within 2 years. Normally for Mill duty gearboxes ideal TBM is 5 years or more in some cases.

Fig.4 Failed gearbox of stand no 16 Fig.5 Broken cage bar of input shaft bearing of stand no 16-gearbox

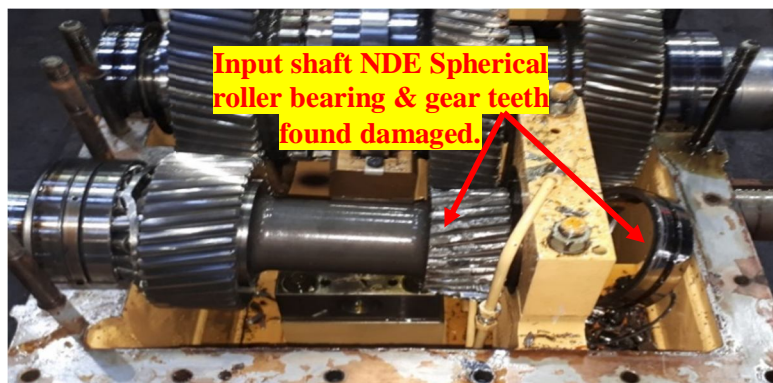
Fig.6 Failed gearbox of stand no 15

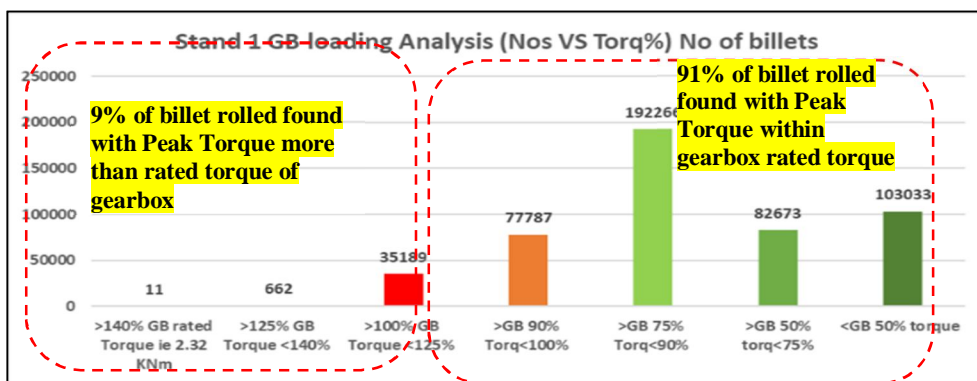
Fig.7 NBM Stand no 1 load analysis.

IBA Data was analyzed for all stands during the last one year. The load trend from 01.09.2019 to 22.09.2020 for stand no 1 is plotted in graph trend & given below in figure 7. From below data analysis, it was found that in past one year, there are 35,862 nos. of billet rolled which had peak torque value more than 100% rated input torque of gearbox which constitute around 9% of total billet rolled in a year (i.e. total 4.6 lakh billets) whereas for rest 91% billets peak torque was found within rated capacity of gearbox. As per Mill duty gearbox standard AGMA 6010, only 7 peaks (during start stop i.e. momentarily occasional peaks) are allowed in a day more than rated torque capacity of gearbox. However, there is no standard available for operation peak load more than 100% and it is addressed through proper selection of gearbox. Taking 7 occasional peaks per day, in one year around 2500 occasional peaks are allowed but in this case of stand no 1, number of billets having peak torque more than rated capacity was large in numbers i.e. around 35,862 in which 662 nos. of billets were critical cases where peak torque had gone more than 125% of rated input torque & 11 nos. were high impact load cases when peak torque was found more than 140% of rated gearbox torque as shown below in table refer figure 8

- For all mill stand gearboxes high torque alarm to be given on gear box nominal input torque rating (for example Stand#1 nominal Torque load is 1.65 KNm). If it goes beyond the nominal input torque for 5 seconds, then it will trigger an alarm and auto stoppage of subsequent billet discharge from furnace for 3 minutes.

- Current logic of stand 1 trip at 90 % (2.5KNm) motor torque in case of cold billet to be changed to 78 % (1.91 KNm). Trip command to be generated if stand 1 cross 78 % of motor torque (which is 120% of gearbox nominal torque value) for one second. Tripping of stand#1 in case of cold billet having low temperature will not allow the cold billet to move further in other mill stands thus avoid overloading.

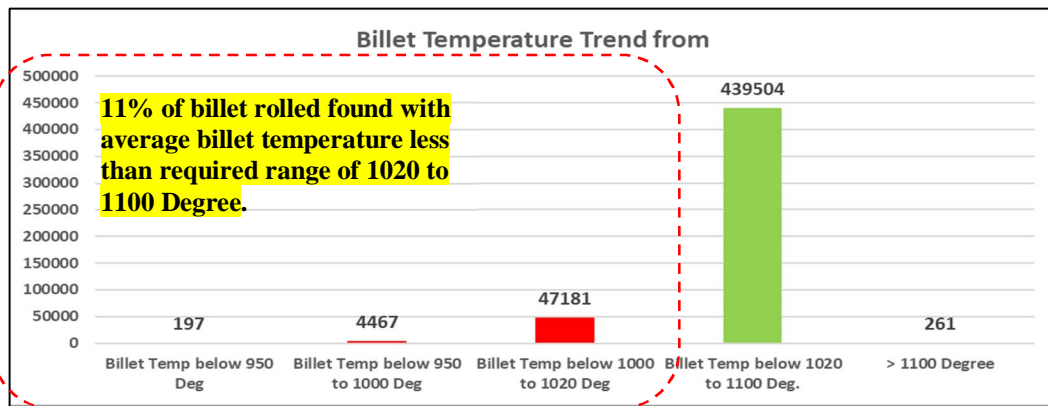
Fig.9 Billet Temperature Analysis

All above 11 nos. critical cases were happened in recent 3 months (i.e between July to Aug'20) and billet temperature was found lower than required range 1020 °C to 1100 °C which means billet soaking & heating was not done adequately and led to high rolling peak torque. Billet temperature trend for last year also plotted below in bar graph as shown in figure

Around 11% of total billet rolled in past one year was found with average temperature less than required range of 1020 °C to 1100 °C which is closer to peak torque cases of 9% in which torque was found more than 100% of the rated capacity of the gearbox.

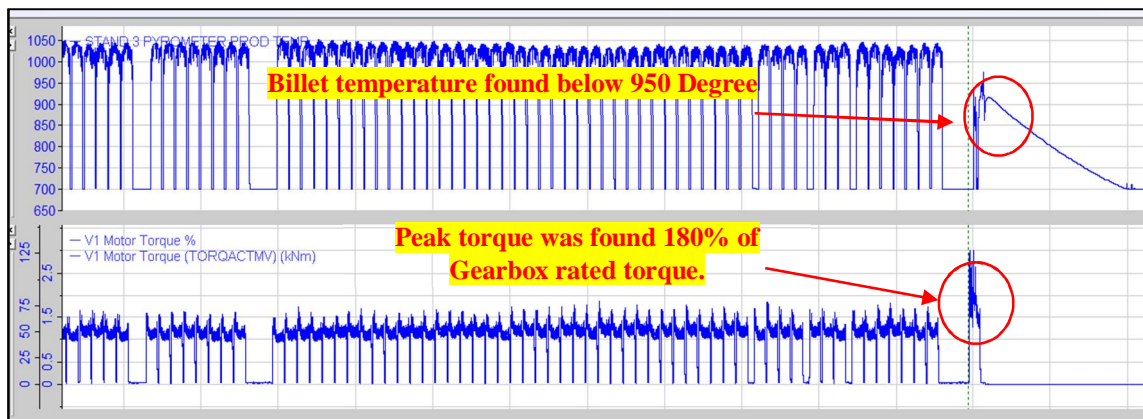
Fig.9 IBA data Analysis on 25th July'20

On 25th July at around 11 pm, Maximum peak torque was found 125% of motor Torque ie 3.05 KNm which is equivalent to 180% of gearbox rated torque when the billet temperature found below 950 °C (fig.10).
