A Case Study on Reliability Improvement of New Bar Mill Stand Gearboxes

Ankush Sharma¹, Himangshu S Mandal², T Thirumurugan³, N Rajesh Kumar⁴, Md Perwaiz Kaiser⁵, Rajiv Garg⁶
 One Shared Services Technology Group, Tata Steel Limited, Jamshedpur, 831001, Jharkhand, India

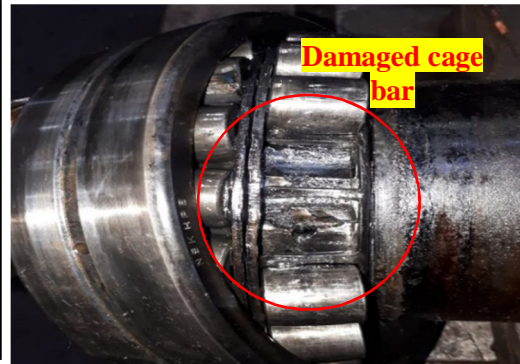
Heating marks were found on bearing rolling elements with cage breakage and few rolling elements came out from cage refer figure 2 & 3. This gearbox (overhauled) failed after giving service life of 1.1 year.

Fig.2 GA drawing of NBM stand 1 Gearbox Fig.3 Failed Bearing of Stand no 1 gearbox.

In all failure cases of mill stand gearboxes, failed bearings and its components metallurgical analysis was done in Sc Services Lab. No gross material abnormality with respect to chemistry, hardness and microstructure was observed in the bearing elements.

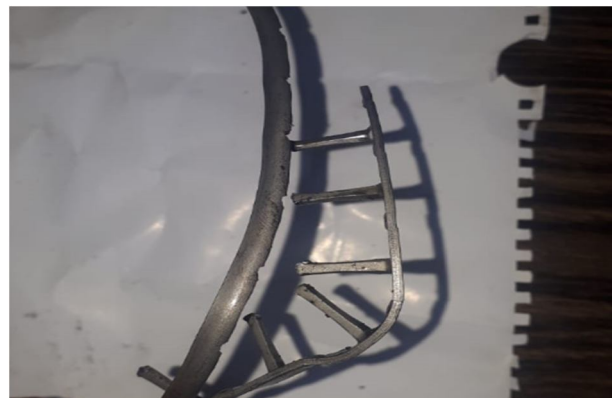
In past also in 2019 abnormal sound was observed during rolling from stand no 16 gearbox. Mill was stopped for inspection of stand no. 16 gearbox by opening the inspection covers and it was found that input pinion shaft NDE spherical roller bearing cage broken refer fig.4 & 5. Similarly, in 2018 Stand no 15-gearbox failed during service with same phenomenon of input shaft NDE bearing damaged & gear teeth damaged refer figure 6. In all the cases the gearbox was failed very prematurely within 2 years. Normally for Mill duty gearboxes ideal TBM is 5 years or more in some cases.

Fig.4 Failed gearbox of stand no 16 Fig.5 Broken cage bar of input shaft bearing of stand no 16-gearbox

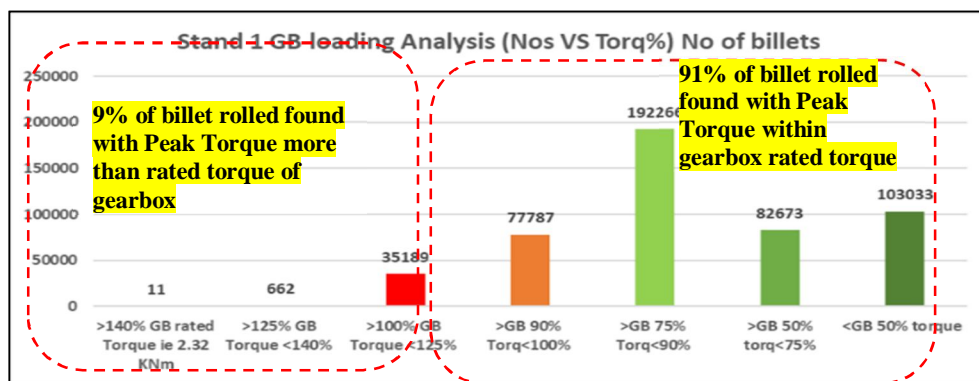
Fig.7 NBM Stand no 1 load analysis.

IBA Data was analyzed for all stands during the last one year. The load trend from 01.09.2019 to 22.09.2020 for stand no 1 is plotted in graph trend & given below in figure 7. From below data analysis, it was found that in past one year, there are 35,862 nos. of billet rolled which had peak torque value more than 100% rated input torque of gearbox which constitute around 9% of total billet rolled in a year (i.e. total 4.6 lakh billets) whereas for rest 91% billets peak torque was found within rated capacity of gearbox. As per Mill duty gearbox standard AGMA 6010, only 7 peaks (during start stop i.e. momentarily occasional peaks) are allowed in a day more than rated torque capacity of gearbox. However, there is no standard available for operation peak load more than 100% and it is addressed through proper selection of gearbox. Taking 7 occasional peaks per day, in one year around 2500 occasional peaks are allowed but in this case of stand no 1, number of billets having peak torque more than rated capacity was large in numbers i.e. around 35,862 in which 662 nos of billets were critical cases where peak torque had gone more than 125% of rated input torque & 11 nos. were high impact load cases when peak torque was found more than 140% of rated gearbox torque as shown below in table refer figure 8

- For all mill stand gearboxes high torque alarm to be given on gear box nominal input torque rating (for example Stand#1 nominal Torque load is 1.65 KNm). If it goes beyond the nominal input torque for 5 seconds, then it will trigger an alarm and auto stoppage of subsequent billet discharge from furnace for 3 minutes.

- Current logic of stand 1 trip at 90 % (2.5KNm) motor torque in case of cold billet to be changed to 78 % (1.91 KNm). Trip command to be generated if stand 1 cross 78 % of motor torque (which is 120% of gearbox nominal torque value) for one second. Tripping of stand#1 in case of cold billet having low temperature will not allow the cold billet to move further in other mill stands thus avoid overloading.

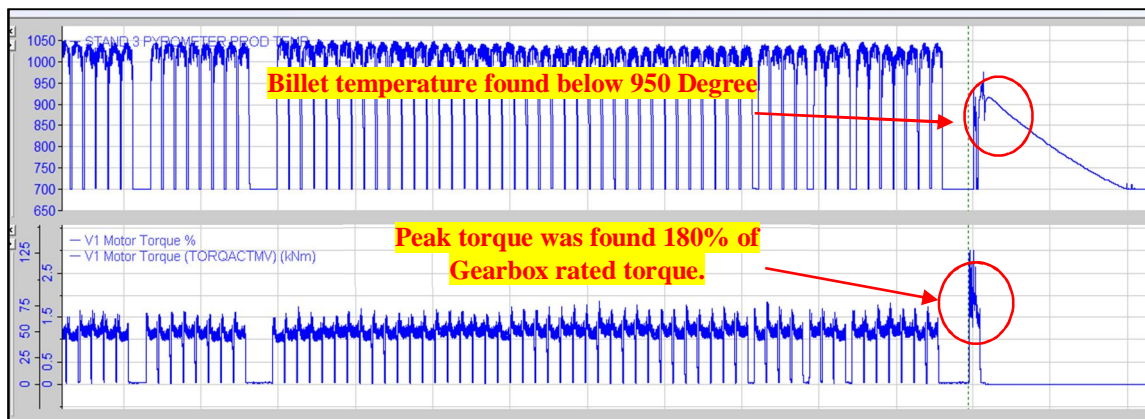
Fig.9 IBA data Analysis on 25th July'20

On 25th July at around 11 pm, Maximum peak torque was found 125% of motor Torque ie 3.05 KNm which is equivalent to 180% of gearbox rated torque when the billet temperature found below 950 °C (fig.10).

Such high impact torque load is detrimental for bearings cages & caused initiation of cage breakage.
