A Case Study on Reliability Improvement of New Bar Mill Stand Gearboxes

Ankush Sharma¹, Himangshu S Mandal², T Thirumurugan³, N Rajesh Kumar⁴, Md Perwaiz Kaiser⁵, Rajiv Garg⁶
 One Shared Services Technology Group, Tata Steel Limited, Jamshedpur, 831001, Jharkhand, India

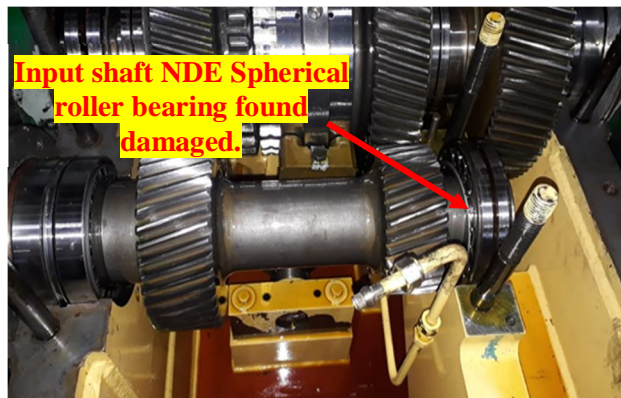
In past also in 2019 abnormal sound was observed during rolling from stand no 16 gearbox. Mill was stopped for inspection of stand no. 16 gearbox by opening the inspection covers and it was found that input pinion shaft NDE spherical roller bearing cage broken refer fig.4 & 5. Similarly, in 2018 Stand no 15-gearbox failed during service with same phenomenon of input shaft NDE bearing damaged & gear teeth damaged refer figure 6. In all the cases the gearbox was failed very prematurely within 2 years. Normally for Mill duty gearboxes ideal TBM is 5 years or more in some cases.

Fig.4 Failed gearbox of stand no 16 Fig.5 Broken cage bar of input shaft bearing of stand no 16-gearbox

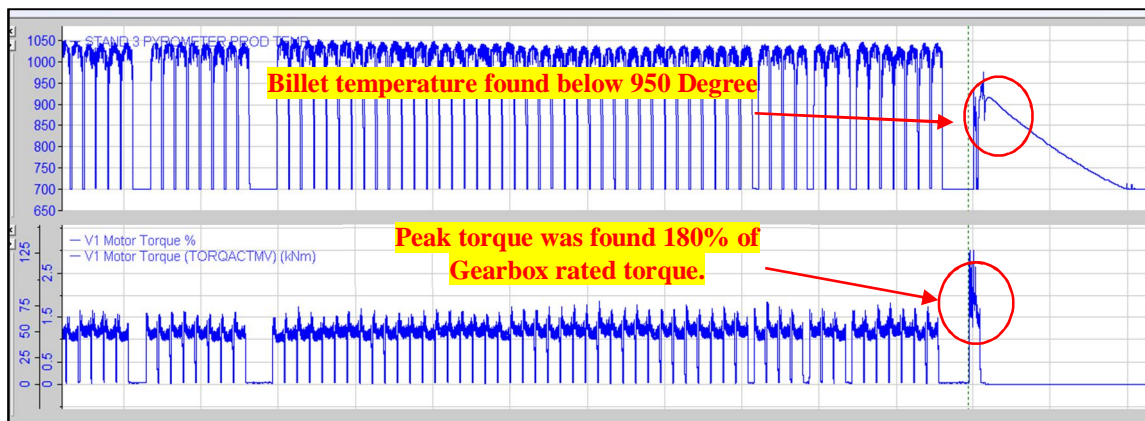
On 25th July at around 11 pm, Maximum peak torque was found 125% of motor Torque ie 3.05 KNm which is equivalent to 180% of gearbox rated torque when the billet temperature found below 950 °C (fig.10).

Such high impact torque load is detrimental for bearings cages & caused initiation of cage breakage.

Fig.9 IBA data Analysis on 25th July'20

- Current logic of stand 1 trip at 90 % (2.5KNm) motor torque in case of cold billet to be changed to 78 % (1.91 KNm). Trip command to be generated if stand 1 cross 78 % of motor torque (which is 120% of gearbox nominal torque value) for one second. Tripping of stand#1 in case of cold billet having low temperature will not allow the cold billet to move further in other mill stands thus avoid overloading.
