# A Case Study on Reliability Improvement of New Bar Mill Stand Gearboxes

Ankush Sharma<sup>1</sup>, Himangshu S Mandal<sup>2</sup>, T Thirumurugan<sup>3</sup>, N Rajesh Kumar<sup>4</sup>, Md Perwaiz Kaiser<sup>5</sup>, Rajiv Garg<sup>6</sup>  
 One Shared Services Technology Group, Tata Steel Limited, Jamshedpur, 831001, Jharkhand, India

**Abstract:** This paper describes the major work carried out in study & analyzing the critical reasons for failure of mill stand drive gearboxes that had occurred in New Bar Mill (Rebar Mill) in past 5 years. Suggest improvement measures and maintenance guidelines to decrease the probability of failure and hence develop an action plan for reliability improvement of New Bar Mill stand gearboxes. In the process, study on basics of gearbox and on rolling process of New Bar Mill has been done. Present production data analysis has been done for actual mill load condition. Based on present mill load data, current running service factor of gearboxes has been calculated. Many gearboxes of New bar mill stand found with low service factor than recommended as per AGMA standards. Accordingly, upgradation of mill drives gearboxes have been done for higher s

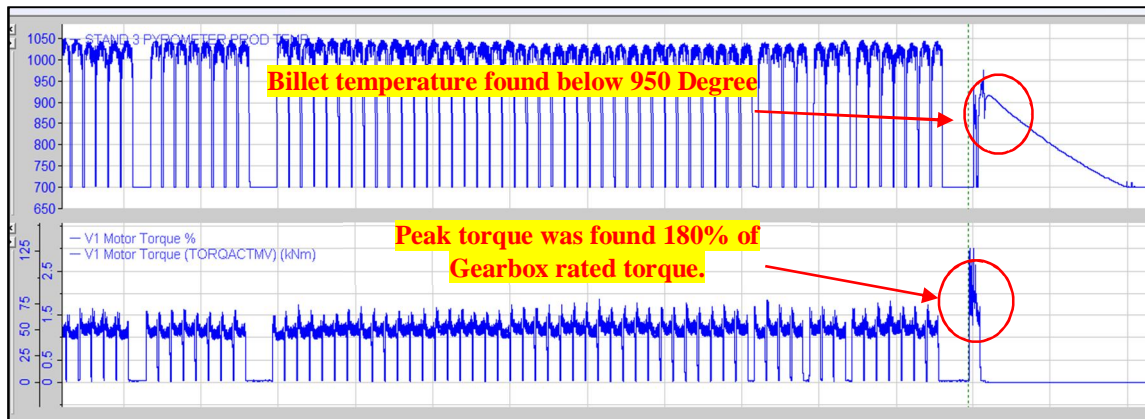
On 25<sup>th</sup> July at around 11 pm, Maximum peak torque was found 125% of motor Torque ie 3.05 KNm which is equivalent to 180% of gearbox rated torque when the billet temperature found below 950 °C (fig.10).

Such high impact torque load is detrimental for bearings cages & caused initiation of cage breakage.

Fig.9 IBA data Analysis on 25th July'20

- For all mill stand gearboxes high torque alarm to be given on gear box nominal input torque rating (for example Stand#1 nominal Torque load is 1.65 KNm). If it goes beyond the nominal input torque for 5 seconds, then it will trigger an alarm and auto stoppage of subsequent billet discharge from furnace for 3 minutes.

- Current logic of stand 1 trip at 90 % (2.5KNm) motor torque in case of cold billet to be changed to 78 % (1.91 KNm). Trip command to be generated if stand 1 cross 78 % of motor torque (which is 120% of gearbox nominal torque value) for one second. Tripping of stand#1 in case of cold billet having low temperature will not allow the cold billet to move further in other mill stands thus avoid overloading.
