Prevention of Damages & Accidents in PSC I-Girders during Stressing & Erection Works

Abhijit Mangaraj¹, Nitin Bobade², Ananya P. Parida³

Department of Civil Engineering, Gandhi Institute For Technology Autonomous

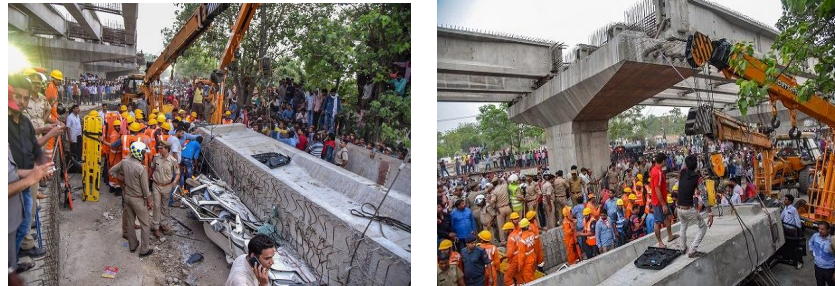
This is the major case of PSC girder failure in our country. About 80% of failures are falling in this category. The main cause of this type of failure is due to improper supporting arrangement below girder soffit and insufficient inclined/ cross supporting and due to no interconnections between 2 adjacent girders.

- a) negligence in supporting arrangement of girders,
- b) poor supervision during supporting,
- c) Improper temporary interconnections between adjacent girders.
- d) Entry & movement of unskilled workers in supporting area without Supervisor.
- e) Girder directly over bearings, with full load on Bearings.
- f) Machinery and equipment movement below & around the girders causing touch and vibrations to girder system.

Fig 1.2:- Varanasi UP Flyover Girders collapse on 15-May-2018

- a) All supporting work shall be carried out under strict supervision and control of experienced Engineers, Supervisors.
- b) Not a single support shall be removed or relocate, unless the permission granted by Engineer-in-Charge. This is one of the main cause of girder toppling.

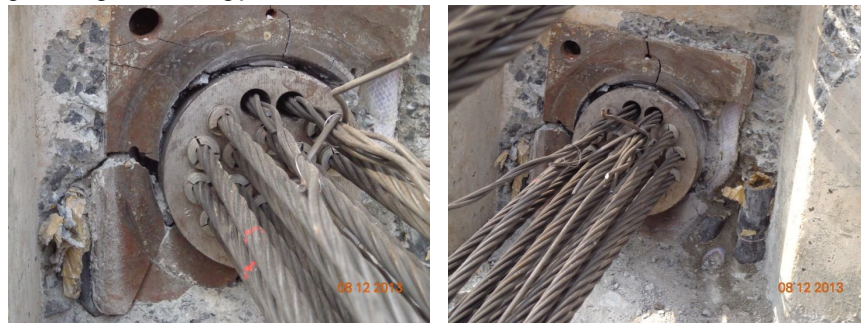
PSC Girder End Block is most congested part of girders. Due to various types of Multilayer mesh behind Anchor cones, at bearing location, Sheathing ducts, dowels of diaphragm, this girder end block portion become congested. Further steel bar overlaps and other unwanted ducts make it further congested and due to very high compression zone, damages of Anchor cone puncturing, Anchor Head insertion of concrete skin removal are occurred.

In one case extra ducts were inserted by Site Engineer for the provision of bearing top sleeves grouting. Due to these ducts cavity forms and hollow portion remain inside the girder resulting in insertion of Anchor Head inside girder during stressing. This effect & effect due to cavitation is shown in following photos.

- a) Congestion & lapping of steel at End Block portion.
- b) Provision of unwanted ducts within End Block portion
- c) Improper placing, sequencing, vibrating & curing of Girder Concreting.
- d) Concrete slurry leakage through shuttering joints.

Fig 2.1:- Failure due to cavitation & grouting ducts (Anchor Cone Puncture)

- a) Lapping of steel shall not be provided in end block portion.
- b) Other than sheathing, no ducts shall be provided in end block portion.
- c) During concreting utmost care shall be taken for placing, sequencing, vibrating & curing of concrete. Form vibrators must be additionally used.
- d) Before stressing cavitation, honeycombs around anchor cones and in end block portion must be ensure by hammer ringing test. If any cavitation or honeycomb detect, then grouting of concreting with suitable material must be carried out prior to stressing.
- e) Additional MS square plate can be provided after approval from Engineer-in-Charge.

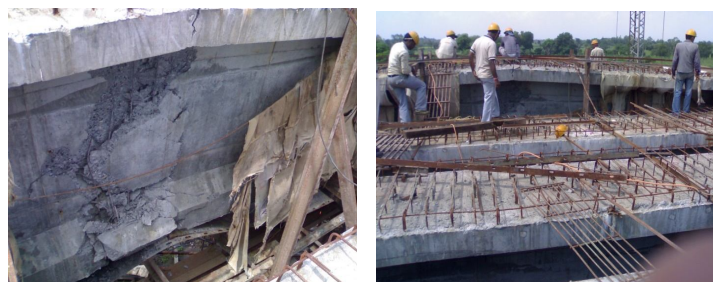
Concrete sequencing and placing is very much important for Girder concreting. Now days for long girders and for cast-in-situ girders, concrete placing is mostly carried out by Concrete Pump, Boom Placer and Mobile Tower Crane. By using the above machinery utmost care shall be taken that, concrete shall be poured and placed in layer from. No heap of mix shall be deposited within mould. In one of case of major failure, it was observed that contractor deployed 2 nos of mobile tower crane and layer sequence was not strictly followed. Due to which slurry and mortar get deposited in the middle portion of girder. Appearance of girder was very good after deshuttering, but during final stage stressing girder cracks & broke at midsection due to very low flexural strength.

Fig 3.1:- Crushing of concrete at weak flexural zone due to insufficient conc strength

- a) Improper pouring sequencing, placing and vibrating the concrete.
- b) Holding pipe of pump/ boom placer or mouth of concrete bucket over the steel reinforcement resulting in segregation of course aggregates from concrete mix.

- a) Proper pouring sequencing, placing & vibrating of concreting strictly followed.
- b) Pump/ boom placer pipe & concrete bucket mouth shall not hold over the steel reinforcement, to avoid the segregation of concreting.
- c) Strict concrete quality control shall be followed.

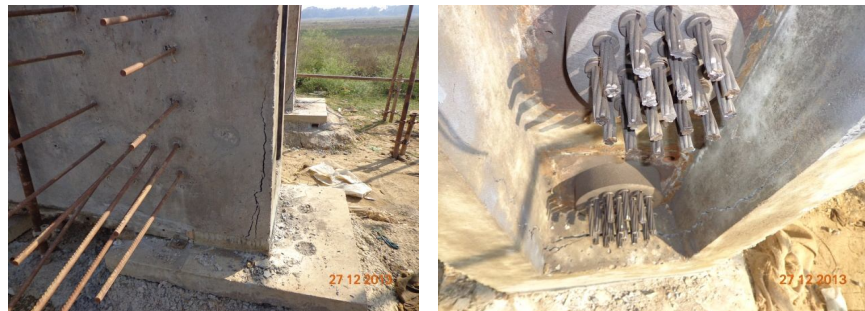
During stressing due to application of high compressive stresses, girder tends to hogging and after full stressing upward deflection of girder (Hogging) is observed at mid-section, and about 70% of girder length remains unsupported due to thus upward deflection. Hence complete girder load came at end block portion of the PSC Girder. Due to this excessive load at end block, end portion of girder tends to move downward in casting bed. If casting bed is rigid at ends, then skin portion of girder soffit and edges cracked, which damages the girder. Sometimes anchor cones get affected in this stage. Cracking & damages due to this cause are shown in photograph.

- a) Providing rigid casting bed at End Block portion of the Girder.

Fig 4.1:- Removal of Girder Concrete skin due to Rigid casting bed at End Block portion.

- a) Providing semi-rigid or flexible bed at End Block portion of the girder.
- b) If rigid bed provided for casting, then prior to stressing convert the End Block Bed into semi-rigid or flexible type by wooden blocks.

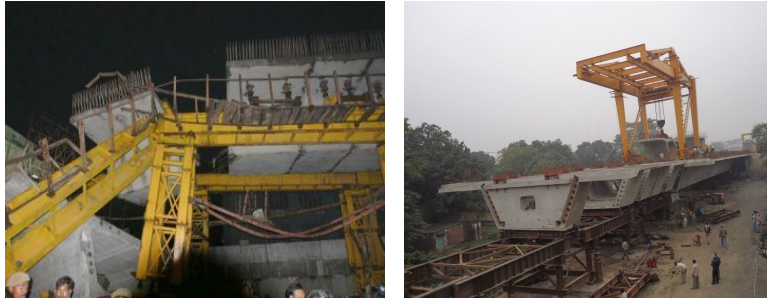
In this type of failure, it occurs due to insufficient compacted bed for casting beds, staging platforms and ground supported launching platforms. Under beneath layer of beds may be loose, saturated, cavitation, hollow or weak pipe lines below staging are the main reasons. Following are the cases where such failure occurred in recent history.

- a) Insufficient compaction of beds for casting, staging & launching platforms.
- b) Unknown presence of pipe lines, storm water drainage, drainage tunnels etc.
- c) Water leakage below beds.

Fig 5.1: (a) Hyderabad Flyover accident in 2007 due to failure of staging. (b) Ground supported launching arrangement before staging failure on NH-16.

- a) Ensure the desired compaction for all ground layers.
- b) Identify the underground ducts, pipelines, drainage lines and prepare the appropriate plan to safeguard the staging from settlement.
- c) There shall be no leakage or underground flow of water below the bed layers.

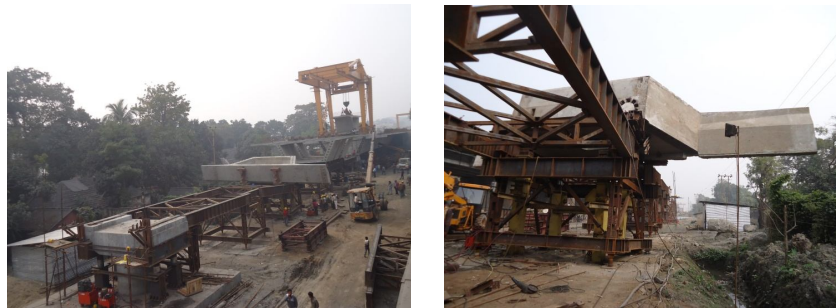
Fig 5.2:- Segment erection failure due to settlement of uncompact bed.
