Prevention of Damages & Accidents in PSC I-Girders during Stressing & Erection Works

Abhijit Mangaraj¹, Nitin Bobade², Ananya P. Parida³

Department of Civil Engineering, Gandhi Institute For Technology Autonomous

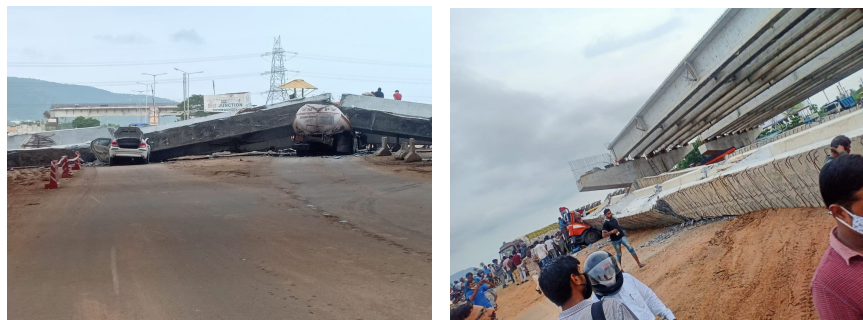
This is the major case of PSC girder failure in our country. About 80% of failures are falling in this category. The main cause of this type of failure is due to improper supporting arrangement below girder soffit and insufficient inclined/ cross supporting and due to no interconnections between 2 adjacent girders.

- a) negligence in supporting arrangement of girders,
- b) poor supervision during supporting,
- c) Improper temporary interconnections between adjacent girders.
- d) Entry & movement of unskilled workers in supporting area without Supervisor.
- e) Girder directly over bearings, with full load on Bearings.
- f) Machinery and equipment movement below & around the girders causing touch and vibrations to girder system.

Fig 1.1:- Anakapalli AP NH-16 Flyover Girder Collapse On 6-Jul-2021

- a) All supporting work shall be carried out under strict supervision and control of experienced Engineers, Supervisors.
- b) Not a single support shall be removed or relocate, unless the permission granted by Engineer-in-Charge. This is one of the main cause of girder toppling.

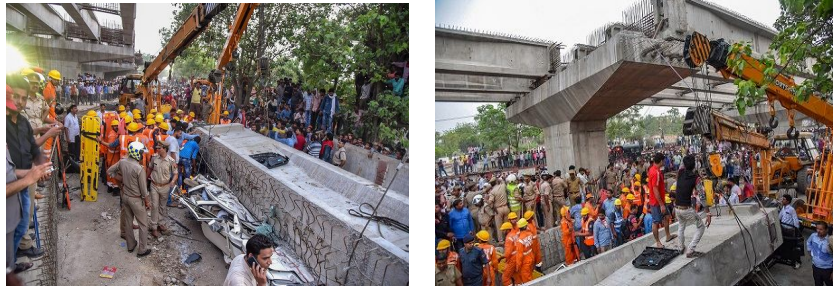
Fig 1.2:- Varanasi UP Flyover Girders collapse on 15-May-2018

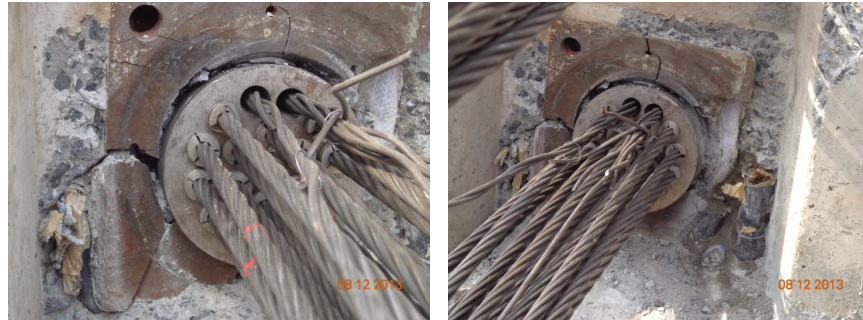
In one case extra ducts were inserted by Site Engineer for the provision of bearing top sleeves grouting. Due to these ducts cavity forms and hollow portion remain inside the girder resulting in insertion of Anchor Head inside girder during stressing. This effect & effect due to cavitation is shown in following photos.

- a) Congestion & lapping of steel at End Block portion.
- b) Provision of unwanted ducts within End Block portion
- c) Improper placing, sequencing, vibrating & curing of Girder Concreting.
- d) Concrete slurry leakage through shuttering joints.

Fig 2.1:- Failure due to cavitation & grouting ducts (Anchor Cone Puncture)

- a) Lapping of steel shall not be provided in end block portion.
- b) Other than sheathing, no ducts shall be provided in end block portion.
- c) During concreting utmost care shall be taken for placing, sequencing, vibrating & curing of concrete. Form vibrators must be additionally used.
- d) Before stressing cavitation, honeycombs around anchor cones and in end block portion must be ensure by hammer ringing test. If any cavitation or honeycomb detect, then grouting of concreting with suitable material must be carried out prior to stressing.
- e) Additional MS square plate can be provided after approval from Engineer-in-Charge.

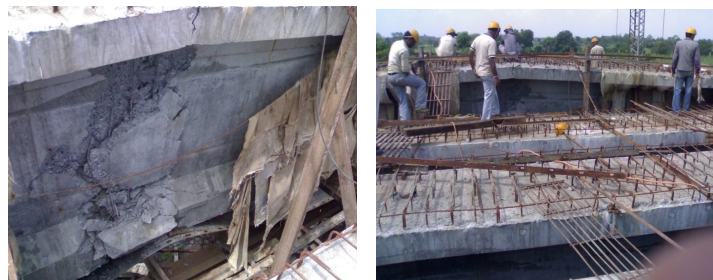
Fig 3.1:- Crushing of concrete at weak flexural zone due to insufficient conc strength

- a) Improper pouring sequencing, placing and vibrating the concrete.
- b) Holding pipe of pump/ boom placer or mouth of concrete bucket over the steel reinforcement resulting in segregation of course aggregates from concrete mix.

- a) Proper pouring sequencing, placing & vibrating of concreting strictly followed.
- b) Pump/ boom placer pipe & concrete bucket mouth shall not hold over the steel reinforcement, to avoid the segregation of concreting.
- c) Strict concrete quality control shall be followed.

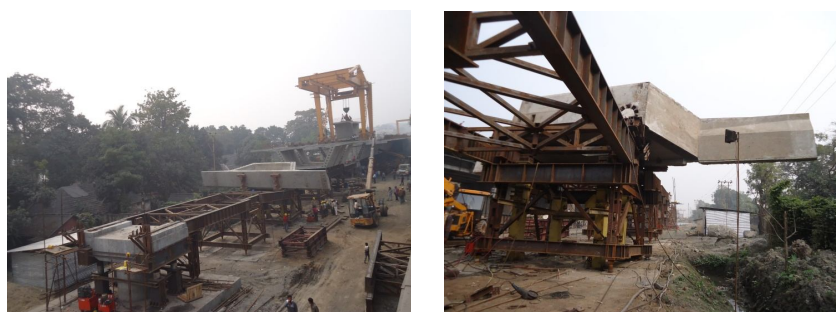
- a) Insufficient compaction of beds for casting, staging & launching platforms.
- b) Unknown presence of pipe lines, storm water drainage, drainage tunnels etc.
- c) Water leakage below beds.

Fig 5.2:- Segment erection failure due to settlement of uncompact bed.

- a) Ensure the desired compaction for all ground layers.
- b) Identify the underground ducts, pipelines, drainage lines and prepare the appropriate plan to safeguard the staging from settlement.
- c) There shall be no leakage or underground flow of water below the bed layers.
