Road Safety Audit: A Detailed Analysis of Dhandhuka to Dholera (SH-20) in Gujrat State

Mateen Ahemed¹, Dr. Sunil Sugandhi²

Jawaharlal Institute of Technology, Borawan, Khargone

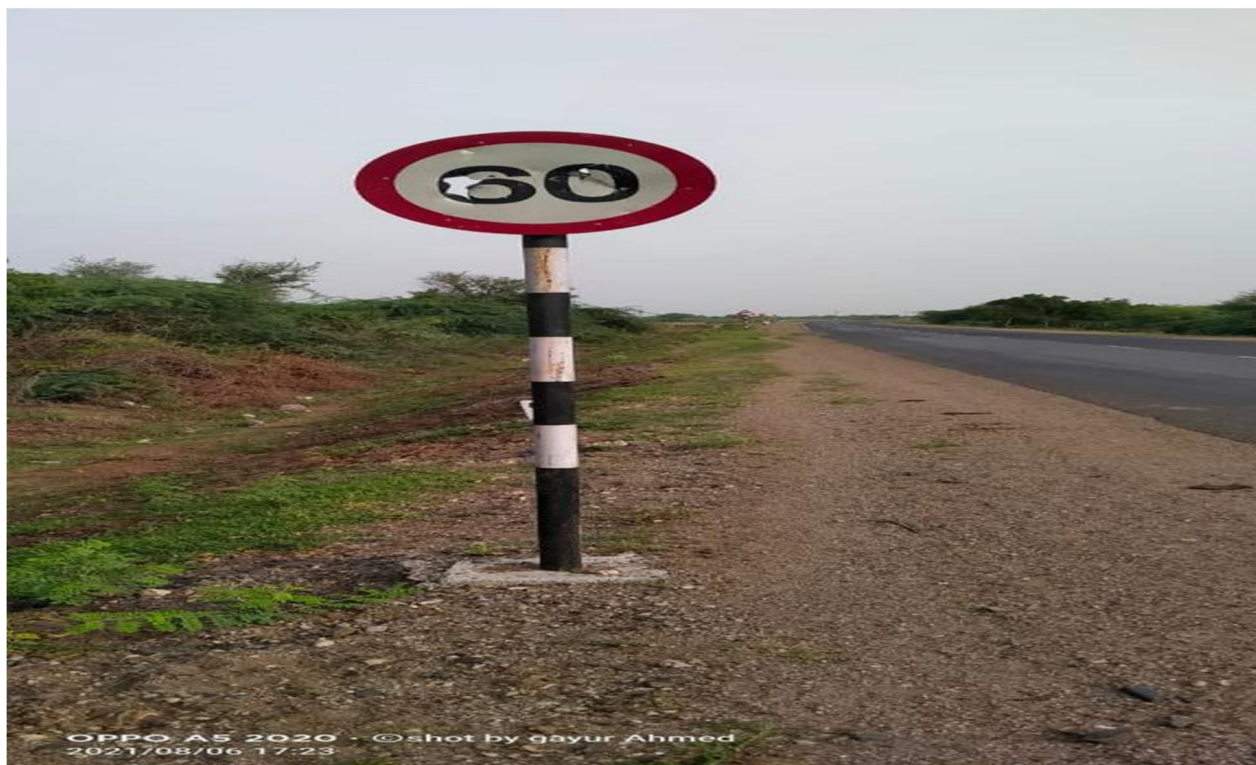
Ch. 26+500 Damaged speed limit sign board

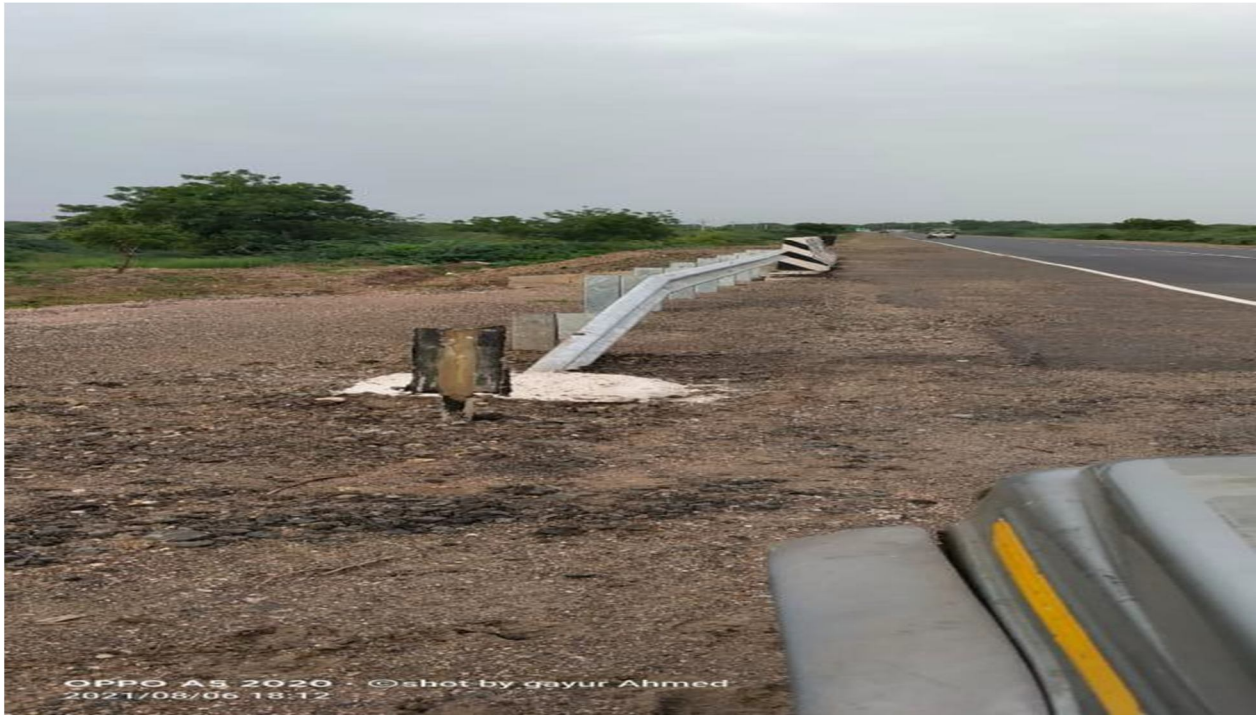
Ch. 7+700 Hazard marking sign board found damaged & faded condition

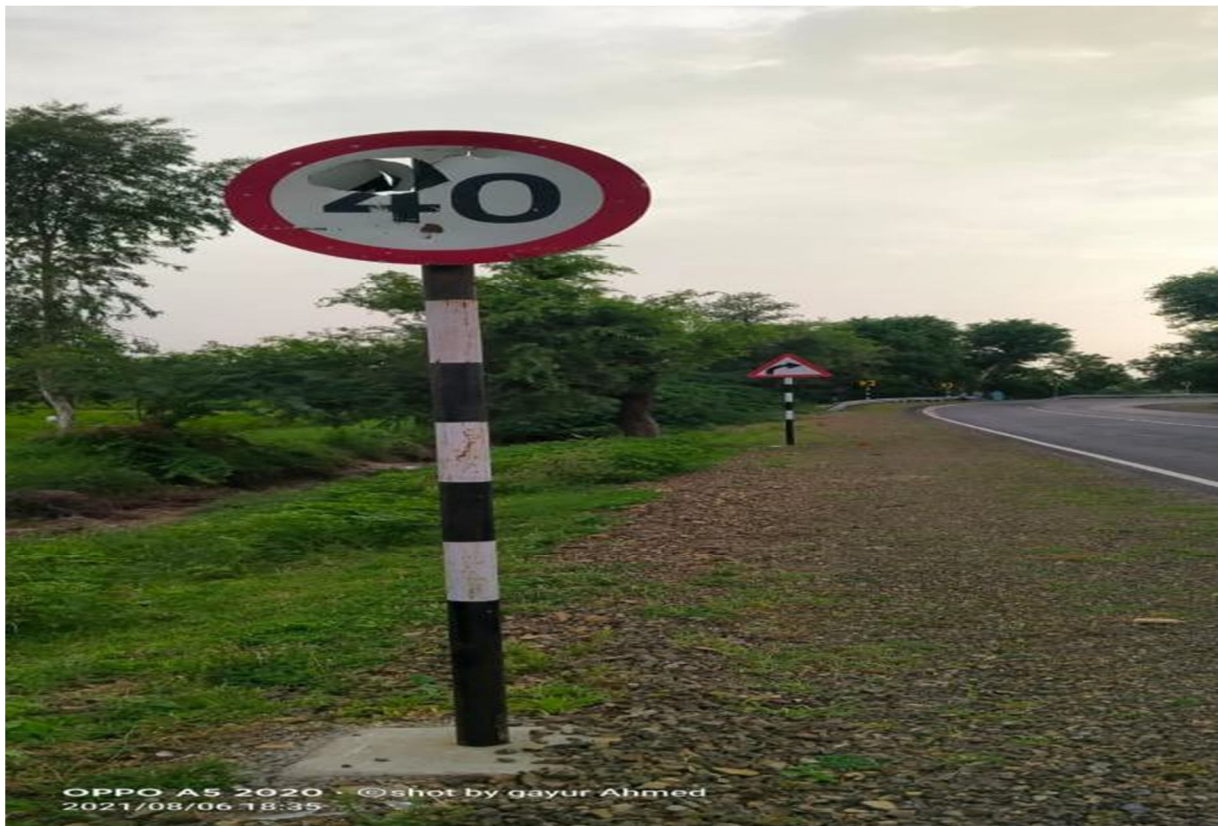
Ch. 16+485 Speed Limit sign board found in damaged condition

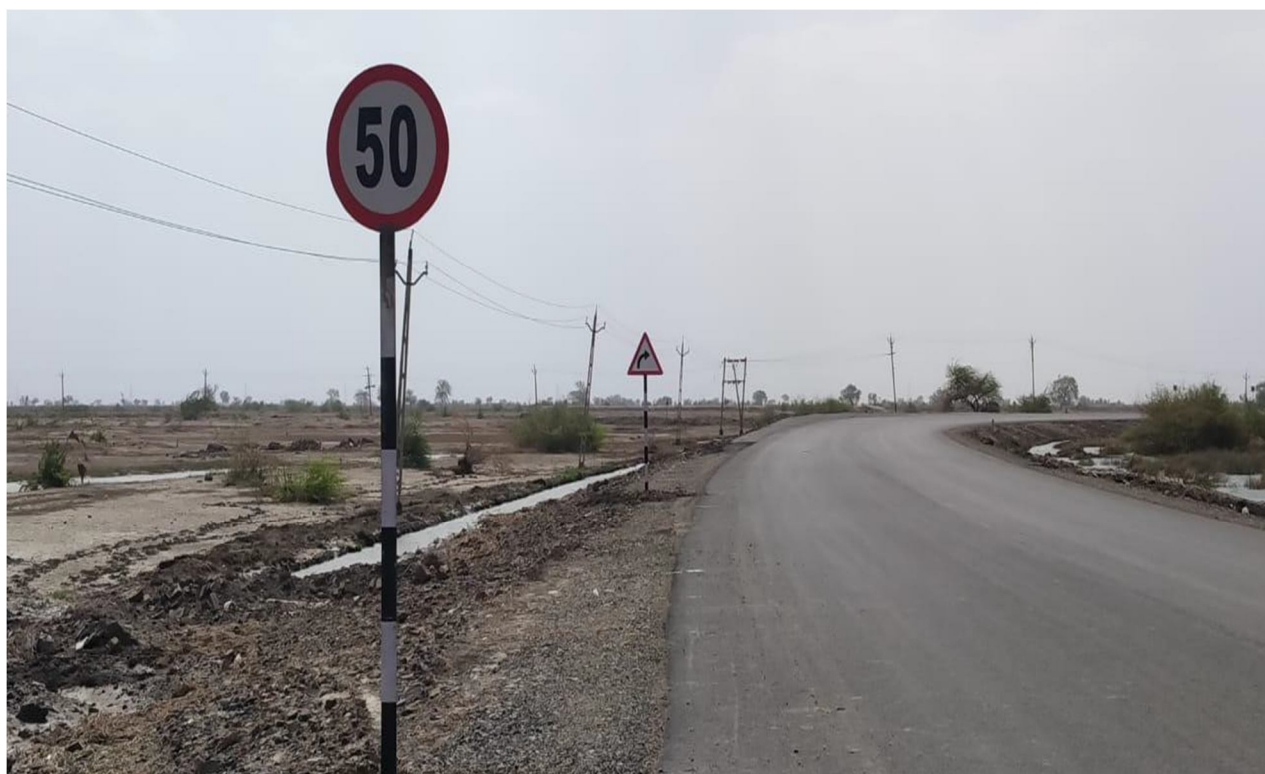
Ch. 20+900 Missing road marking & rain cuts observed near earthen shoulder

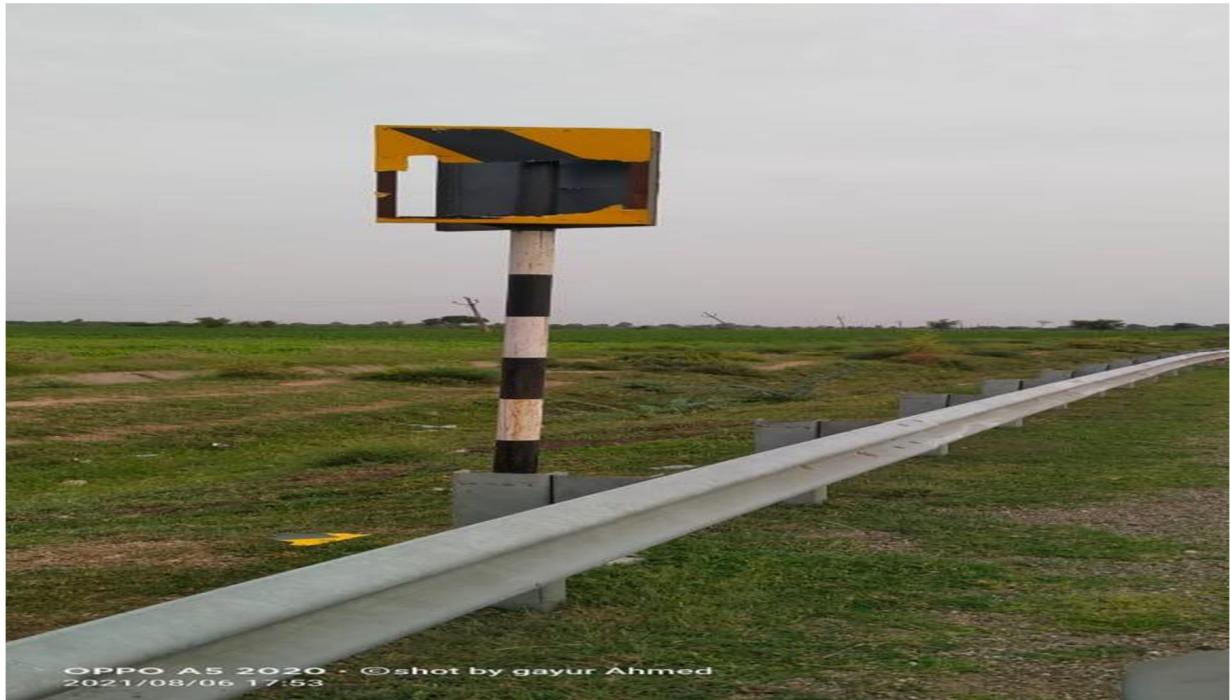
Ch. 16+440 Right hand chevron sign board found in damaged condition

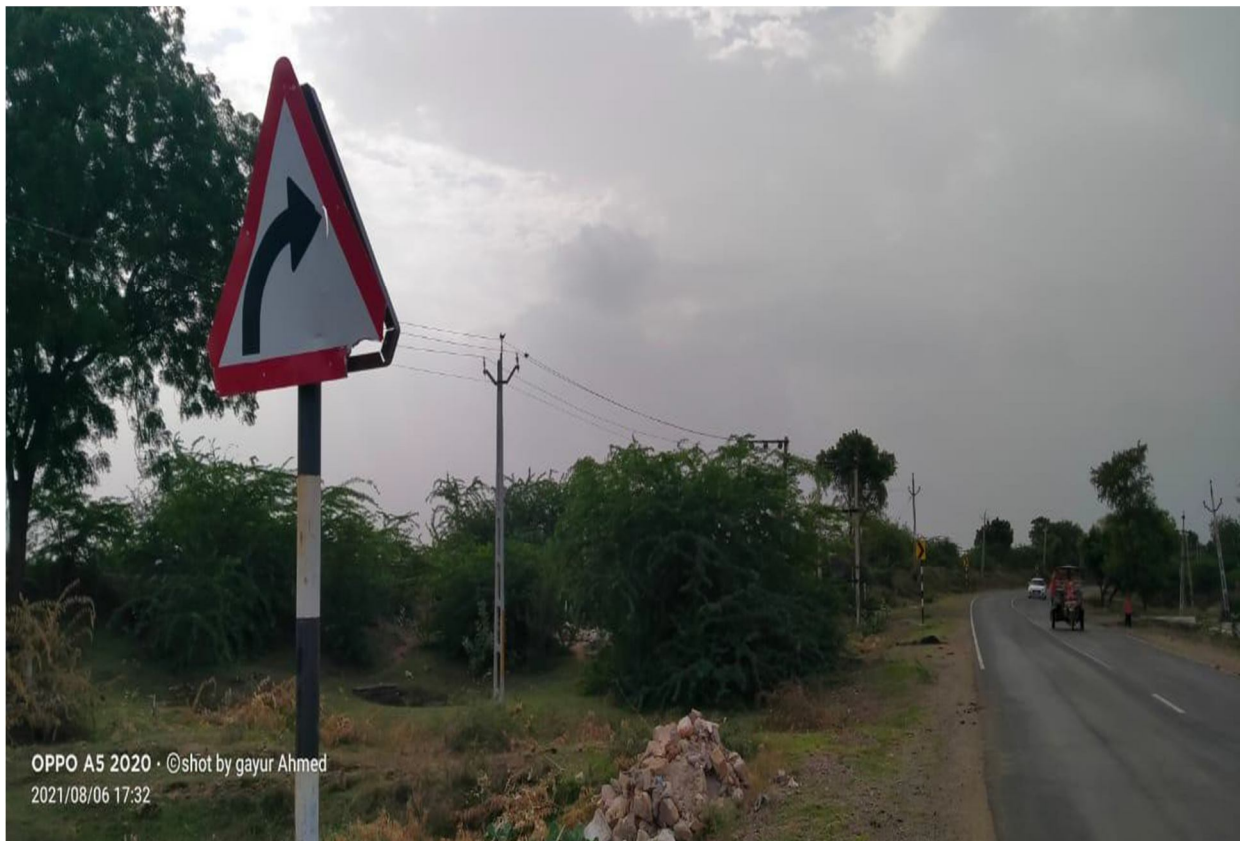
Ch. 3+635 Left turn sign board found in damaged condition & construction material dumped near shoulder

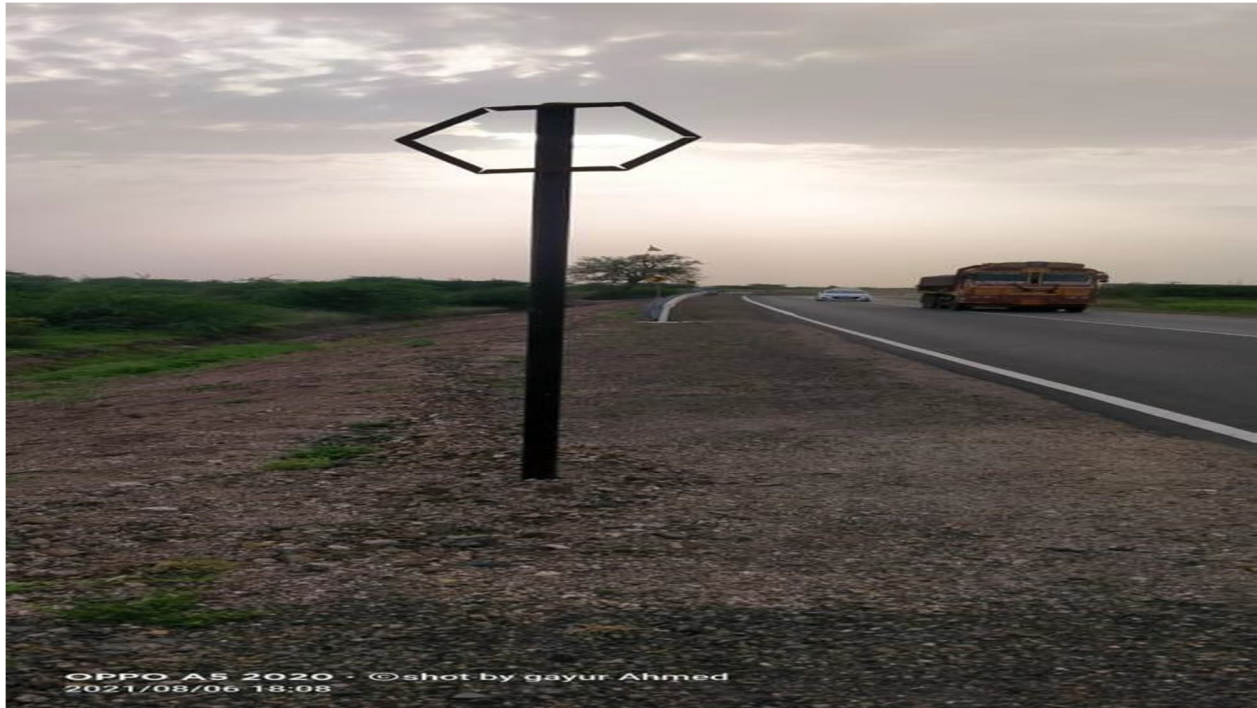
Sign board found damaged at Ch. 7+290

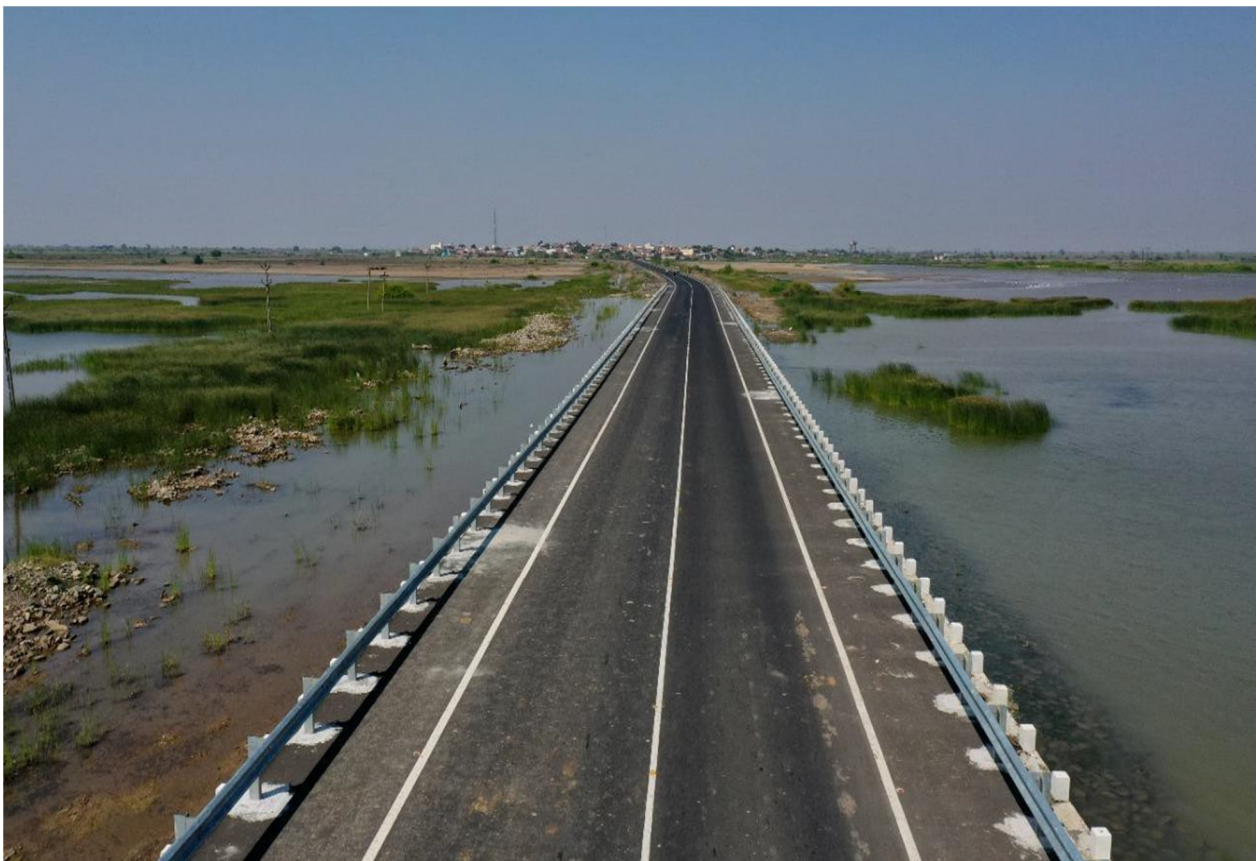
24+260 Left turn chevron sign are missing & protection wall has been suggested in place of W-Beam cross barrier

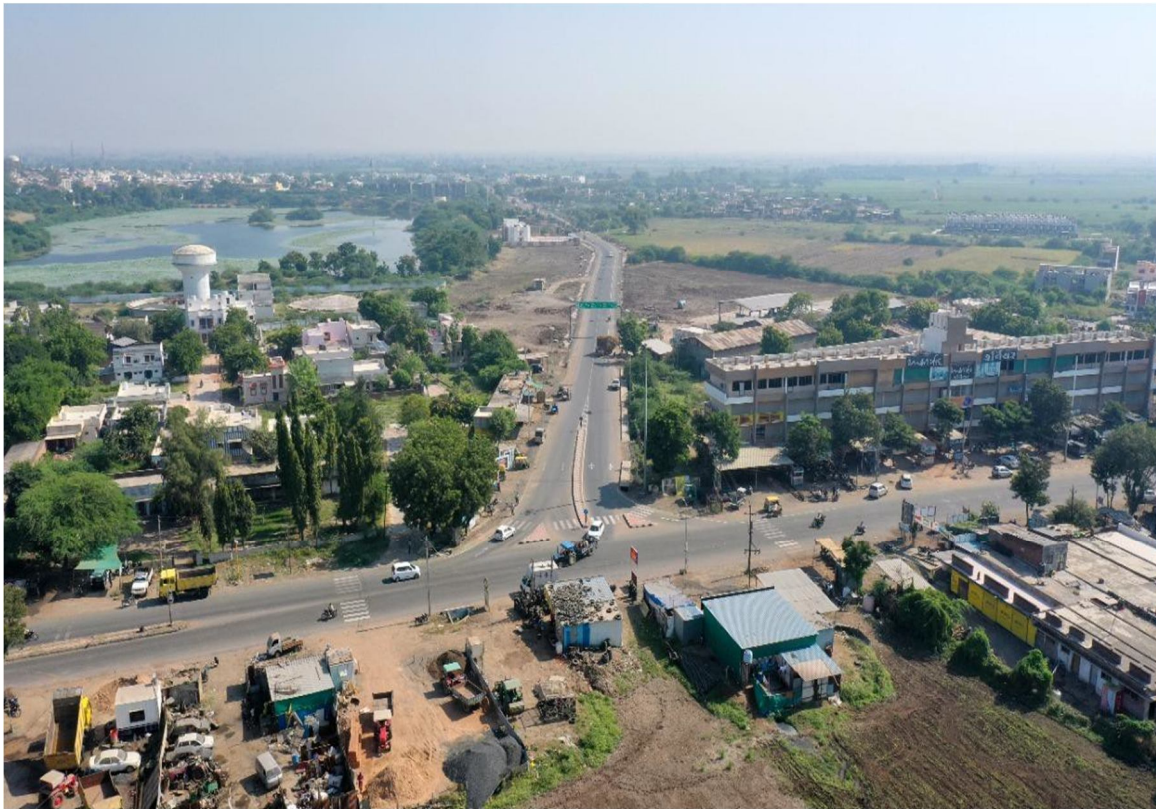
Ch. 0+000 Black Spot point Observed

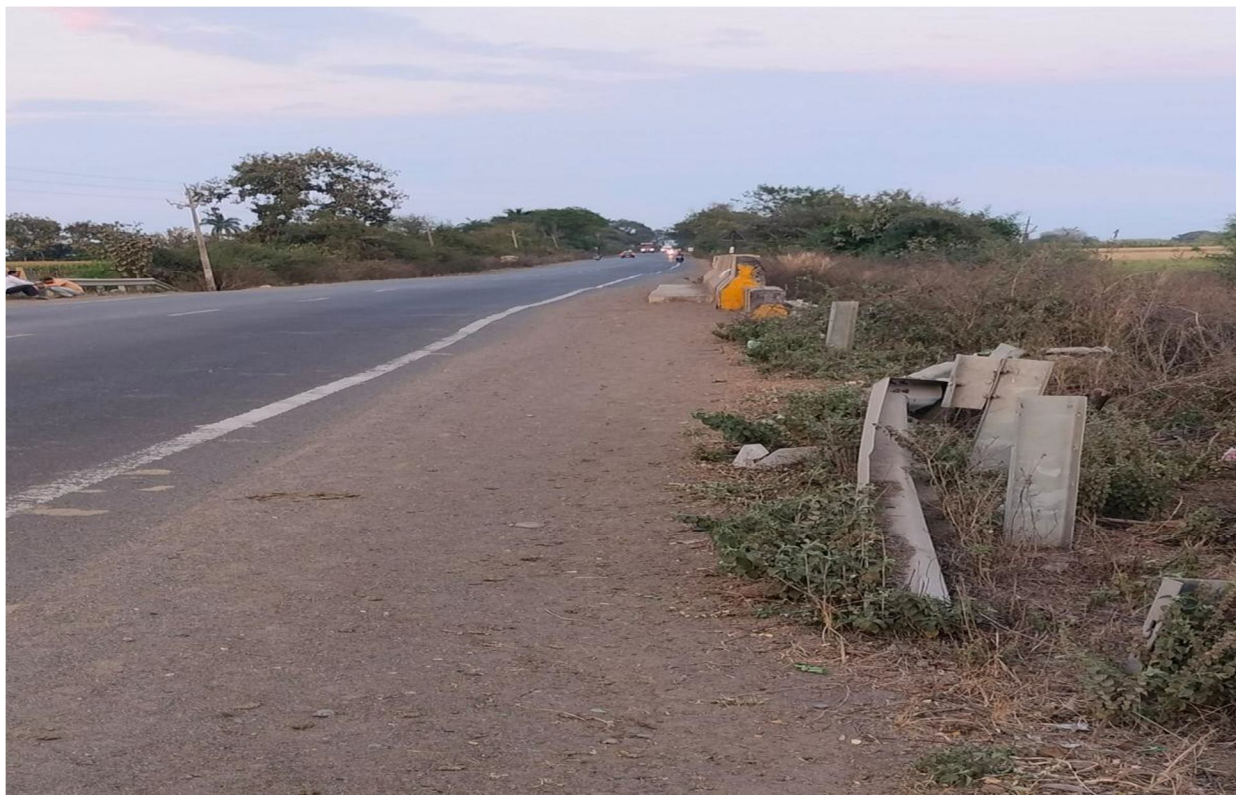
Ch. 15+750 Metal Beam Crush Barrier (MBCB) damaged must be repaired

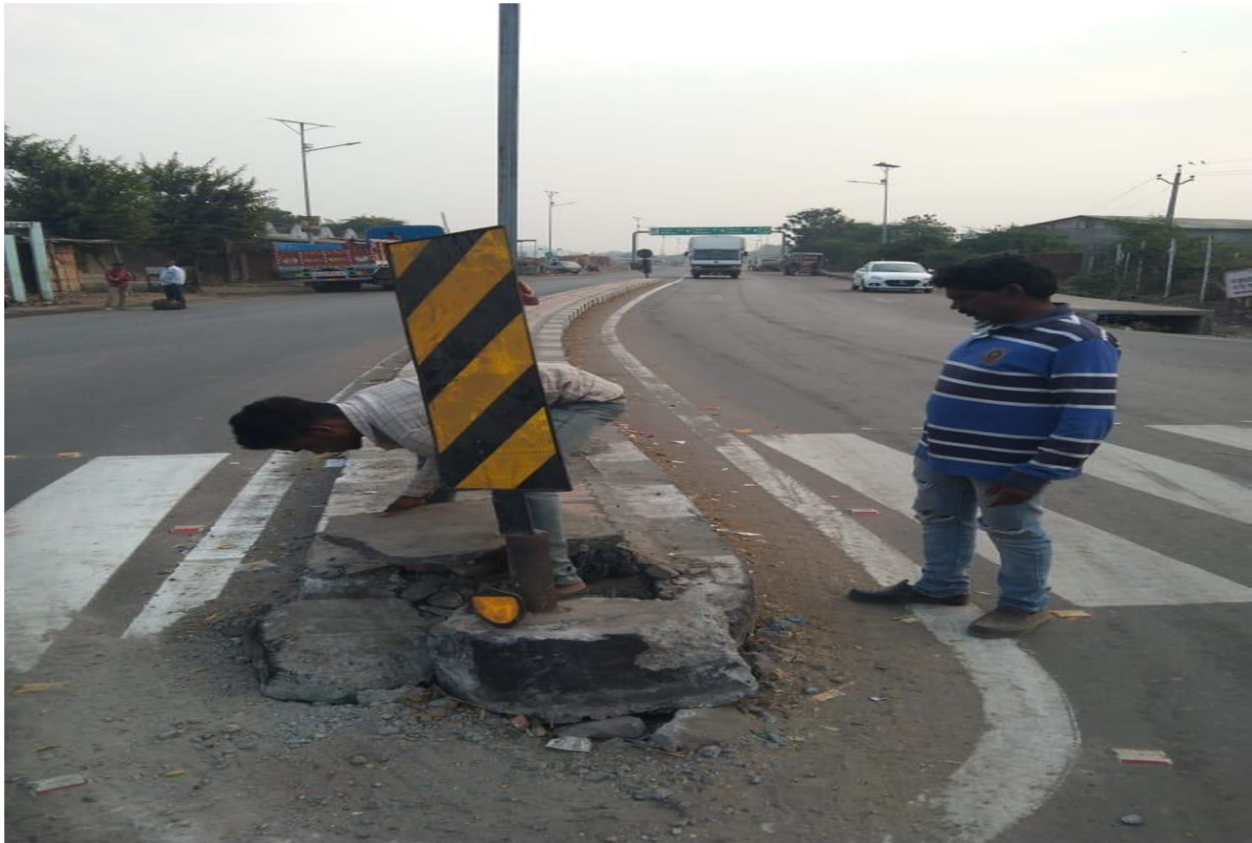
Ch. 0+010 Damaged delineator sign board should be changed & median side kerb should be repaired.

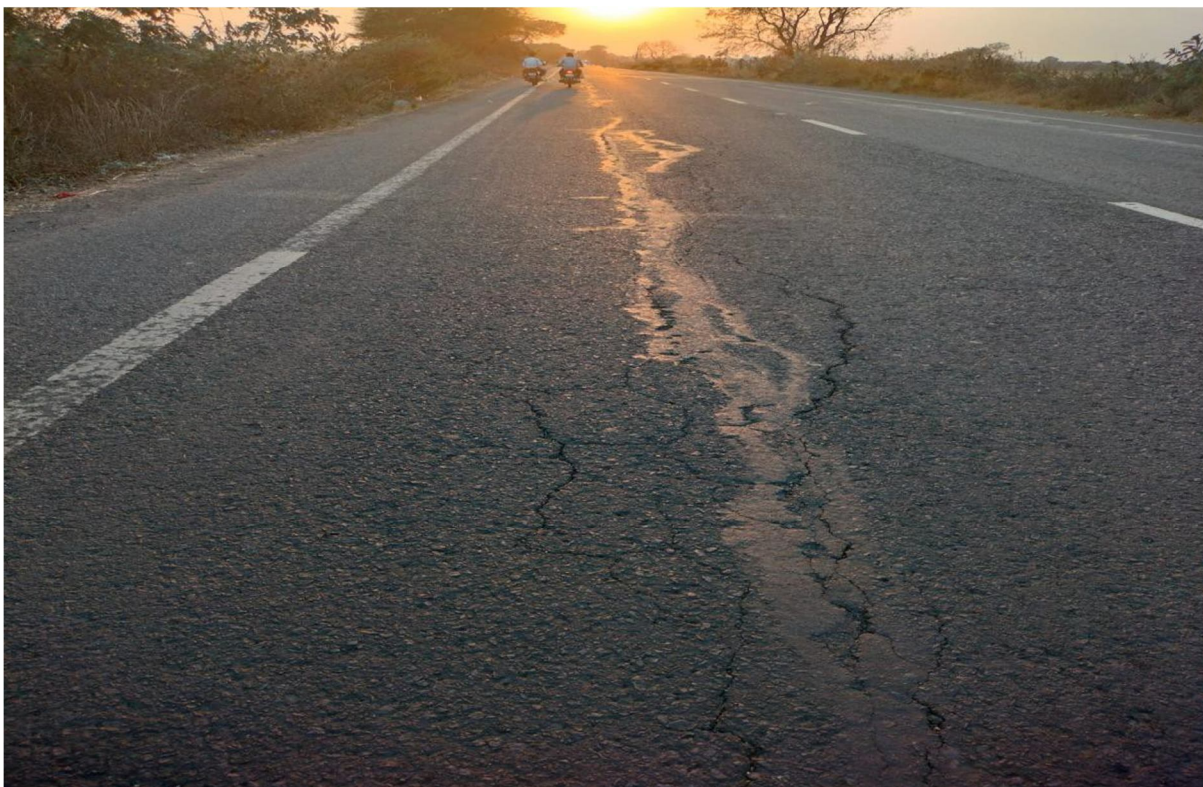
Ch. 3+530 Alligator cracking is observed on Pavement Surface

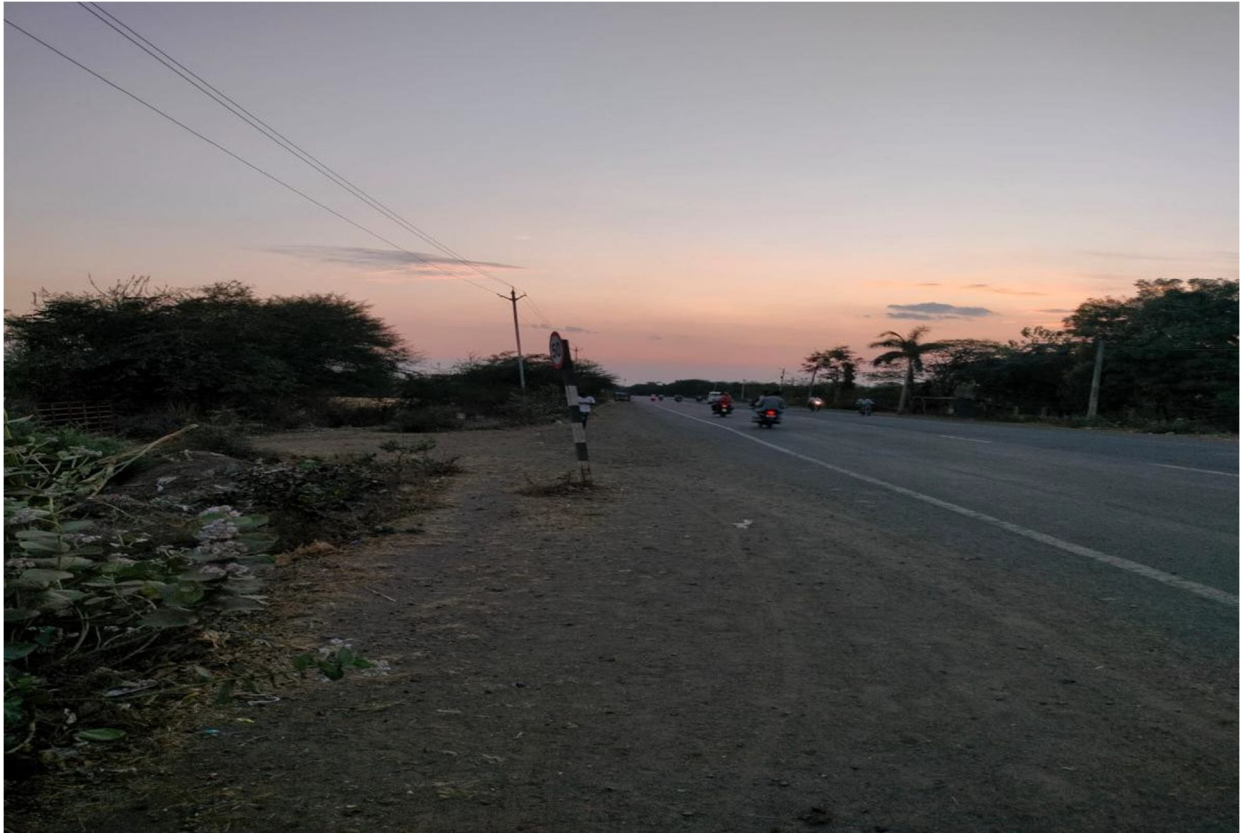
Ch. 20+560 Damaged Speed Limit Sign Must be repaired

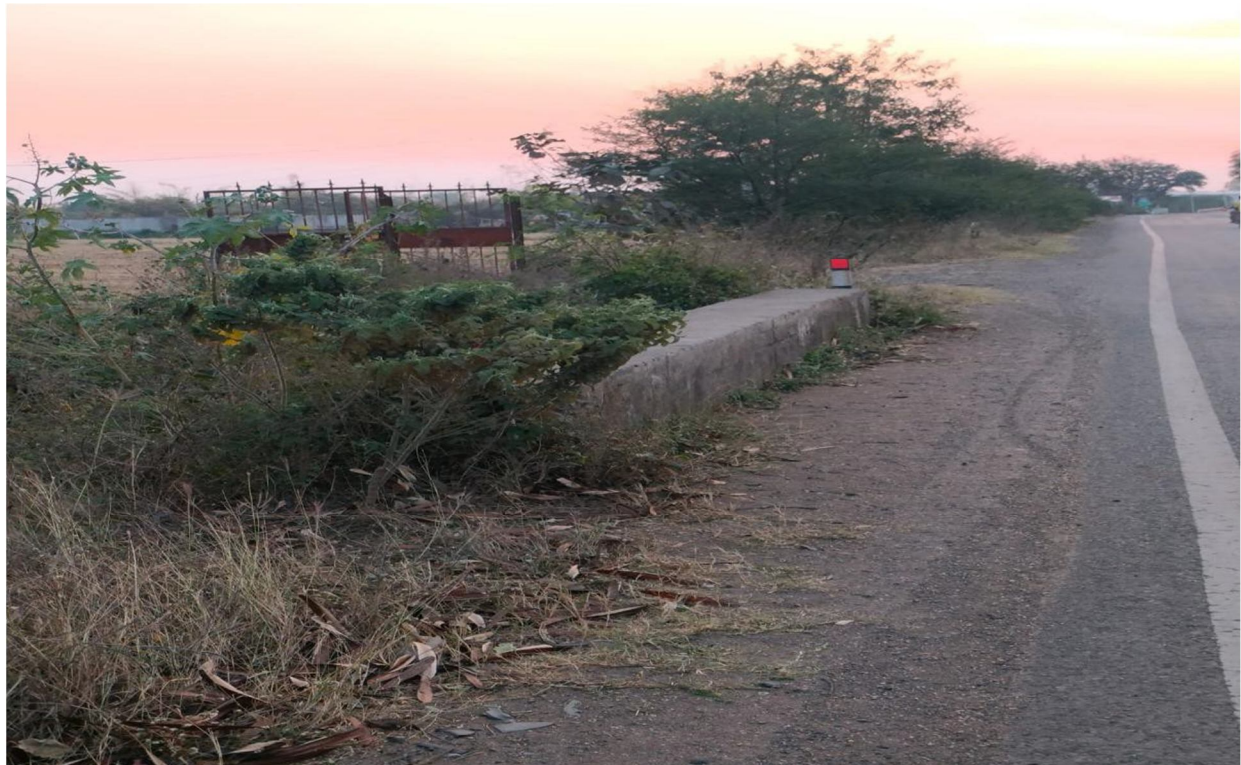
Ch. 17+574 Pipe Culvert Should be painted as per specification
