# Road Safety Audit: A Detailed Analysis of Dhandhuka to Dholera (SH-20) in Gujrat State

Mateen Ahemed<sup>1</sup>, Dr. Sunil Sugandhi<sup>2</sup>

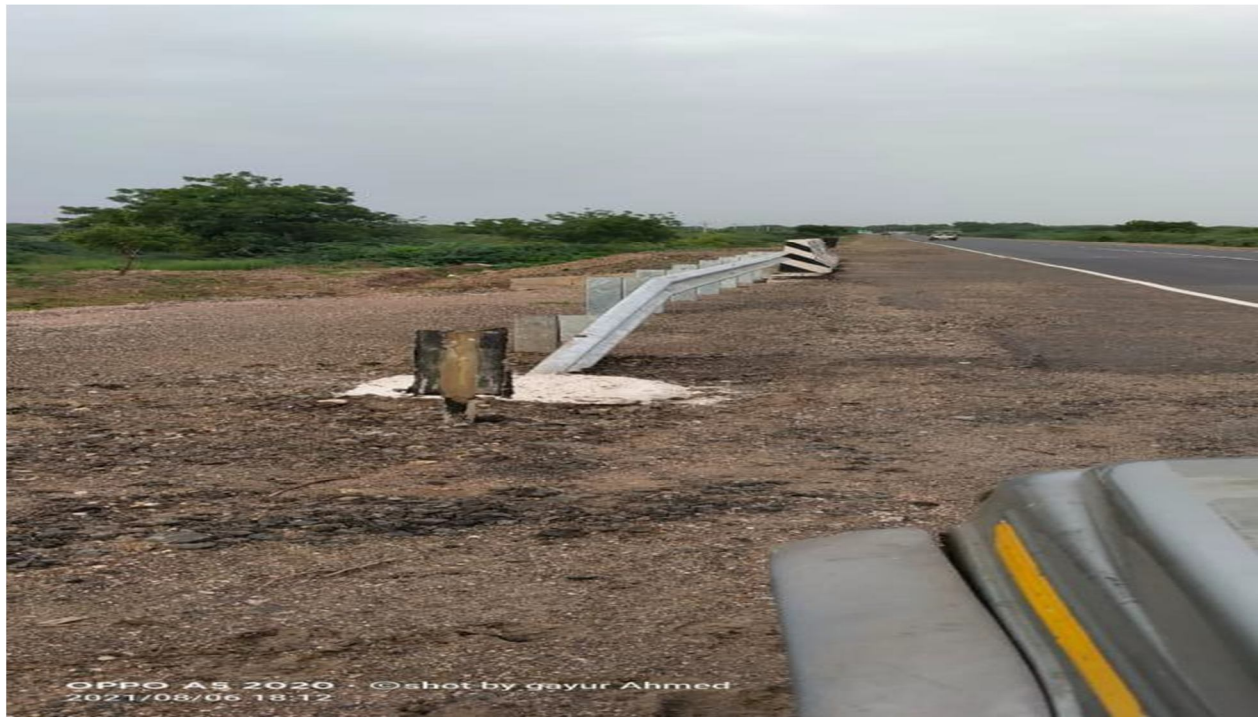
Ch. 7+700 Hazard marking sign board found damaged & faded condition

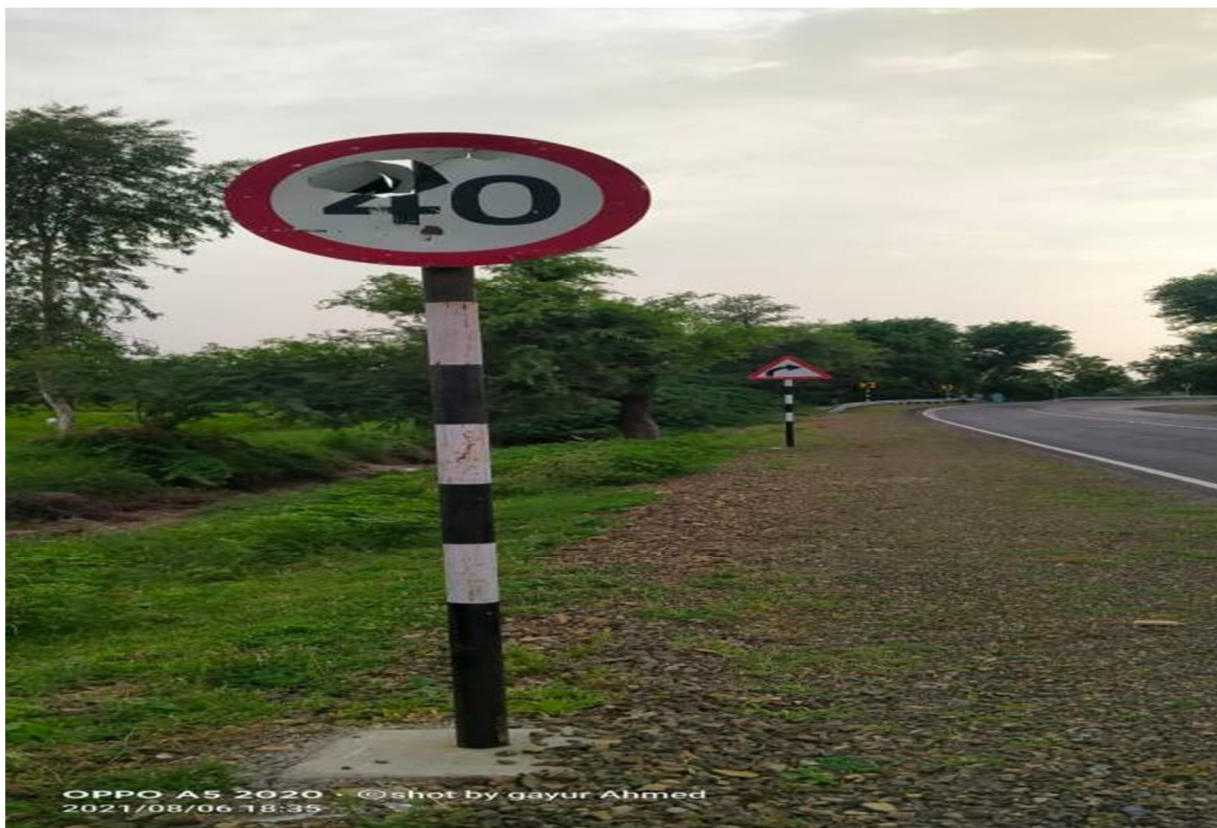
Ch. 16+485 Speed Limit sign board found in damaged condition

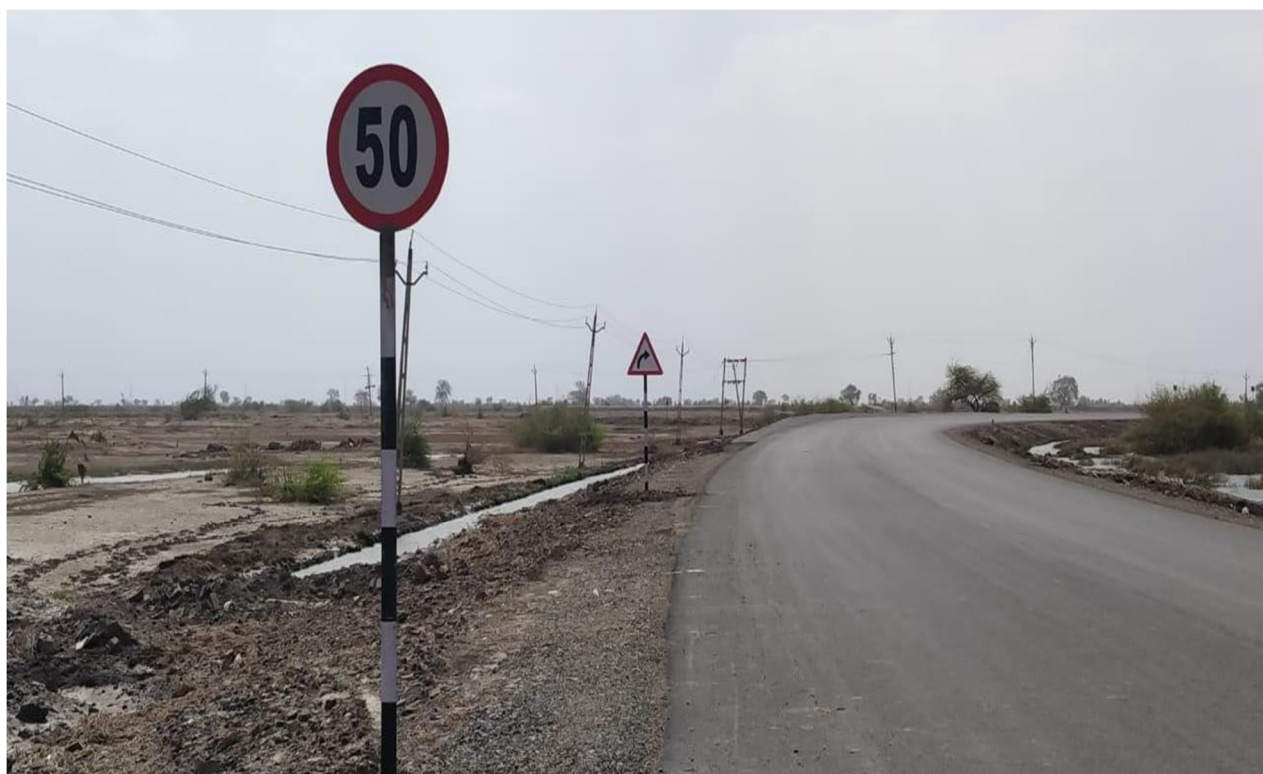
Ch. 20+900 Missing road marking & rain cuts observed near earthen shoulder

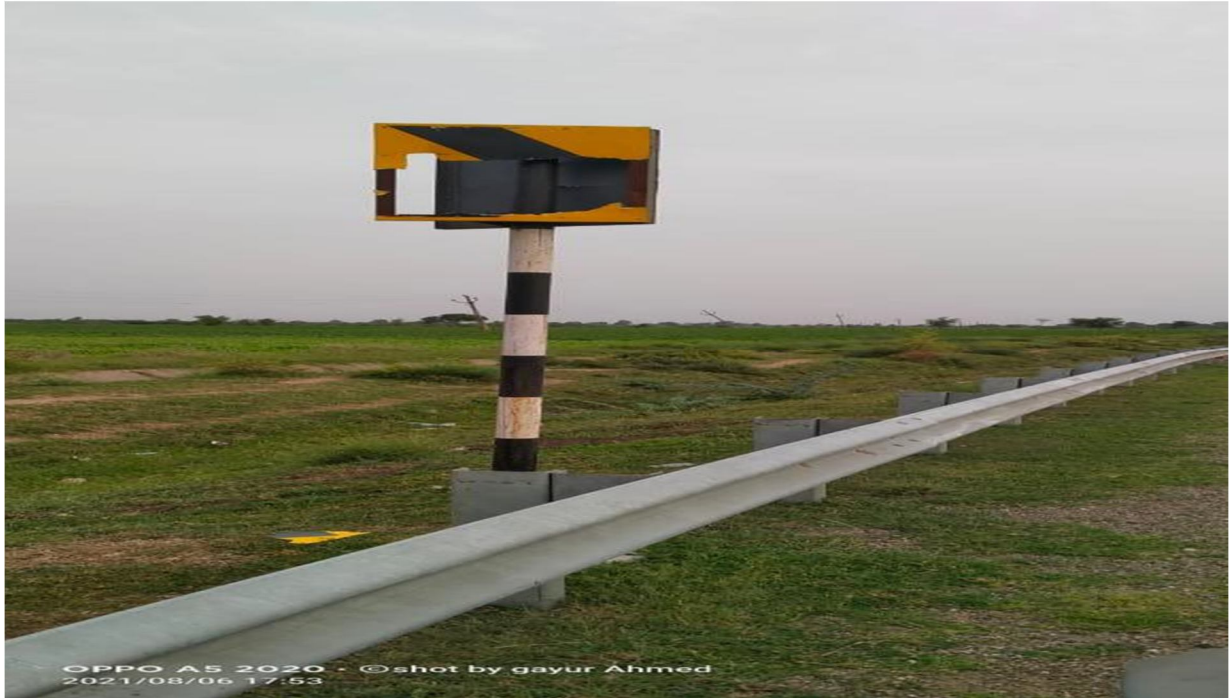
Ch. 16+440 Right hand chevron sign board found in damaged condition

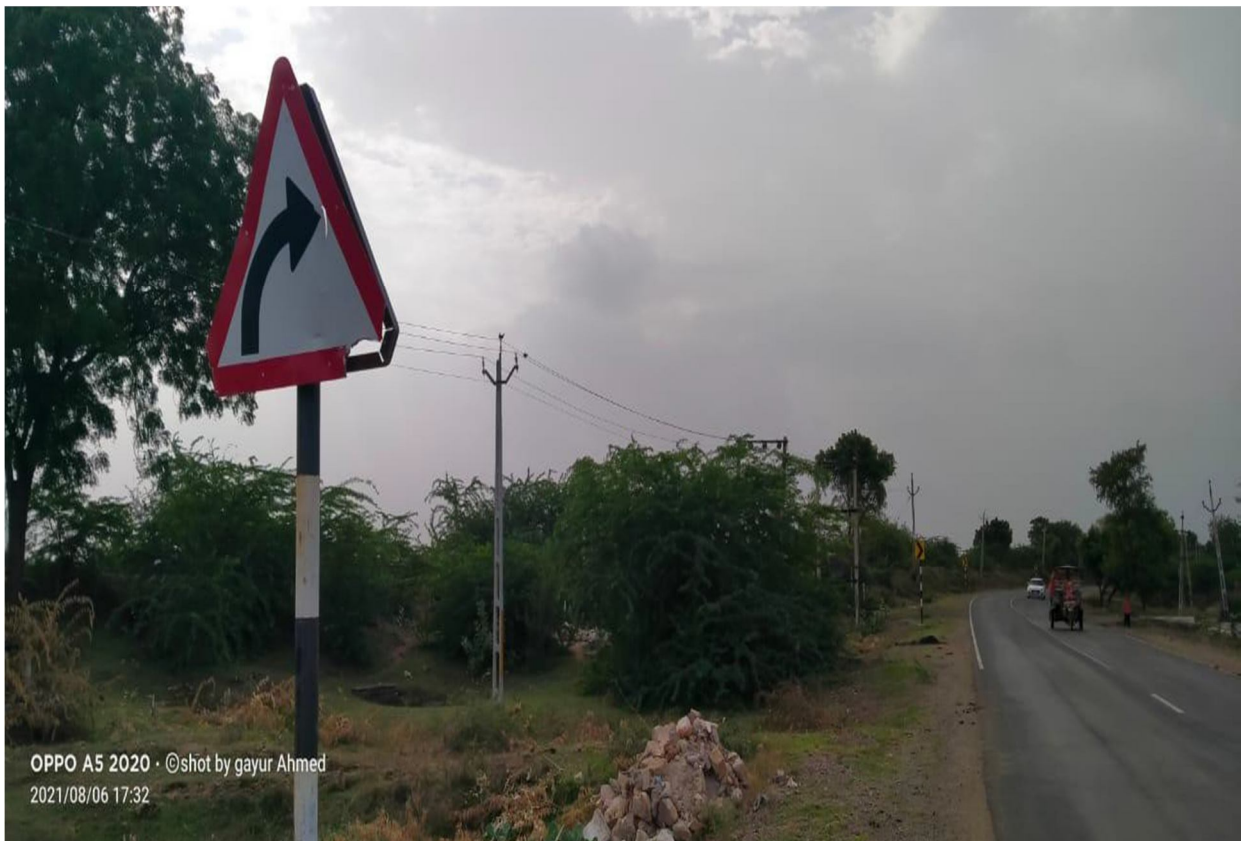
Ch. 3+635 Left turn sign board found in damaged condition & construction material dumped near shoulder

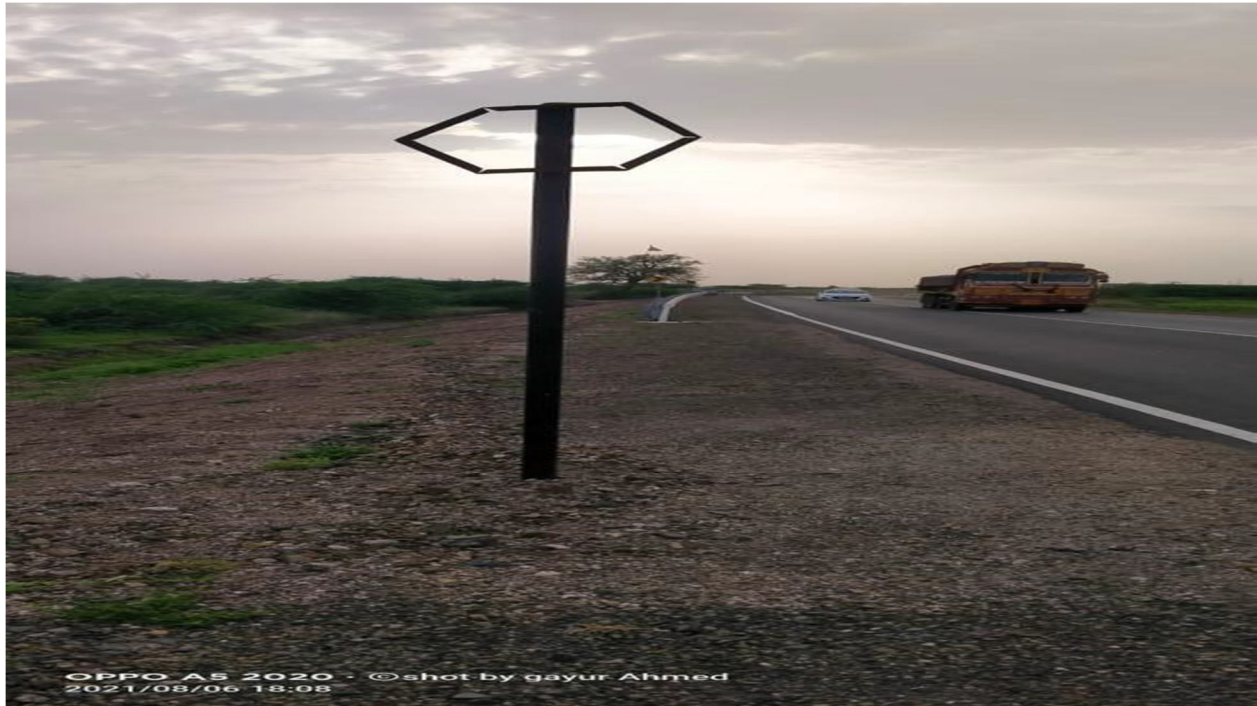
Sign board found damaged at Ch. 7+290

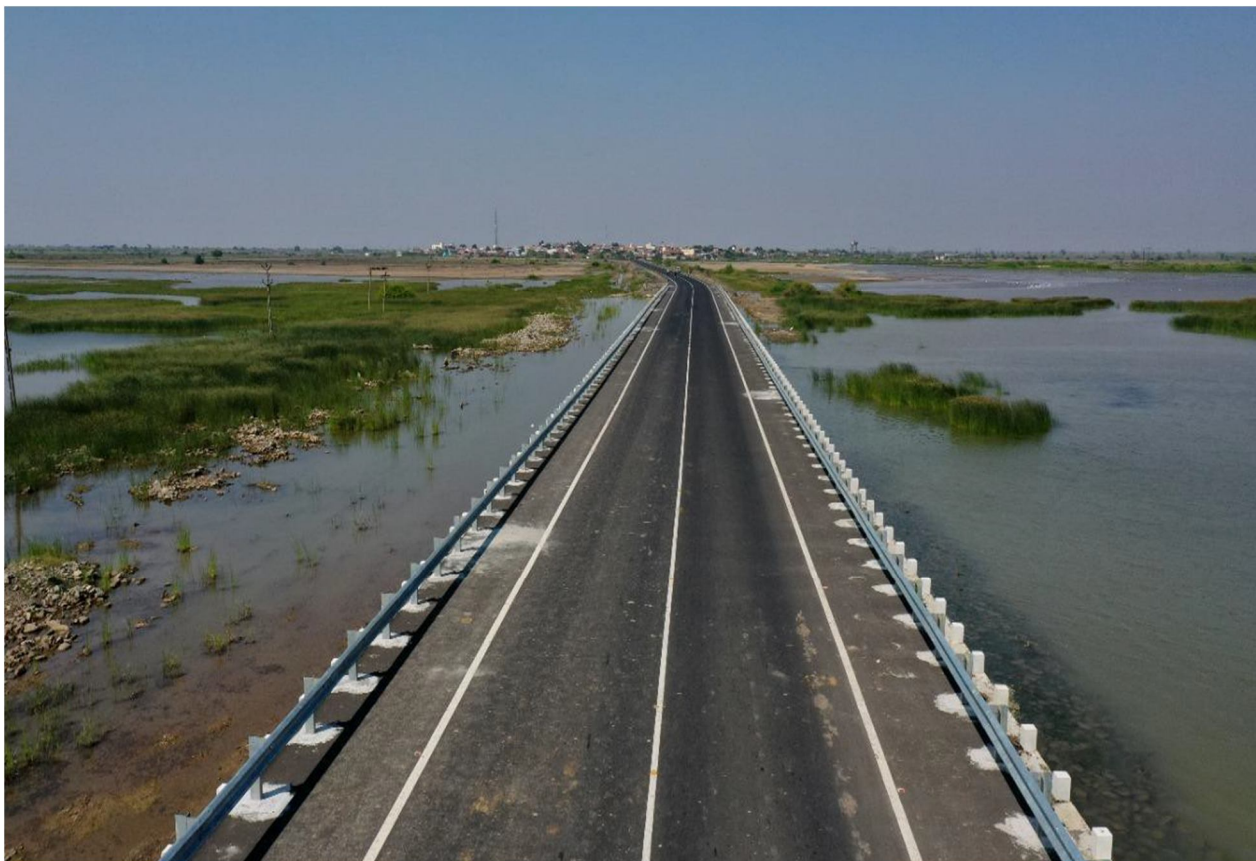
24+260 Left turn chevron sign are missing & protection wall has been suggested in place of W-Beam cross barrier
