Road Safety Audit: A Detailed Analysis of Dhandhuka to Dholera (SH-20) in Gujrat State

Mateen Ahemed¹, Dr. Sunil Sugandhi²

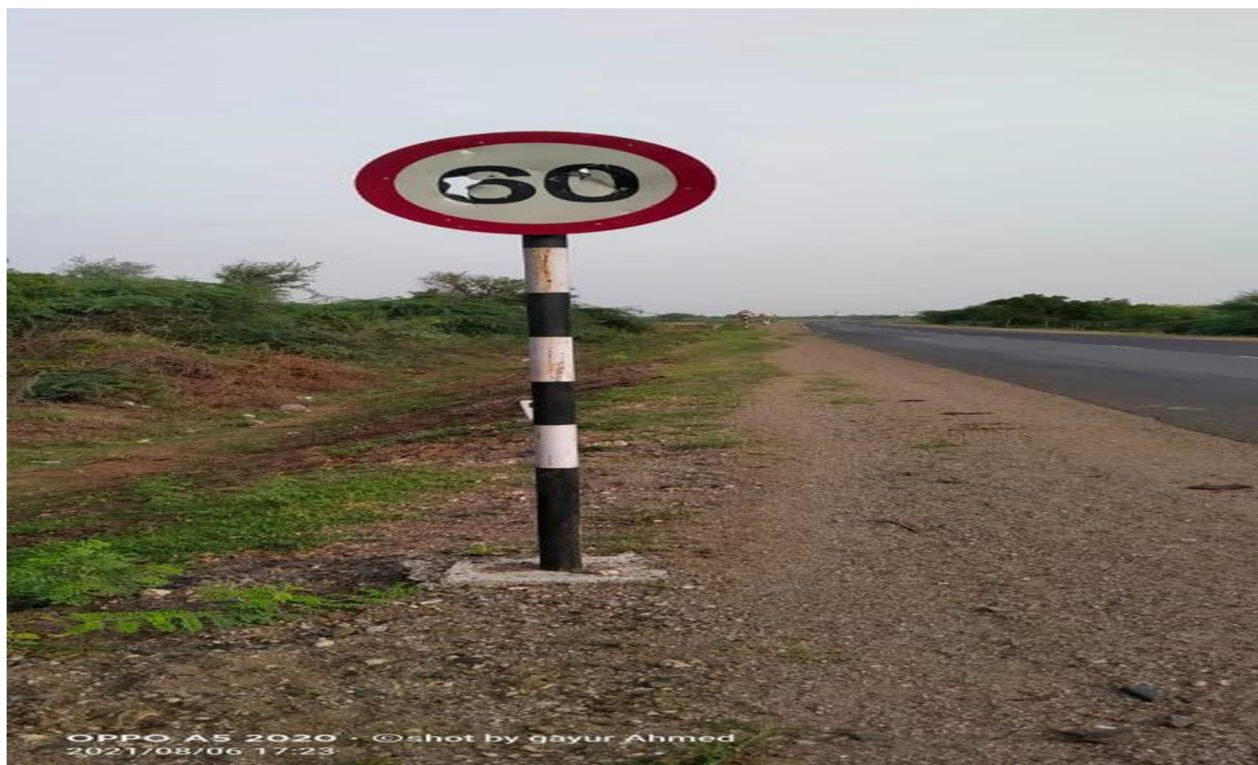
Ch. 26+500 Damaged speed limit sign board

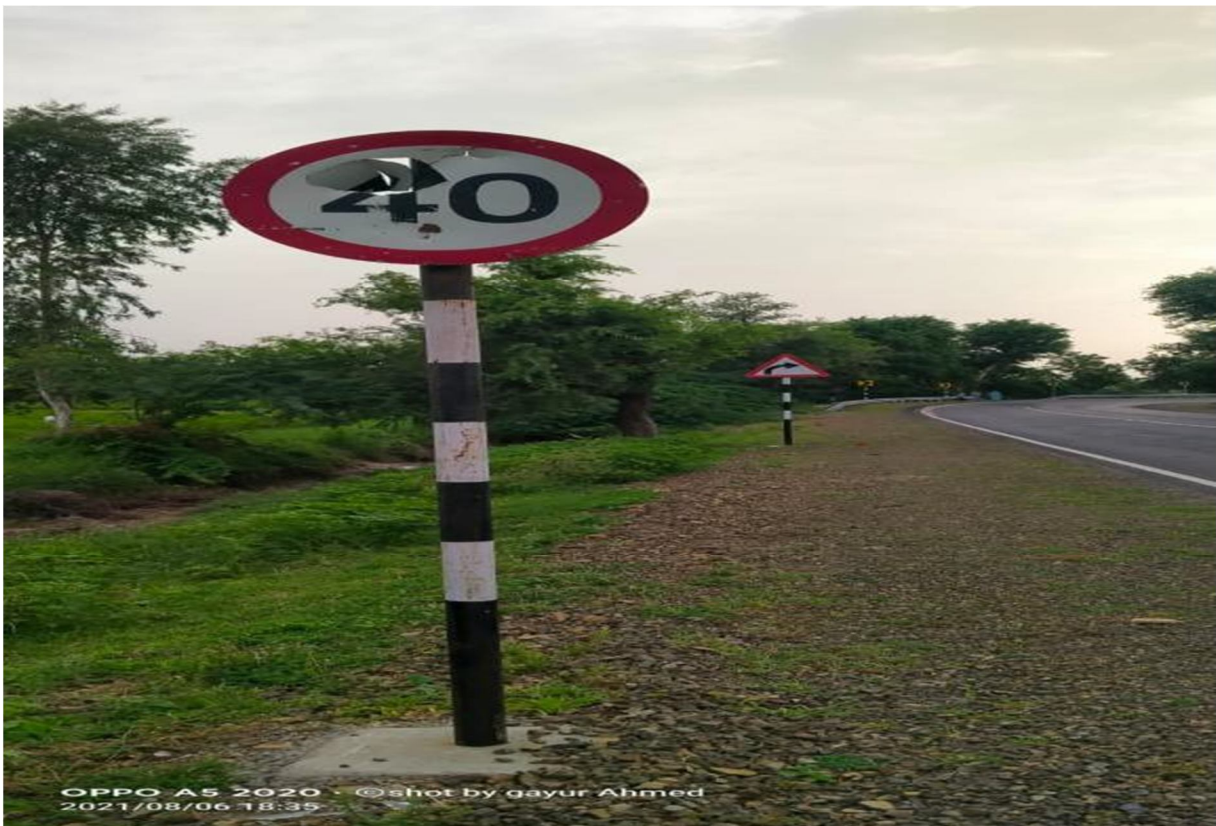
Ch. 16+485 Speed Limit sign board found in damaged condition

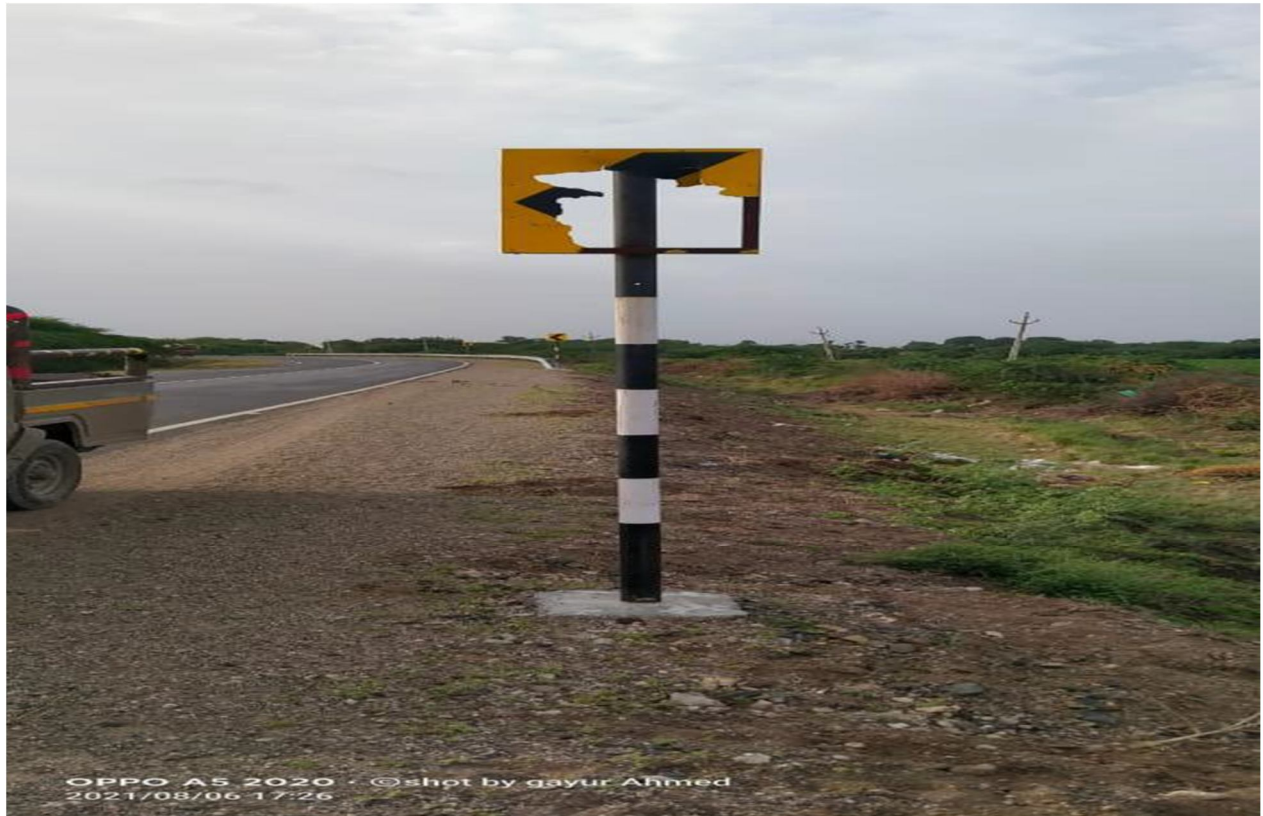
22+300 Left turn chevron sign board found in damaged condition

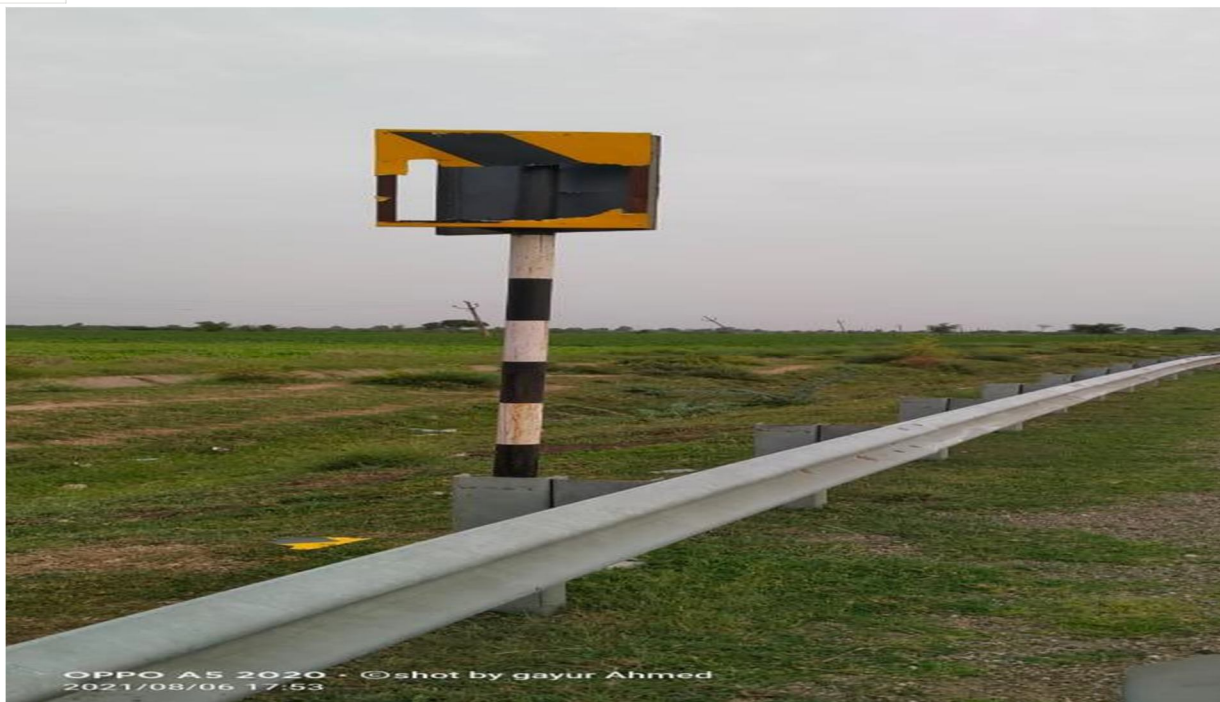
Ch. 16+440 Right hand chevron sign board found in damaged condition

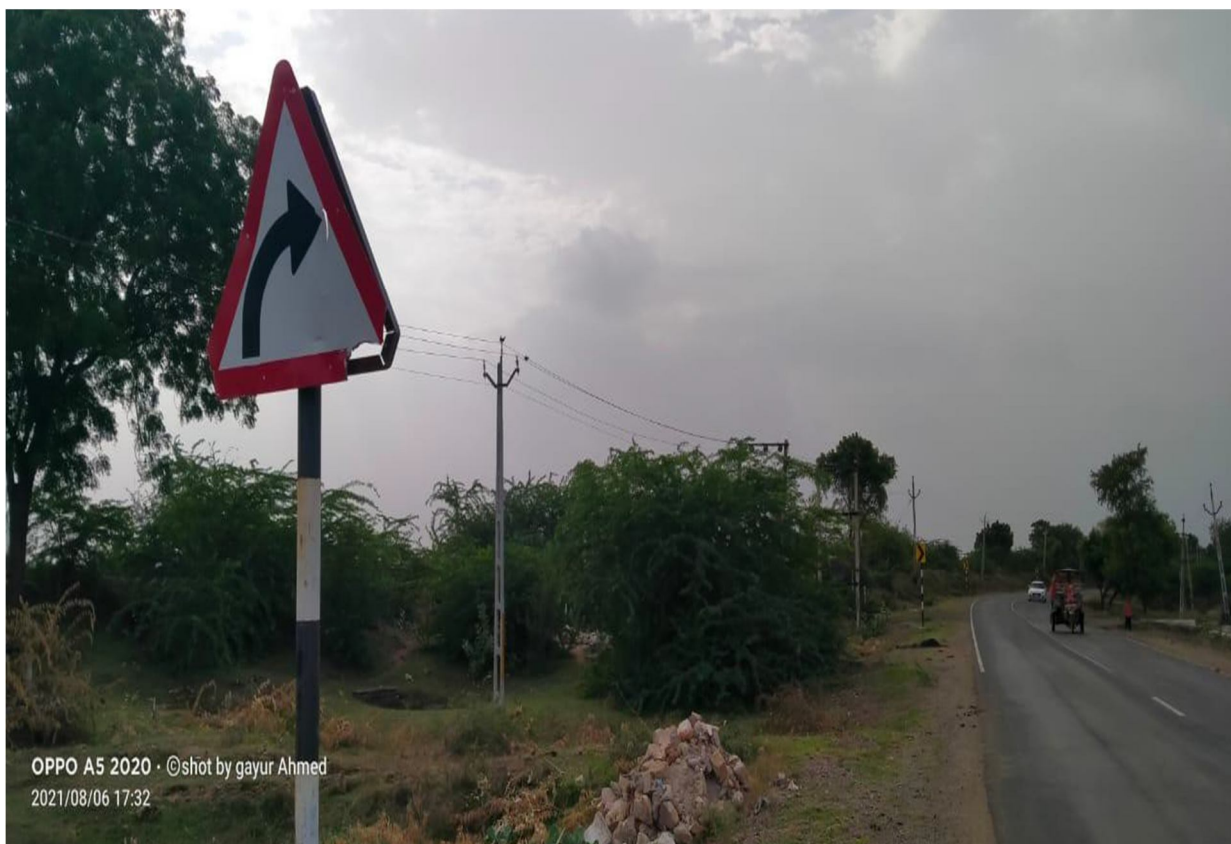
Ch. 3+635 Left turn sign board found in damaged condition & construction material dumped near shoulder

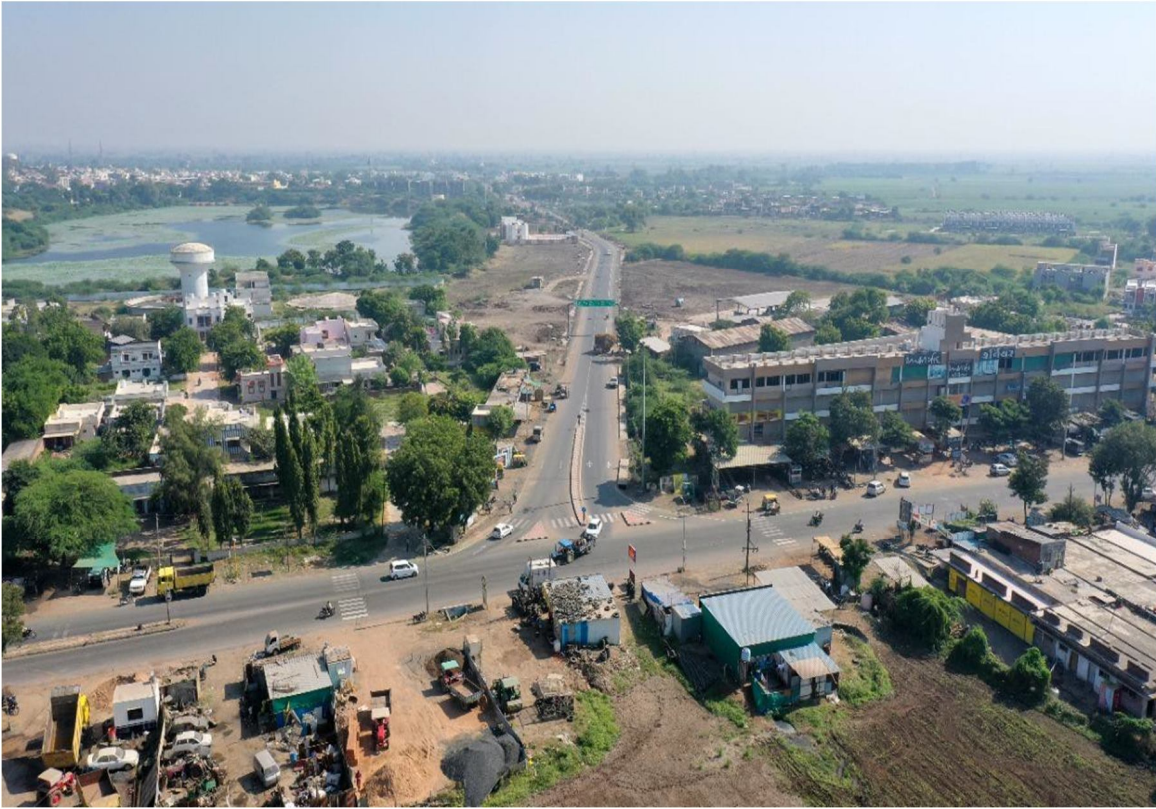
Ch. 0+000 Black Spot point Observed

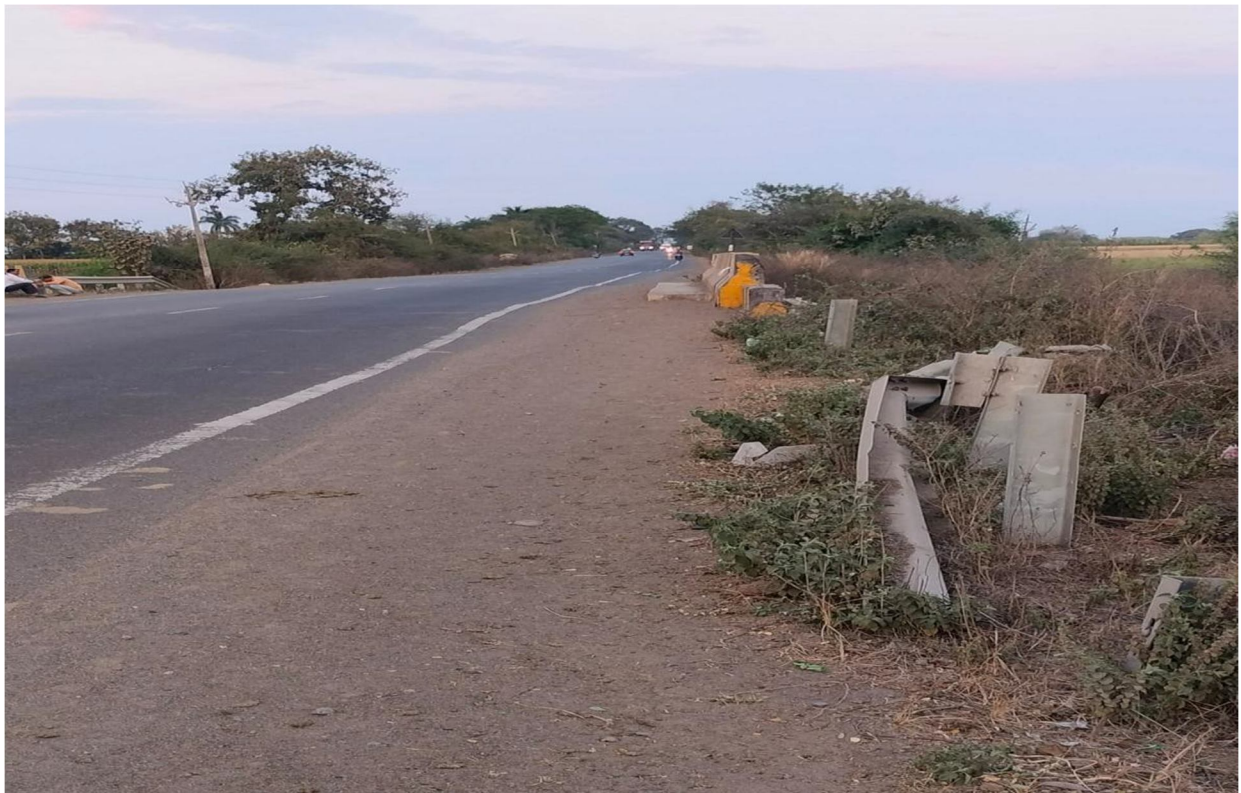
Ch. 15+750 Metal Beam Crush Barrier (MBCB) damaged must be repaired

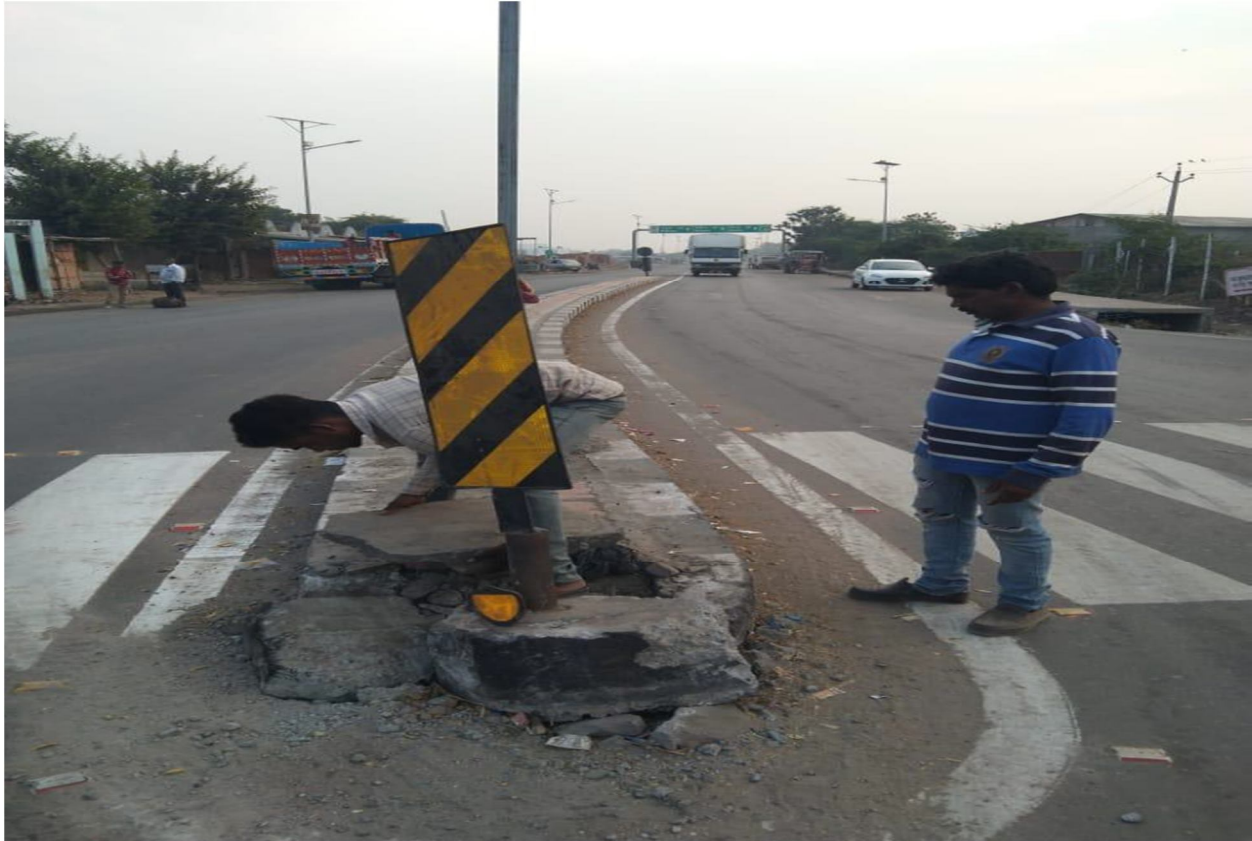
Ch. 0+010 Damaged delineator sign board should be changed & median side kerb should be repaired.

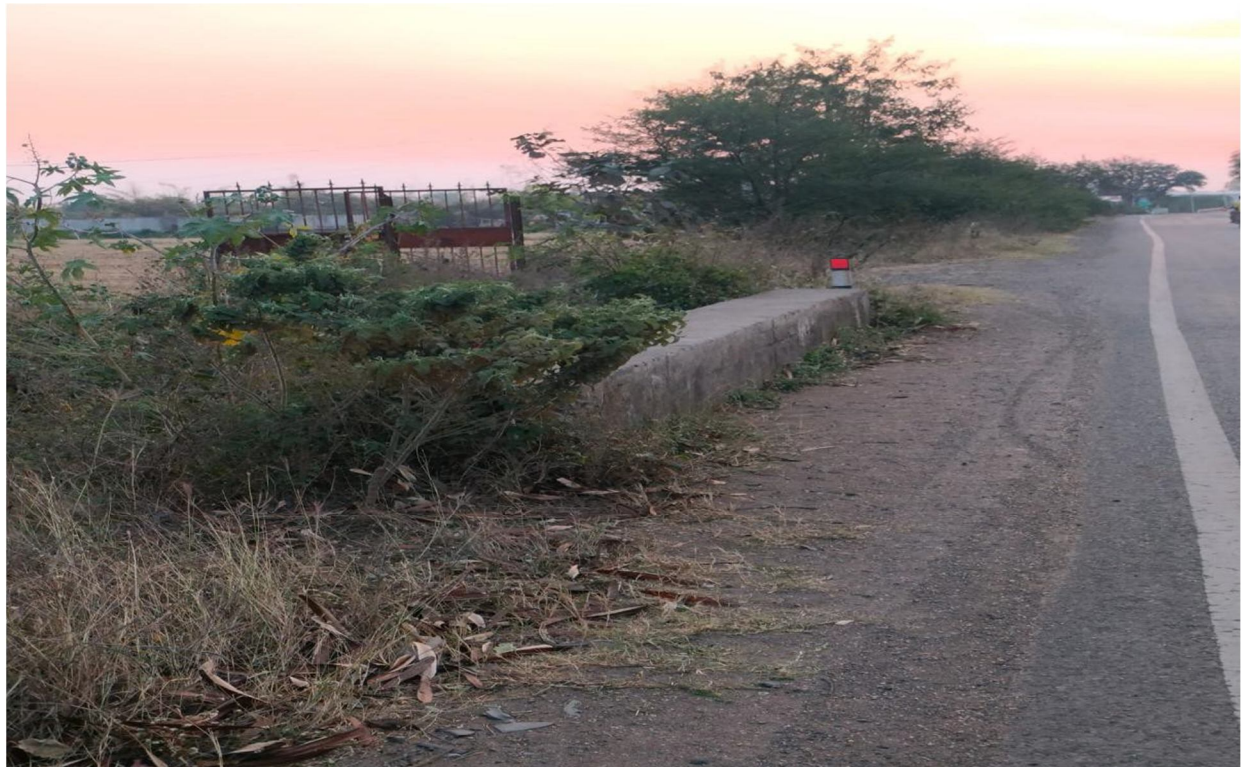
Ch. 17+574 Pipe Culvert Should be painted as per specification
