Improvisations in Traditional Lime Work, Punjab, India

The case for study is a traditional historic Havelli (Mansion) in Punjab restored by the author as site Conservation Architect under the guidance of CRCI, New Delhi. The project was completed in a span of 6 months in 2008. Many a restorative techniques used are non-conventional and help in giving a new direction to the traditional processes of restoration.

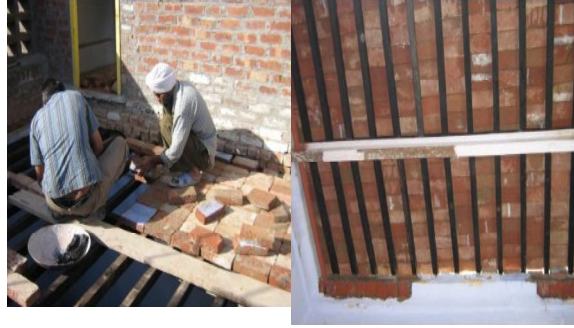
First layer of tile laid

Soffit of roof restored

- 2) *First layer of brick:* the first layer of brick was laid over the wooden purlins, reusing most of the original bricks and by inter changing the face of the brick. Whitewashed brick faces were laid facing the terrace as against their earlier positions when they were facing below.

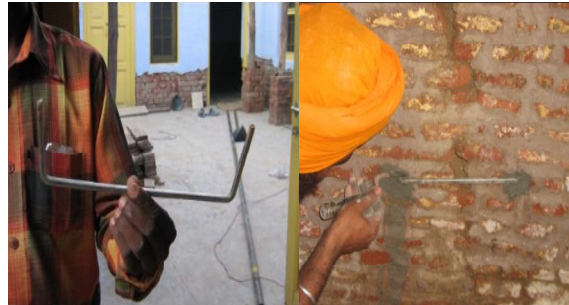
Mild steel C pin

C Pin Staple on wall crack

3) *Lime grouting*: lime pressure grouting was undertaken for consolidating a crack in masonry. The crack was first stitched with mild steel C Pins of 10mm dia. Thereafter, the crack was filled with lime grout forced into the fissures of the masonry through a grouting machine. The lime forced with pressure reaches the internal fissures of the masonry and fills in the gap. This operation though proved to be a failure in the said case and the wall in 24hrs time bulged out. After further investigation into the cause of the same, it was learnt that the wall so treated has internal mud mortar layer and the thus the mud after absorption of moisture from lime grout swelled up causing the bulging effect in the wall.

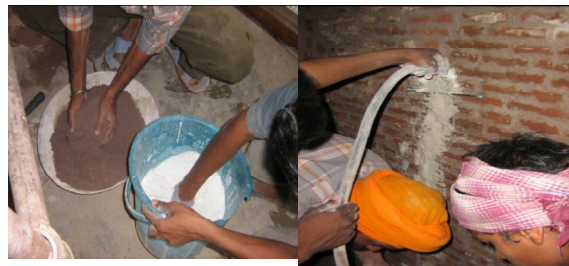
Lime grouting mixture

Lime grouting of crack

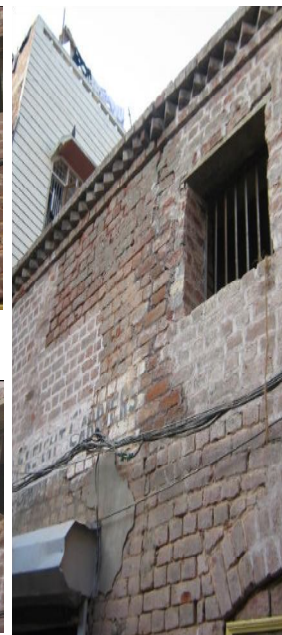
Crack masonry opened up

Consolidated restored wall

- 4) *Masonry consolidation through rebuilding*: Many cracks in the masonry which were only one course deep were restored by removing the bricks and re-laying the masonry in lime mortar, carefully building in interconnected joints between the new and old masonry. The important aspect to take into account though is that before consolidating the masonry the probable cause for crack was identified and the corrective measures were taken so that the restored masonry might not fall under stress.
- 5) *Plinth protection to walls*: plinth protection was provided to walls both from the inside and outside of the building. This ensured check of rising damp in case of traditional walls lacking the damp proof course.

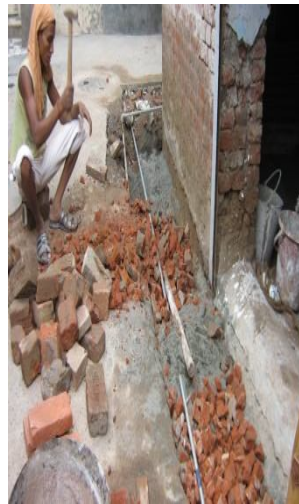
Sand and brick bat layer in plinth protection

Plinth protection layer is built by filling up a trench 750mm wide and 200mm deep. The bottom layer is filled with dry lime mortar 50mm thk. Second layer is of sand 100mm thk. Third layer is of brick bats 50mm thk. Over this the brick tile on edge layer laid in dry lime mortar sloping outward. The rainwater drain pipes open on to the plinth protection.

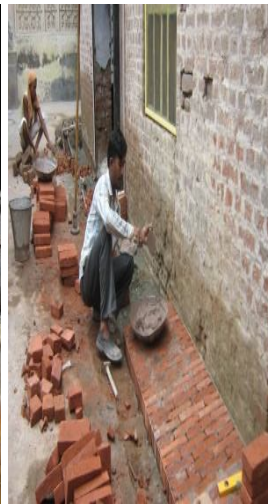
Brick on edge plinth protection in dry lime

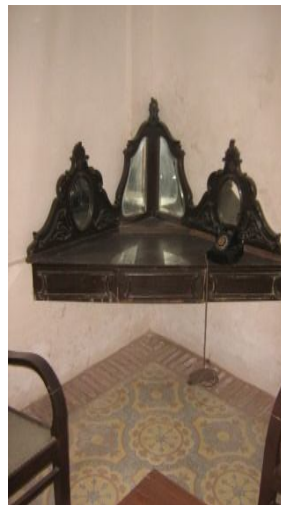
Plinth protection interiors of rooms

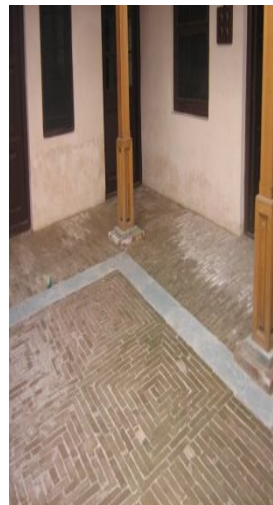
Restored brick on edge courtyard flooring

The central courtyard was restored to traditional brick on edge concentric square in lime mortar. The base was lime concrete base with brick bats, judiciously avoiding cement concreting, hence providing a pervious layer of flooring to recharge rain water. All floorings were treated with anti-termite solution to avoid infestation in future.
