Improvisations in Traditional Lime Work, Punjab, India

The case for study is a traditional historic Havelli (Mansion) in Punjab restored by the author as site Conservation Architect under the guidance of CRCI, New Delhi. The project was completed in a span of 6 months in 2008. Many a restorative techniques used are non-conventional and help in giving a new direction to the traditional processes of restoration.

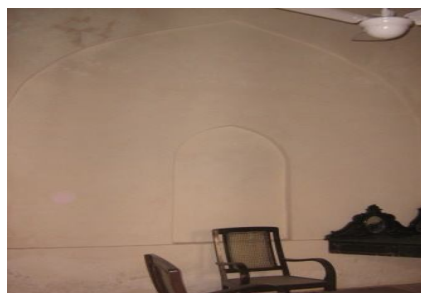
Restored lime plaster

Lime plaster is done traditionally in three coats, the thickness of the coats reduces from base layer being 45mm thick to final top layer being 20mm thick. Each layer is allowed to mature before the next layer is coated. Appropriate curing is carried out during this intermediate period. The two base layers are consolidated by beating the rendered surface with a wooden thapi and a retouch is done till no fine cracks appear on the dried surface. The layers of plaster are smoothen with wooden flat bars as against iron metal flats used in cement plaster rendered surfaces, since lime as stated earlier has a corrosive effect on iron.

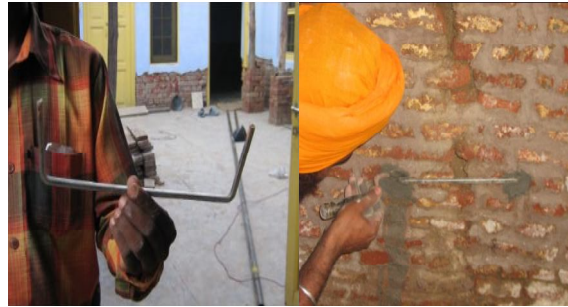
Mild steel C pin

C Pin Staple on wall crack

3) *Lime grouting*: lime pressure grouting was undertaken for consolidating a crack in masonry. The crack was first stitched with mild steel C Pins of 10mm dia. Thereafter, the crack was filled with lime grout forced into the fissures of the masonry through a grouting machine. The lime forced with pressure reaches the internal fissures of the masonry and fills in the gap. This operation though proved to be a failure in the said case and the wall in 24hrs time bulged out. After further investigation into the cause of the same, it was learnt that the wall so treated has internal mud mortar layer and the thus the mud after absorption of moisture from lime grout swelled up causing the bulging effect in the wall.

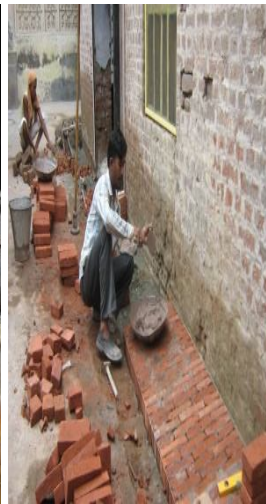
Brick on edge plinth protection in dry lime

Plinth protection layer is built by filling up a trench 750mm wide and 200mm deep. The bottom layer is filled with dry lime mortar 50mm thk. Second layer is of sand 100mm thk. Third layer is of brick bats 50mm thk. Over this the brick tile on edge layer laid in dry lime mortar sloping outward. The rainwater drain pipes open on to the plinth protection.

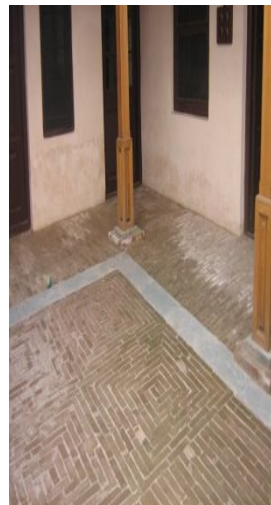
Restored brick on edge courtyard flooring

The central courtyard was restored to traditional brick on edge concentric square in lime mortar. The base was lime concrete base with brick bats, judiciously avoiding cement concreting, hence providing a pervious layer of flooring to recharge rain water. All floorings were treated with anti-termite solution to avoid infestation in future.
