Road Safety Audit and a Case Study of SH-26 & SH-27 from Khandwa to Sanawad (M.P.) India

Siddhant Karahe¹, Dr. Sunil Sugandhi²

¹P.G.scholar, Transportation Engineering, ²Professor and Dean academic, Civil Engineering Department of Jawaharlal Institute Of Technology Borawan, Khargone (M.P) India

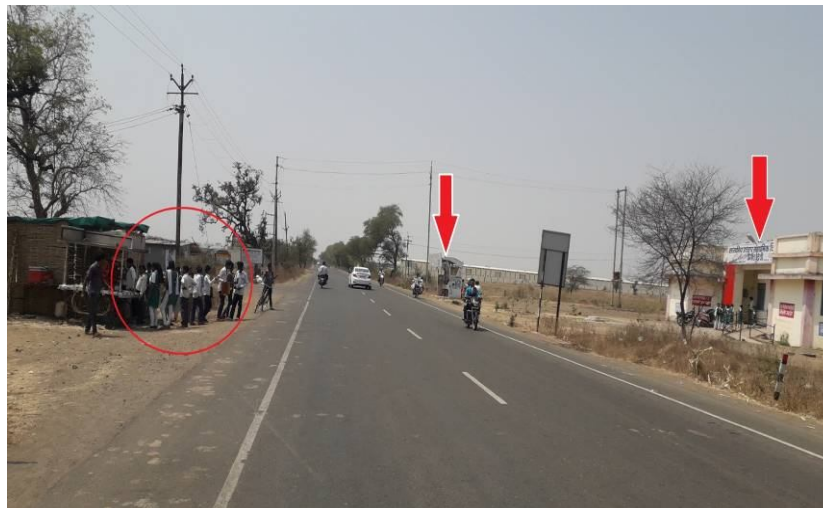
Figure 4:- No signs boards, road markings and speed breaker In Front of Govt.School Takali Mori (Chhegaon Devi)

C. Figure 4 showed that there is a school on the right side of the highway near Takali mori (Chhegaon Devi). It is approximately outside the nearby village, and it appears most of the young children attending the school walk along the edge of the highway from the village. This exposes them to a risk of a collision with fast-moving traffic. Young children who attend the school cross the highway. This location is identified as hazardous locations during safety audit. Appropriate crossing sites are not found with proper signs, marking, delineations and speed reducing devices and proper engineered speed-breakers are also not found at this place.

- C. Pedestrian crossing markings, speed breaker on both side (enter& exist of school zone) with markings should be provided and speed limit sign board to control the speed of the vehicle. Appropriate speed reducing devices prior to the locations are to be provided. Crosswalks with appropriate marking and delineations should be placed. Appropriate signs should be erected to warn through traffics about school zones.

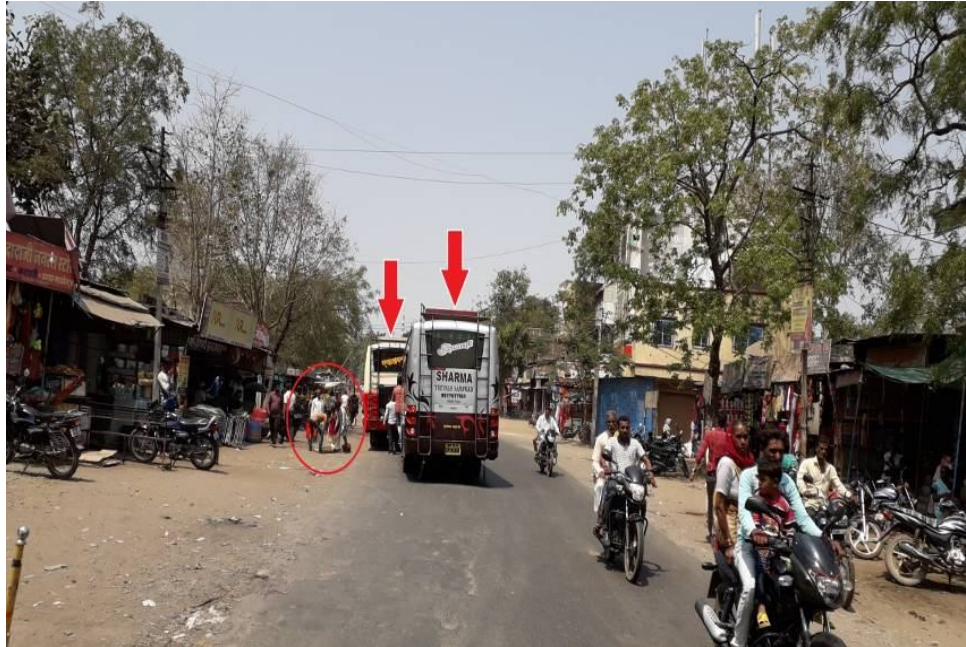
Figure 5:- Passenger boarding and alighting, bus stops on the carriageway of the highway at chhegaon Makhan (kherda village)

- D. Figure 5 showed that road markings missing and Passenger boarding and alighting, bus stops placed exactly at the carriageway of the highway. Stoppage makes movement of through vehicles unsafe and on the highway congestion and compels through vehicles to use opposite lane on the highway. Further, people also waited for public transport System on road side and created lot of congestion problems on road side. Bus stops causes' traffic jams on the highway and even accidents.

- D. Proper road markings should be given on the road. Zebra crossing and Stoppage of vehicle on the carriageway is to be strictly prohibited. Stoppage of passenger bus should be on bus stand only.

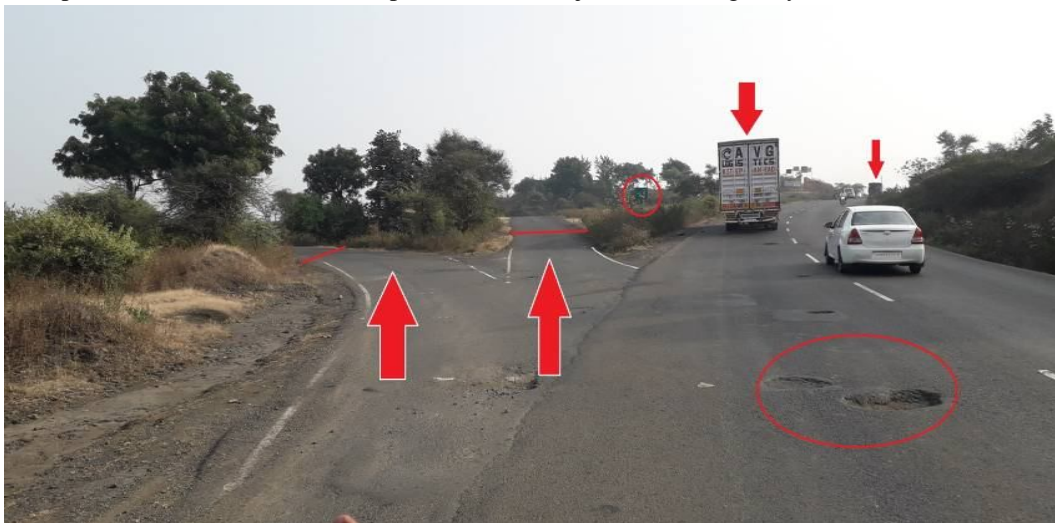
Figure 6:- Heavy trucks do not follow diversion road and rule & regulations and potholes at ghat section between Chhegaon Makhan (Kherda village) To Roshiya

- E. Figure 6 showed that due to speed difference, heavy vehicles need to have a special lane for it not only to improve the traffic performance but also for safety purpose. To avoid the steep gradient for heavy vehicle diversions are given as shown in photo but the heavy trucks not follow the rule & regulation and go straight on steep gradient which results in a higher crash risk. Heavy vehicle (i.e. trucks) need more space due to their large dimensions but the diversions which are given have not proper width. It shows the speed of the heavy vehicle in the uphill grade is slower than passenger cars .This speed difference created delays and reduce the traffic performance of the road. Road traffic accidents increases due to potholes on the road cause the traumatic spinal injuries, bones injuries, etc. The continuous contact with potholes present on the road leads to major effects on the human health like back pain, etc. No. of accidents are increases day by day. Potholes damage to human body and vehicles.

- E. Carry out regular or needy maintenance and markings of road safety signs. Required improvement in the form of proper width at diversion roads. Heavy trucks must follow diversion road with rule & regulations.

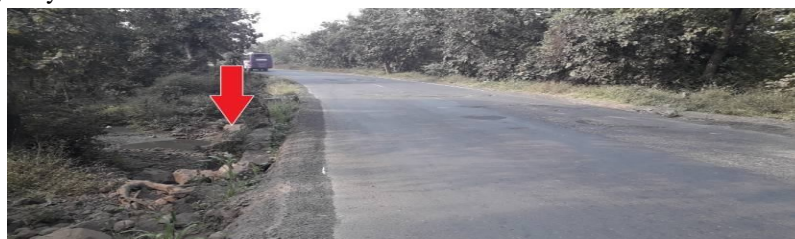
Figure 9:-Formation width is eroded due to excess rainfall.

- H. Figure 9 showed that formation width is eroded due to excess rainfall. Chance of vehicle to fall into drain at night and also it has insufficient berm width. Shoulders are not there on both this place should be declared as non-over taking zone because chance of vehicle to fall into valley at nights Diver may not know the situation of the road ahead, moves with the same speed. This causes the vehicle to lose the control and may be a chance of overturning and after few days the construction of new retaining wall is started.

- F. Shoulders shall maintain to the level of the carriageway.
- G. Buses stopped randomly are to be strictly prohibited.
- H. Retaining wall to be constructed to increase formation width. If the side hill is cut then the formation width and shoulder width is increased. There should be proper marking and sign board to warn the vehicles.

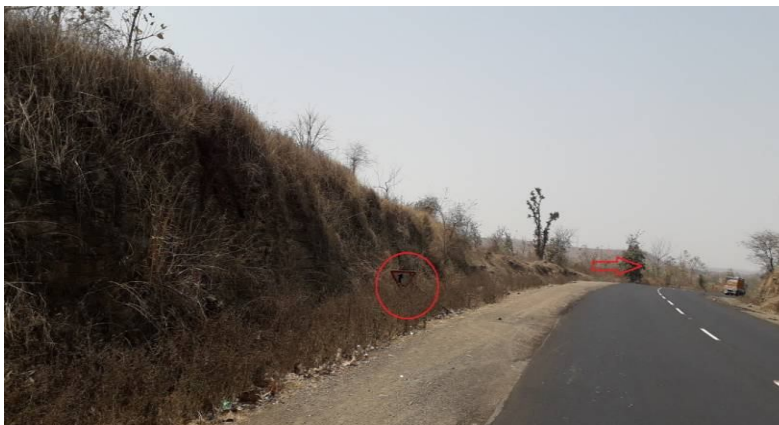
Figure 10:-Sign board direction changed due to wind force or hit by any vehicle

- I. Figure 10 showed that Sign board direction changed due to wind force or hit by any vehicle. Improper directional signs create confusion to the drivers and they mislead the travel time. Sharp curves lessen the sight distance and create tension to the drivers.

- I. Proper maintenance of the sign board needs to be done at regular intervals. Sign boards and markings need to be checked once in six months.
- J. Designated waiting areas for trucks are to be provided. Stoppage of vehicle on the shoulders is to be strictly prohibited.

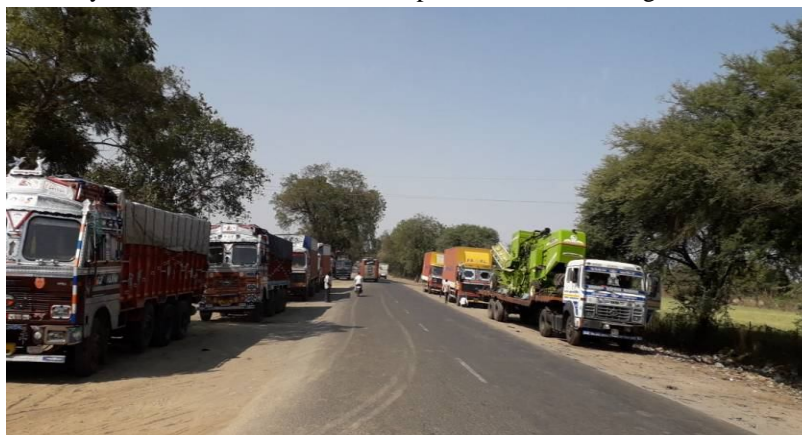
Figure 11:-Provision for Heavy Vehicles

- J. Figure 11 showed that there is no waiting area for trucks waiting. As a result, trucks wait occupying walkway and shoulder. Illegal parking/ stoppage makes movement of through vehicles unsafe. Parking of trucks on the shoulder creates congestion and compels through vehicles to use opposite lane on the highway. Parking vehicles can create a blind spot and they will be as an accident causing elements on roads

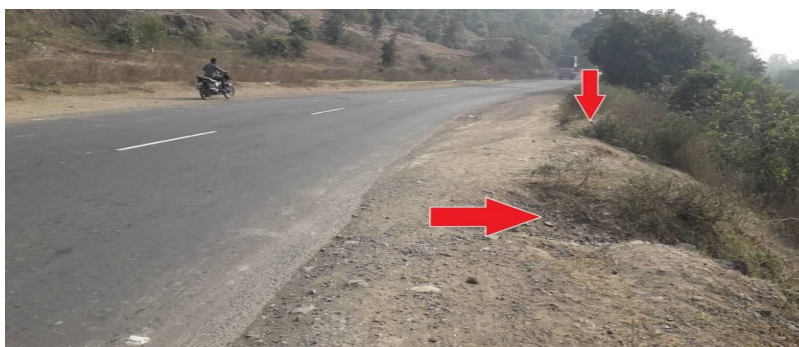
Figure 12:-Unguarded deep valley

- K. Figure 12 showed that deep valley Unguarded deep valley adjacent to road. Hazard for a vehicle to run into the valley during poor visibility and rains. Guard rails are to be provided to prevent the vehicle from falling and rumble strips are to be provided to alert the driver near the valley. Due to damaged shoulder makes movement of through vehicles unsafe. Vehicles may fall into the valley during night.

- K. Guard rails are to be provided to prevent the vehicle from falling and to alert the driver near the valley. Rumble strips are to be provided to alert the driver near the valley.

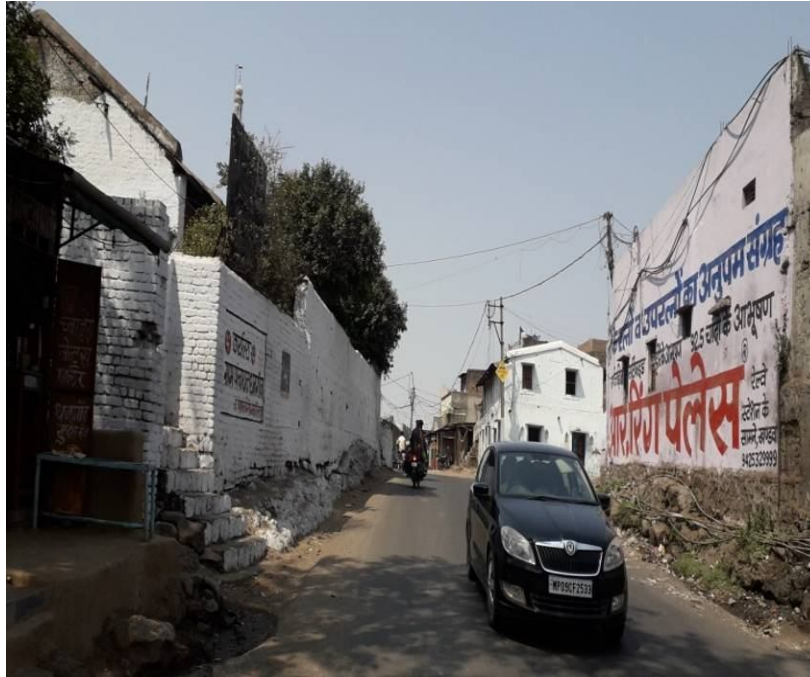
Figure 13:- Shoulder, carriageway width & sight distance due to occupation of wall at dhangoan

- L. Figure 13 showed that the obstruction to line of sight insufficient sight distance due to occupation of wall the sight distance along the road is inadequate or restricted when wall is on the edges of carriageway. Obstruct the sightlines to stationary objects or oncoming vehicles. Inadequate sight distance results in a shorter reaction and response time available to the driver when the change is sighted which results in a higher crash risk. Besides, due to obstructed longitudinal sight distance drivers assume continuation of the present conditions, though alignment changes or traffic hazards suddenly appear. Highway required wide shoulders on each side. Shoulder width and condition is absent at near Dhangoan village on highway (SH 27). It is observed that at this area with high concentration of vehicles and pedestrian such as bazaar, village, bus-stands etc. The jams occur only when a truck or any other heavy vehicle breaks down in the mid of the road. As the stretch is narrow, it becomes difficult for other vehicles to pass on it

- L. The wall should shift at some distance to clear the line of sight. In order to improve pedestrian safety, raised shoulder is recommended. Shoulder should be maintained by increasing width.

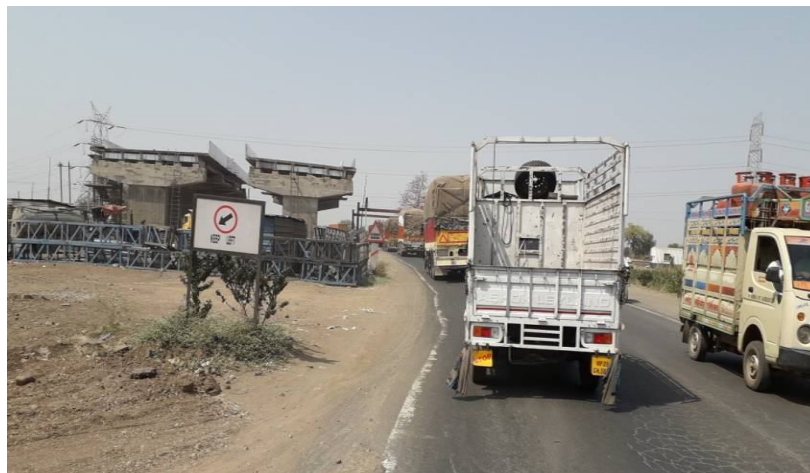
Figure 14:- By having construction of bridge and broad gauge railway on these path problems of traffic jams is raised frequently

- M. Figure 14 showed that by having construction of bridge and broad gauge railway on these path problems of traffic jams is raised frequently. By having construction of bridge and broad gauge railway creates congestion. Waiting or stoppage of vehicles can create a blind spot and they will be as an accident causing elements on roads. The road becomes unsafe and pedestrians are unable to use shoulders.

- M. Due to speed difference, light vehicles need to have a diversion for it not only to improve the traffic performance but also for safety purpose
- N. Guard rails are to be provided to prevent the vehicle from falling and to alert the driver near the river. Rumble strips are to be provided to alert the driver near the river.

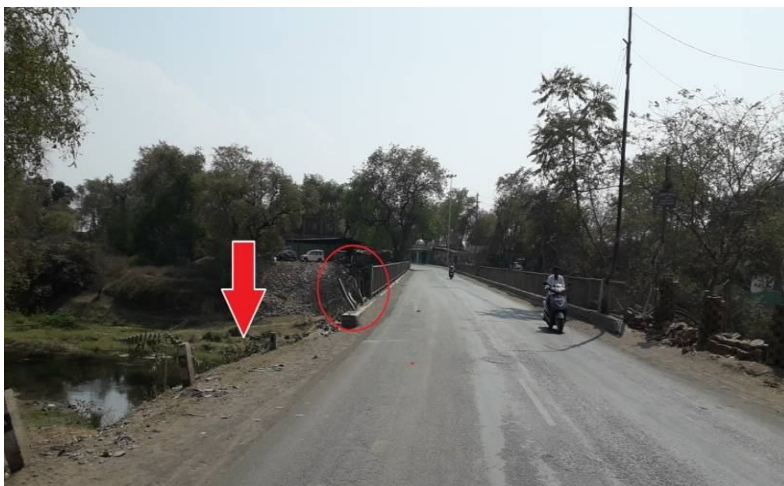
Figure 15:- Guardrails are broken at Sanawad Bridge

- N. Figure 15 showed that guard rails are not there to prevent the vehicle from falling and to alert the driver near the river. Hazard for a vehicle to run into the valley during poor visibility and rains. During night Vehicle may fall into the valley.

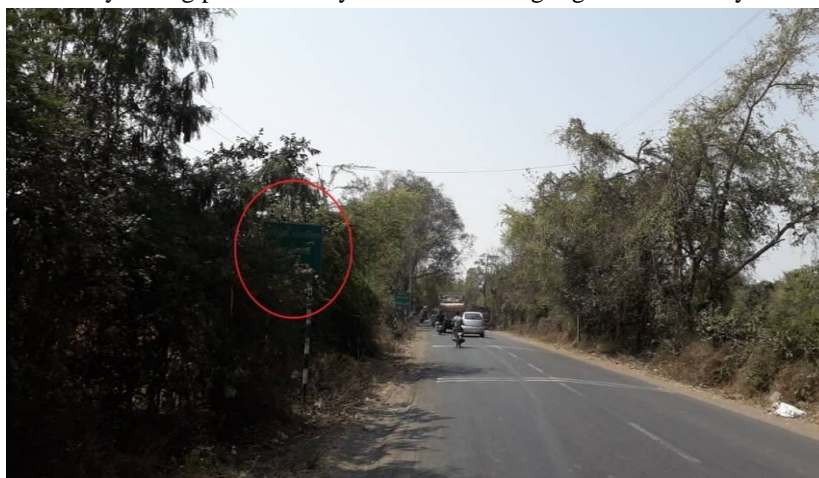
- O. Figure 16 showed that signs board are not at all visible due to vegetation this board also not visible from a distance due to vegetation. During day time due to the shadow of vegetation sign board is not visible.

- O. Tree branches need to trim at regular intervals to maintain visibility.
