# Structural damage at Florida Cando Complex – An Overview

**Abstract:** *In this paper the structural damage at Florida complex is being discussed. In spite of an early report by engineering consultant, giving evidence of possible structural damage and necessity of repairs required, the delay in repair works resulted in a catastrophic collapse of the building in the middle of the night. The study on this collapse of the building opens the discussion on timely actions to be taken during the construction as well as maintenance of the buildings.*

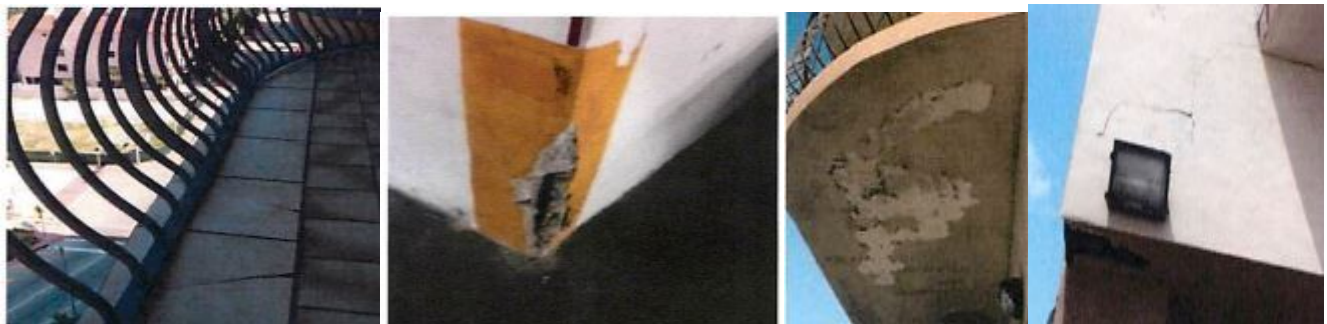
### The building collapsed in stages
