Volume: 5 Issue: XI Month of publication: November 2017

Geohazard and Vulnerability Risk Analysis as Inputs in Mainstreaming Climate Change in Developing Country

Abstract: *The study generally provides analysis on vulnerability risk and geohazard clarification of the entire river system as inputs in mainstreaming climate change in developing country specifically Northern Mindanao, Philippines. It employed evaluative and analytical type of research with the use of primary and secondary data sources. The expected outputs include the GIS-Based category/classification maps and the vulnerability/susceptibility map for the pilot area project.*

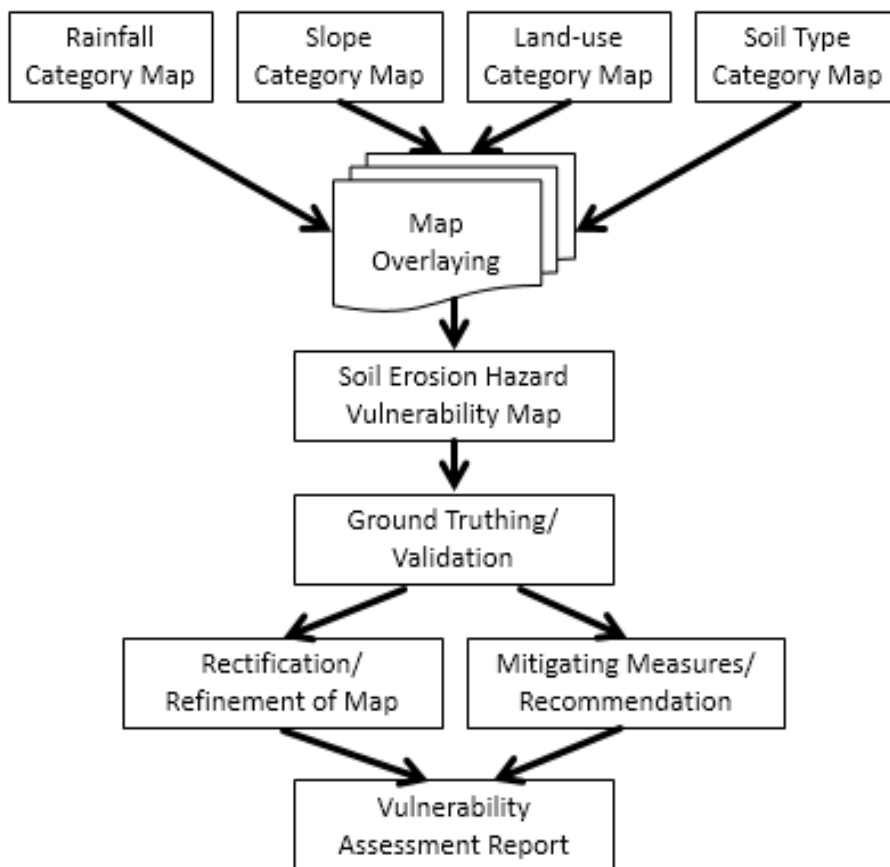
Figure 3. Framework of Soil Erosion Hazard Vulnerability Assessment

- 2) *Soil Erosion Hazard Vulnerability Assessment*: The framework presented in Fig. 3 follows the vulnerability assessment and analysis of soil erosion hazard addressing the four steps namely: (a) Methods of assessing the vulnerability of the area to soil erosion hazard; (b) Identification of critical factors that influence the occurrence of soil erosion; (c) Generation of critical factors category maps and assignment of weights; and (d) Overlaying of physical factors category maps and determination of soil erosion hazard vulnerability map.
