Volume: 5 Issue: XI Month of publication: November 2017

Advanced and Improved Non-Destructive Method for Rail Axle Inspection

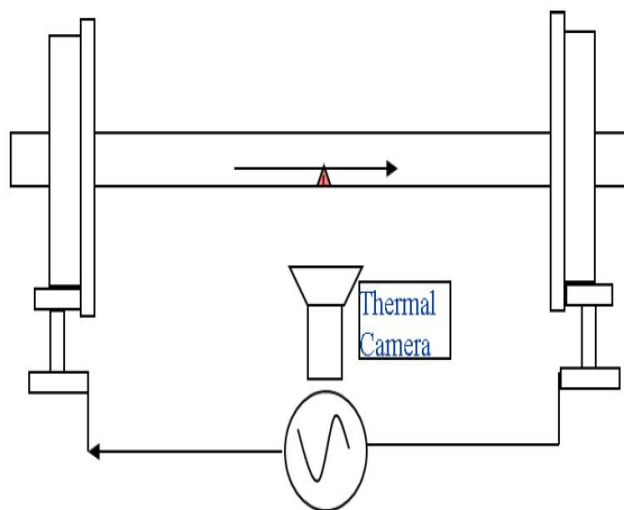
Fig 1 Principle of AC thermography technique

A high frequency electric current is passed through the axle when it passes over the inspection station, causing it to heat slightly. The current flow is distorted near a crack and this result in a different heating pattern. This method which is very sensitive and capable of detecting cracks of 0.8mm deep, only if the right conditions can be reached.

The main concept of this method is shown in Figure 1.

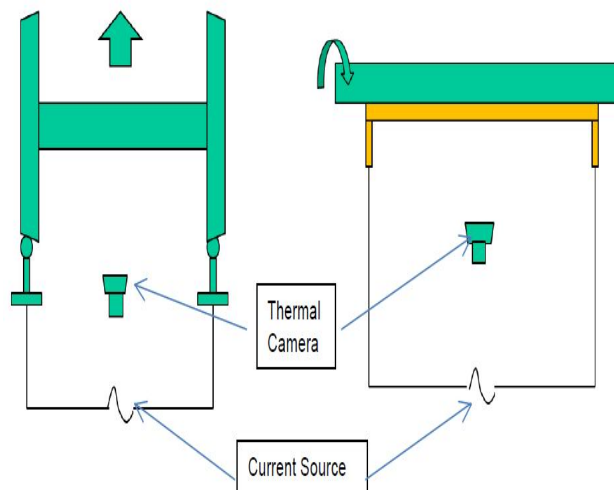
Figure 1 Configurations of the induction system

Left: track mounted system using direct AC. Right: axle mounted on rollers and workshop using induced AC. The project was attempted using modelling and with practical trials, which are described below.

However, to inspect a moving axle, the electric current has to be passed directly through the axle and this can be shown in below figure.

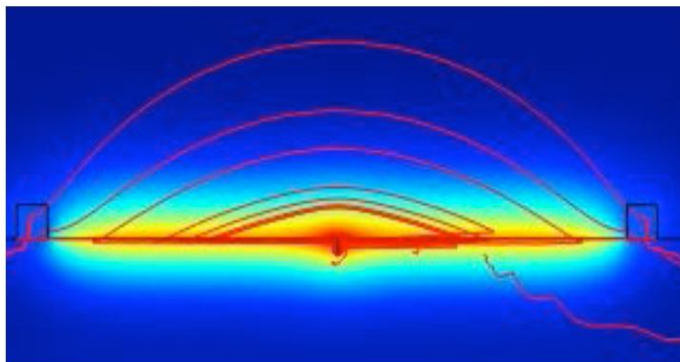
The crack gap was set at $100\mu\text{m}$ and the heating time was up to 3s. The potential at the electrodes was set at 1V (meaning that the current was less for higher frequency). 2D models were used first. Figure shows a typical result.

Fig 2 Showing heating and electric field for 20 KHz, 2 mm deep crack

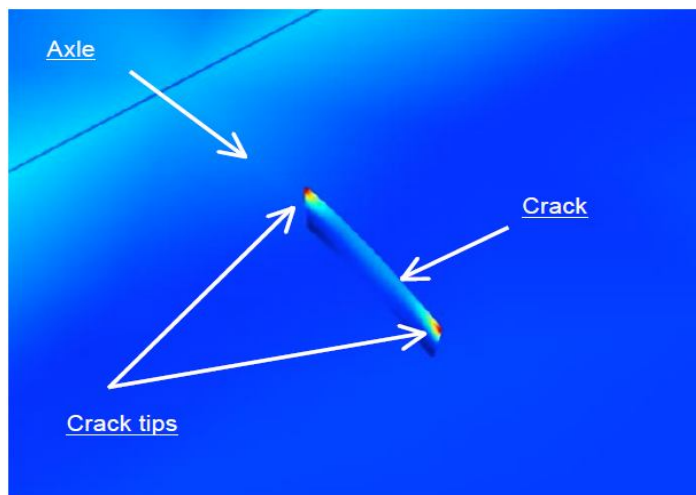
An Indication of crack through 2D models was successful to some extent but could not give a full explanation of crack depth so for this purpose 3D full size model was attempted. The potential shown by the 2D model resulted in 3D model for full axle which proved successful and this result output is shown in the following figure.

Fig 2.1 Figure showing the result output from 3D model

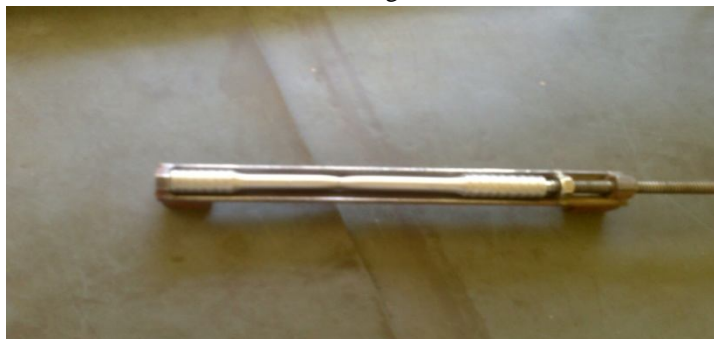
Specimen used i.e. Steel bar of 20mm diameter is as shown in below figure

Figure showing the steel bar of 20mm diameter

To carry out the small scale, set of three samples of 20mm steel bar were manufactured with fatigue crack of different size of 0.9mm, 1.7mm and 4.3mm deep. This fatigue crack depth was accurately measured by ACPD i.e. An ACPD method has been developed as an NDT technique that can accurately characterize surface breaking fatigue cracks in metal specimens. The required high current was able to pass through them by means of direct heating.

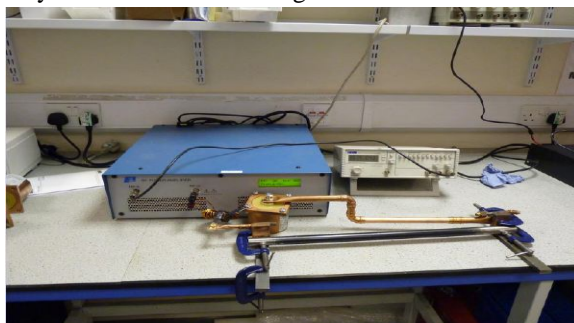
Direct Heating setup for a small scale sample

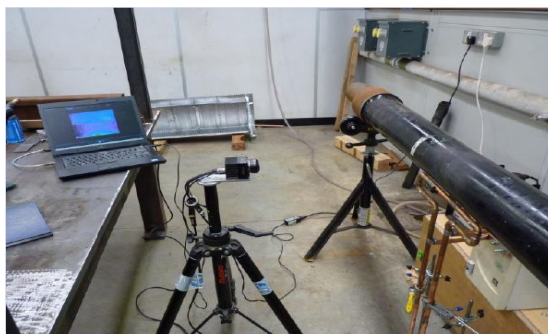
The mode of heating to this setup is through induction system. The full scale arrangements for an axle by induction heating system is shown in below figure

Figure showing the complete Induction method of full axle setup.

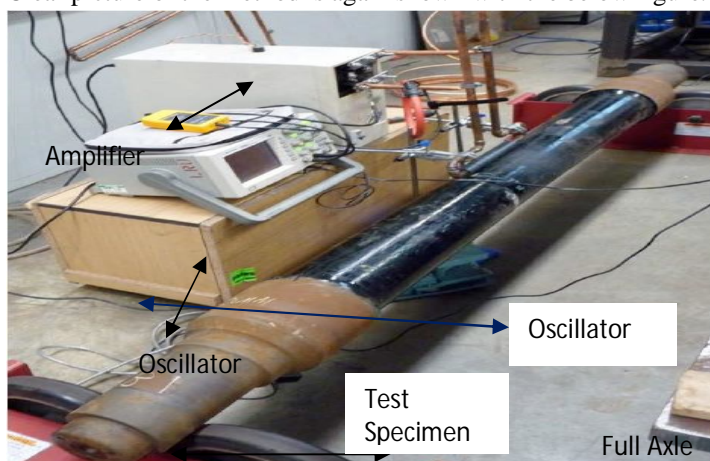
Figure showing the Induction type of heating system.

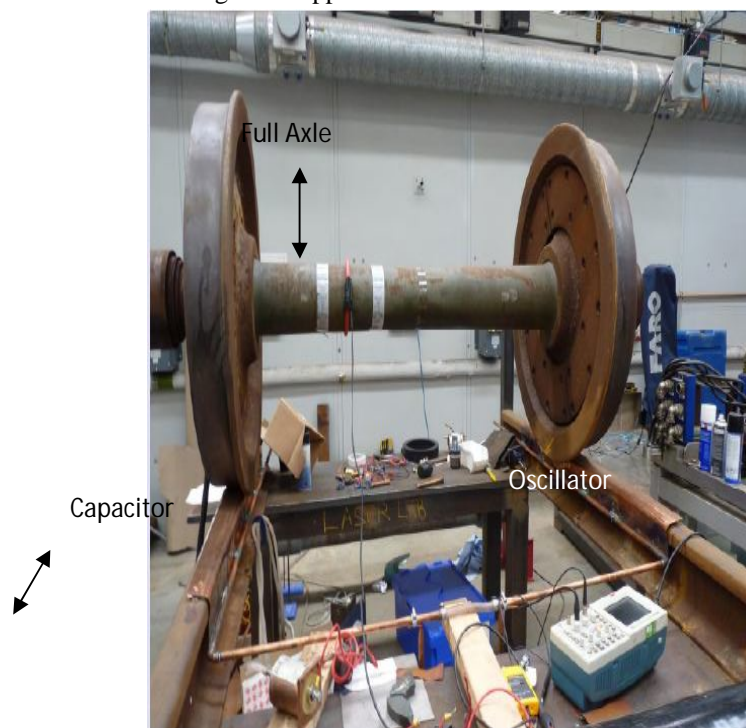
Investigations were carried out for the total view of field of the thermal camera. This was done by making a practical trial of experiment by conducting on full scale working axle. Application of direct current on full axle is as shown in figure.

Direct Heating of Complete Wheel set (Front View)

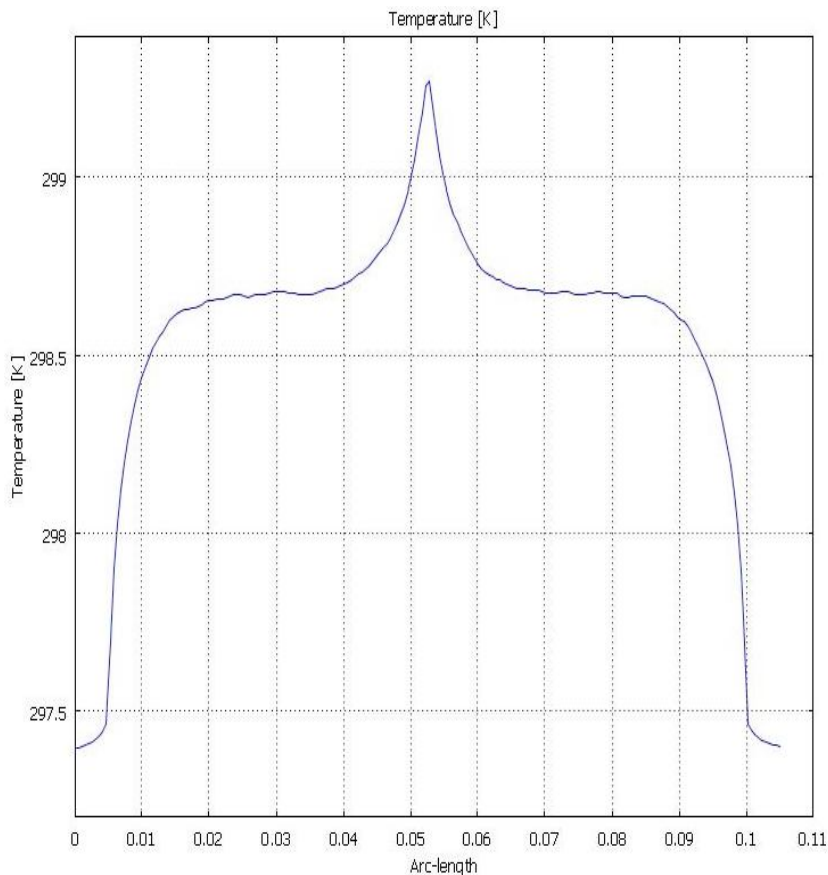
Graph2.1 Showing Surface temperature with 2mm deep crack at 100 KHz.

From the above graph 5.1 we can clearly detect the crack. It shows in X-axis the applied Temperature in Kelvin, it shows that the surface temperature is 298.65°K and crack temperature to be 299.25°K. In Y-axis is the arc length ie the length of the crack depth from the surface. This is shown in below table 2.1.

By looking at the figure 1.6 we can't understand the concept of the method and Probability of crack detection, so to detect the crack in more easy way a cross section of the crack was taken to get a better idea and this is shown in the below figure .

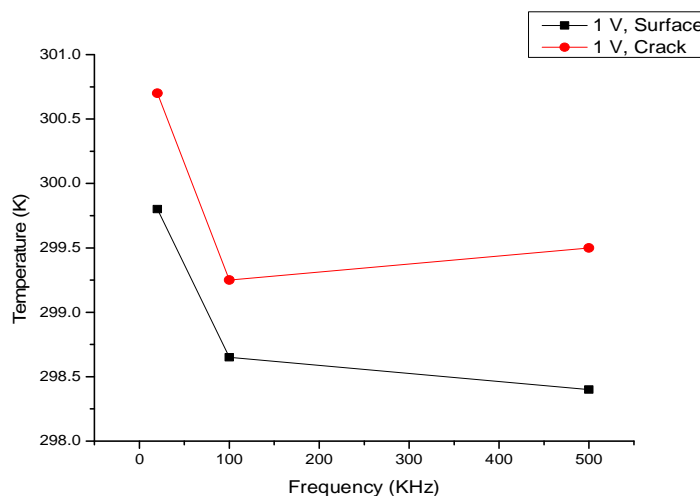
The above results were plotted in the graph 2.2 and the following results were obtained.

Graph 2.2 Crack and Surface temperature Comparison of 2D models.

From the point of view of discrimination the 2D models Showing the Graph 5.2 and Graph 5.3 it appears to be advantage to use as a high a frequency of 500 KHz and potential of 2 V. This gives the better crack detecting probability i.e. Crack temperature being 307°K as the surface temperature being 302.5°K .

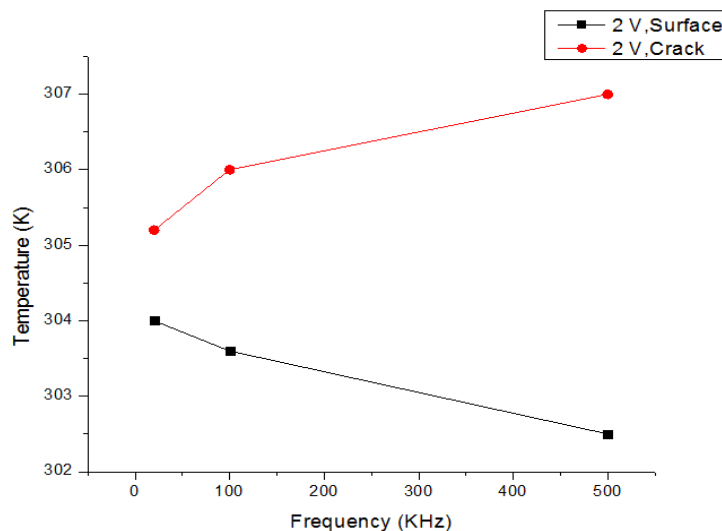
The results were observed by plotting the contents of above table 2.3 in the graph

Graph 2.3Crack and Surface temperature Comparison of 2D models.

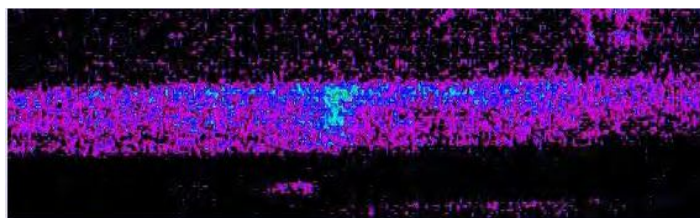
The experiment was carried with direct heating starting with steel bar painted black for quick heating purposes so that it can be more visible in thermal camera, For this purpose Thermoteknix 310L camera was used to take thermal image. So steel bar of 0.9mm fatigue crack was used to check the possibility of visual which proved to be fatal i.e. no proper thermal image could be seen. As this can be seen in the below figure 3.1.

Fig 3.1 Showing the fatigue crack of 0.7mm small scale sample of 20mm steel bar.

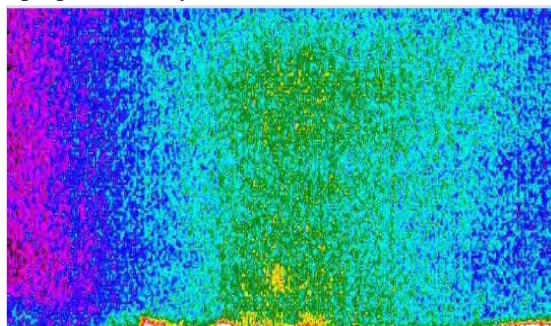
The above figure 5.1 was not pictorially clear to recognize the crack points, so the next sample of 1.7 mm fatigue crack was used again by direct heating. Again for this to no proper visibility was seen. This is shown in below figure 3.2.

Fig 3.2 Showing the fatigue crack of 1.7mm of 20mm diameter steel bar.

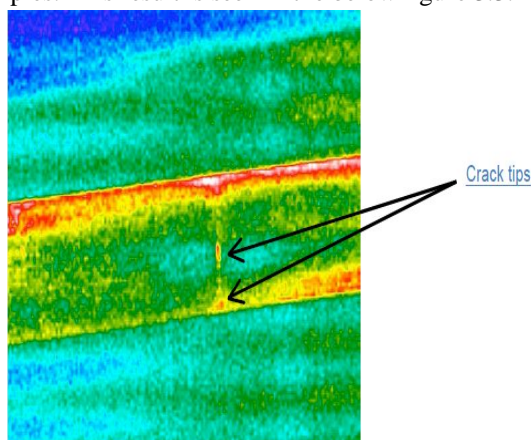
So the final sample of 4.3mm fatigue crack of steel bar was taken and experiment was carried out with direct heating. Using Thermoteknix 310L camera the thermal image was taken and could get satisfaction result of detecting the crack tips, which were more noticeable than the rest of the steel samples. This result is seen in the below figure 3.3.

Fig 3.3 Crack tips are easily noticeable in 4.3mm fatigue crack of steel bar.

From the above figure 5.3 we could easily distinguish between the three samples of steel bar of 20mm diameter. Crack can be easily noticeable in 4.3mm fatigue crack of steel bar because reason is simple, when current is passed across the steel bar by direct heating the crack gets heats up due to this reason the crack tips can be seen. This is shown in the above figure 3.3.

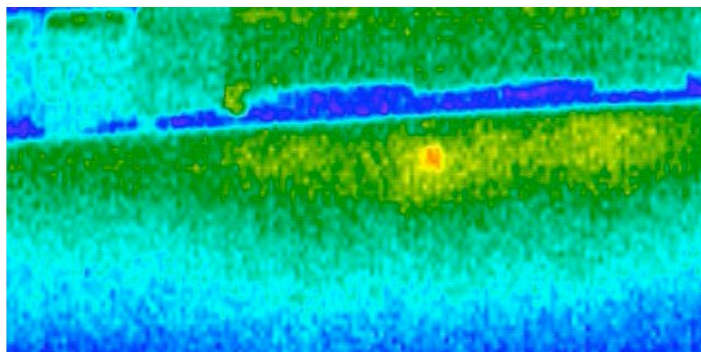
An Axle is made to rotate on its axis as shown in figure 4.11 by a set of rollers connected at the end. This is done to completely cover the axle surface without missing any portion of the surface. A thermal image was taken to see any crack defect in the full axle, by scanning the whole axle. The visibility of hot spot from crack end was seen. This is shown in the below figure 3.4.

Fig 3.4 Clear view of Hot spot from crack end.

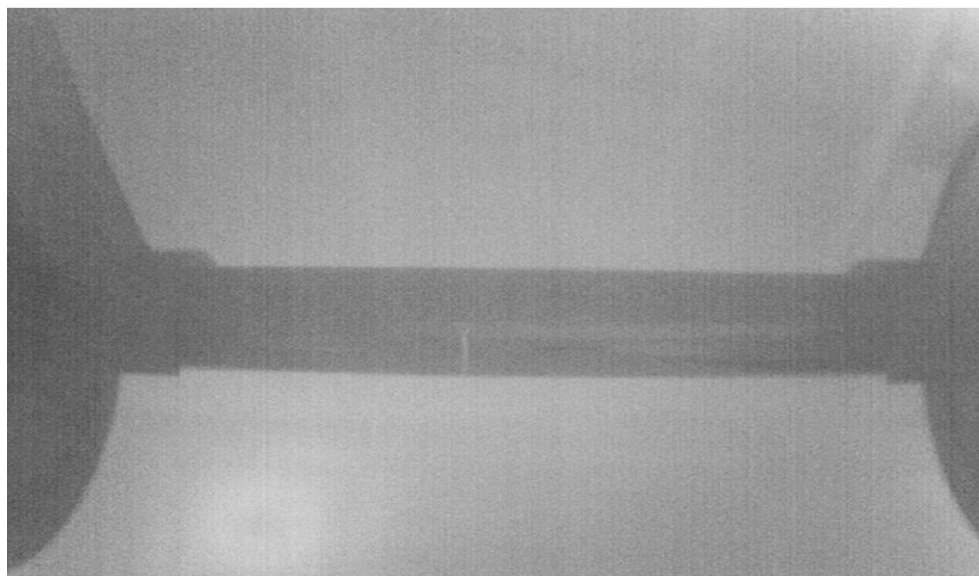
The above image was not still clear so it was magnified and again seen in the camera and could see a small thread like warm wire on an axle as shown in figure 3.5.

Fig 3.5 Showing warm wire on an axle surface.

Axle length between the wheels could be easily viewed by the thermal camera and to detect heat sources so as to check with its sensitivity provided they were above 1mm in size.

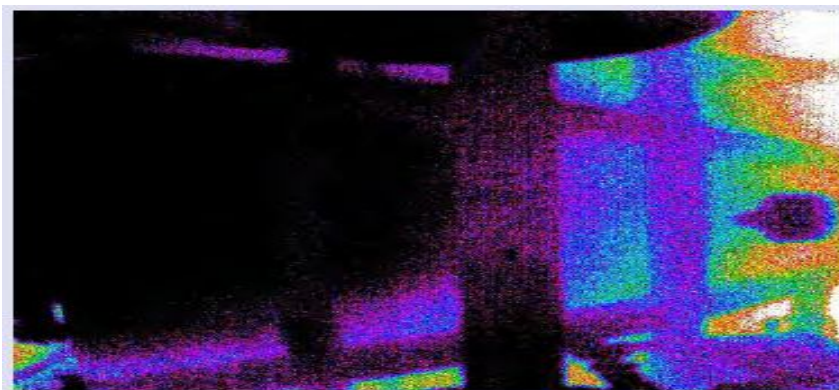
The view from Thermal Camera of the above tests were taken and image was properly examined crack defect was not seen This is shown in below figure 3.7.

Fig 3.7 No crack defect.

With no crack seen other boogie of wheel set was tested and again the result was same that there was no crack on the working axle.
