Road Safety Audit on Selected Stretch of NH-27 (Greenland Chowkdi to Hirasar Diversion)

Akshay Kumar V. Keraliya¹, Ravindra V. Solanki², Jay K. Kalaria³

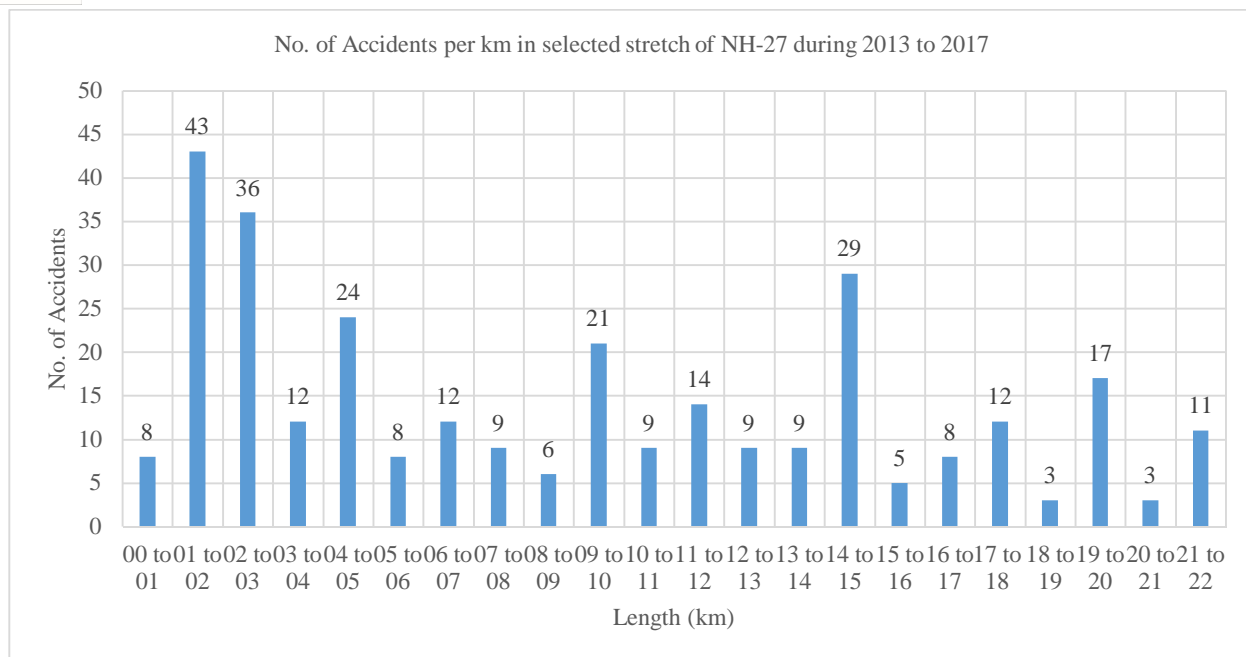
Figure 2. Number of accidents per km length in selected stretch of NH-27 during 2013 to 2017

From the figure number of accidents are more in 6 spots. The spot with high no. of accident is considered as the black spot. In this study stretch there are six black spots are seen, which are Navagam sub-urban area (01-02 km), Indian Oil Corporation Station (02-03 km), Near Maliyasam village (04-05 km), Rural area-Gunda diversion (09-10 km), Kuvadva GIDC (14-15 km), JK Hotel (19-20 km).

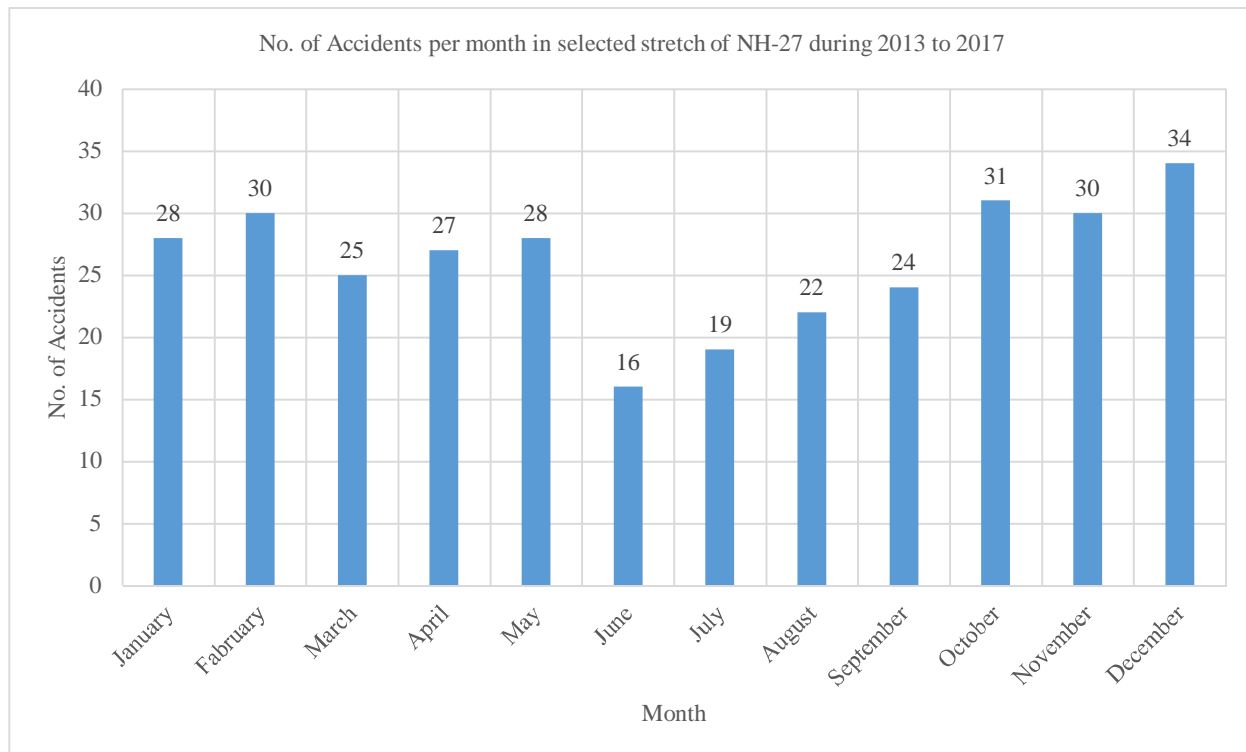
Figure 3. Number of accidents per month in selected stretch of NH-27 during 2013 to 2017

From the figure, the months in which number of accidents occurring more are: December, October, November and February. In other months also no more difference in number of accident except June, July and August.

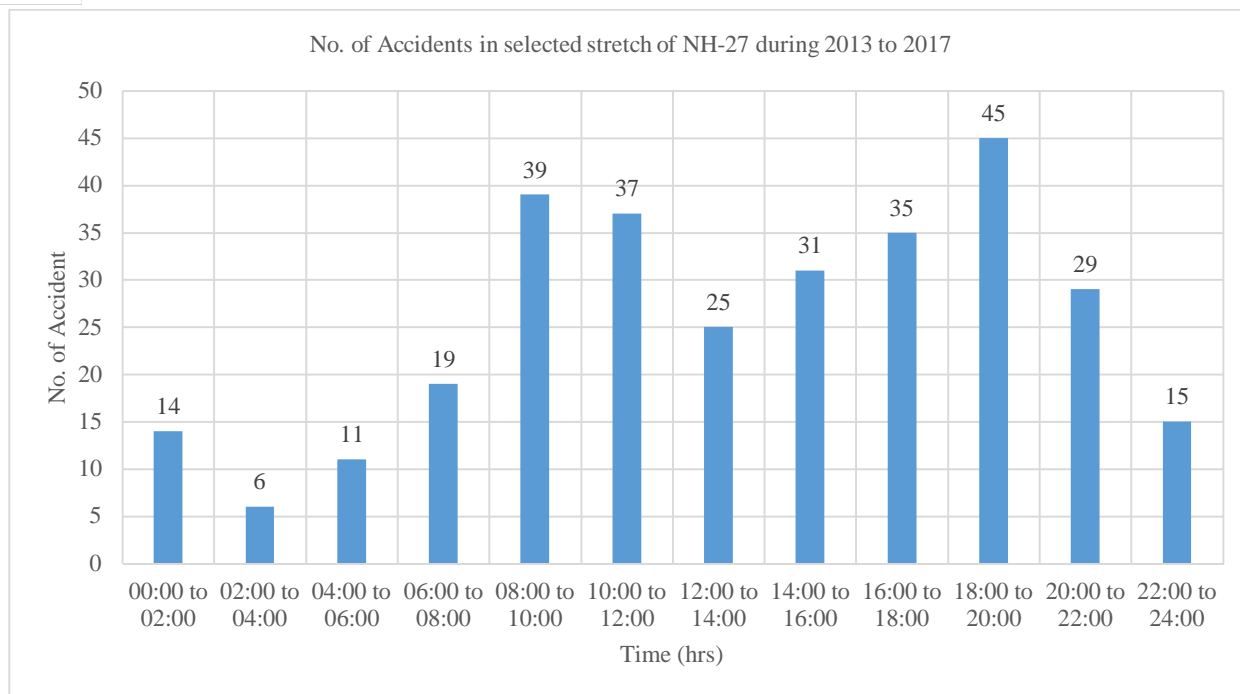
Figure 4. Number of accidents per 2-hour in a day in selected stretch of NH-27 during 2013 to 2017

From the figure, the accidents happened more during day time compare to night time. The reason for that is high traffic during day time. The accidents are more especially in morning peak hour and evening peak hour, when the worker and people living and working in Rajkot city and industrial area adjoining the study highway.

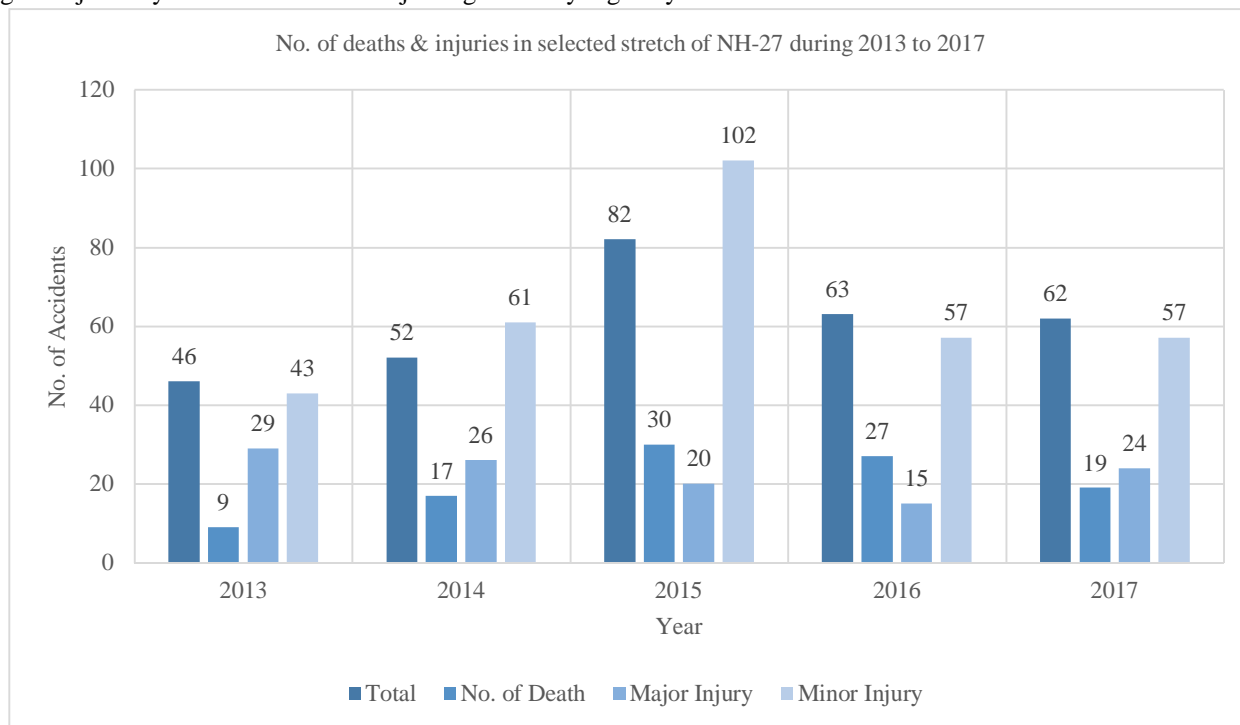
Figure 5. Number of accidents deaths & injuries in selected stretch of NH-27 during 2013 to 2017

From the figure, accidents were peak in year 2015, after that the number of accidents are decreasing. But deaths and major injuries are high. Which shows the requirements of the remedial measures to prevention of accidents.

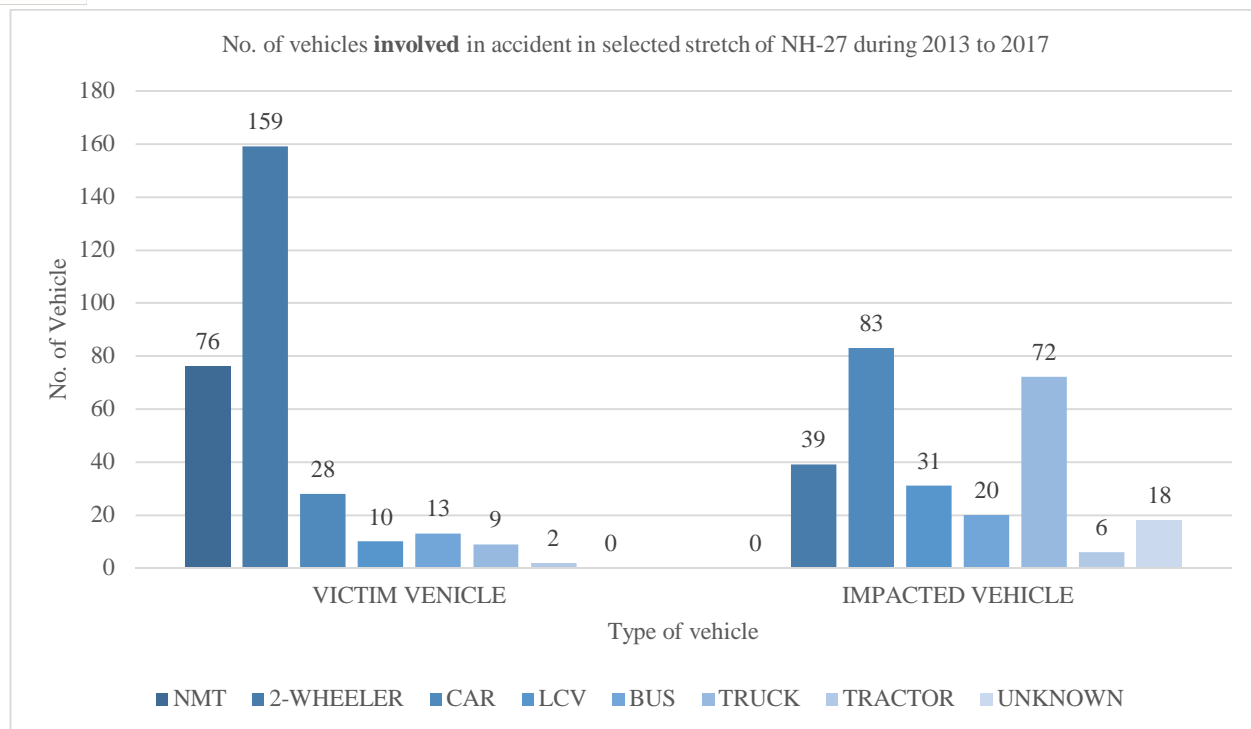
Figure 6. Number impacted vehicles & victim vehicle in selected stretch of NH-27 during 2013 to 2017

From the figure, it is seen that the victim vehicles are NMT (includes pedestrian) & Two Wheeler and impacted vehicles are Car, Truck & Two Wheeler. So the most vulnerable road user in study are NMT (includes pedestrian) & Two Wheeler.
