Volume: 6 Issue: V Month of publication: May 2018

### Conditional Assessment of Building using Non-Destructive Tests

Site 1: IVL Dhunseri Petrochem Industries Private Limited

Site 2: Indus Tower Karnal

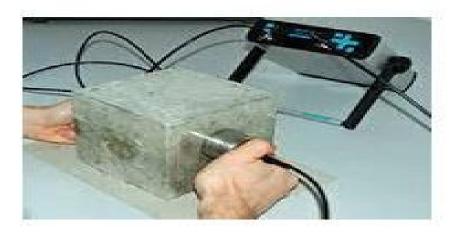
Figure 2 Ultra-Sonic Pulse Velocity

with a receiver. Ultrasonic pulse velocity is			
	influenced by elastic modulus and strength of			
	concrete.			
Core testing	The drilled cylindrical core is removed from the			
	structure, tests may be performed on the core to			
	determine compressive and tensile strength, torsional			
	properties, static modulus of elasticity, etc.			
Carbonation test	Carbonation occurs when CO <sub>2</sub> from air finds its way			
	into the body of concrete through its pores in			
	presence of moisture & water forms carbonic acid			
	which neutralizes the Ca (OH) <sub>2</sub> formed due to the			
	reaction during setting of concrete thus reducing the			
	alkalinity of concrete			
Reinforcement Scanning	The test for reinforcement scanning is done with help			
Test	of HILTI PS 200 Ferro scan a portable system for			
	detecting rebar in concrete structures. The tools help			
	in obtaining the real image of the reinforcement and

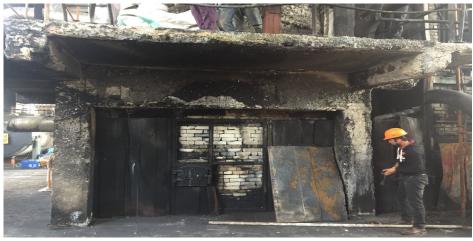
Figure 3 Fire hazardous fluid heating room at 1st Floor

- 4) Results And Recommendations
- a) The concrete strength of the members of all the locations varies from 15-20 N/mm<sup>2</sup>.
- b) The front portion of the room is majorly affected by the fire and heat. Because of high temperature, the concrete cover is spalling out of the main members

- g) The loose material should be removed and jacketing of columns can be done with micro concrete.

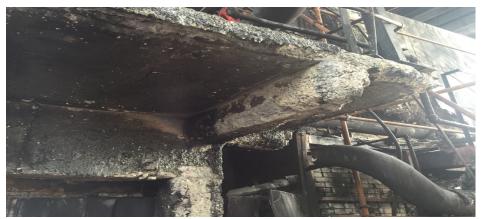
Figure 4 damaged beam and slab portion.

- c) On tamping, hollow sound was observed, which indicates the detachment of concrete cover from its parent member.
- d) The UPV value shows that the concrete quality has been impacted due to fire (high temperature) and at other locations on the ground floor the concrete quality is in excellent condition.

- e) The Core was also extracted from one of the front columns up to 250mm depth, which shows the concrete is affected up to the cover level only.
- f) The pH of concrete is decreased to 9 at 1st floor.

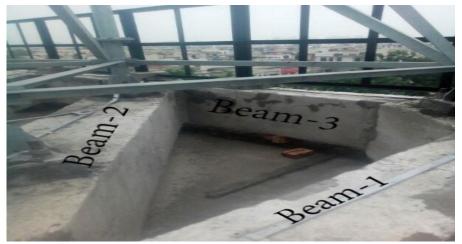
Figure 5 Beams nomenclature

- Introduction: There is a communication tower erected over a Dharmshala building in Sector-4 Karnal. The tower is erected on the rooftop of the building using three main beams and one tie beam. Thus, non-destructive testing of the concrete element along with condition survey to assess the strength & quality of concrete by using Rebound Hammer Test and Ultra Sonic Pulse velocity test and to determine cover & details of reinforcement was obtained by using Ferro scanner. So, the inspection was arranged and the structure was inspected and tested for its existing strength and Quality on dated 25<sup>th</sup> of February 2018
- 2) Objective: The study involves a determination of in-situ strength and quality of concrete and reinforcement details of structural members under investigation. The specific objectives of the study are to know: NDT tests to assess the quality of concrete structures.

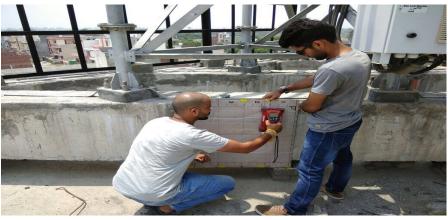
Figure 6 Conducting Ferro scanning of Beam 4

Sr.no	Location	Reinforcement details	
1	Beam 1 (towards the stairs)	3 bars on the face side and 3	
		bars on the bottom side of 20mm	
2	Beam 2 (Central Tie beam)	2 bars on the face side and 3	
		bars on the bottom side of 20mm	
3	Beam 3 (Side beam over the side wall of the	3 bars on the face side and 3	
	building)	bars on the bottom side of 20mm	
4	Beam 4 (near DG set)	3 bars on the face side (1 top bar	
		is of 20mm & two bottom bars	
		are of 16mm)	
		3 bars on the bottom side of	
		16mm

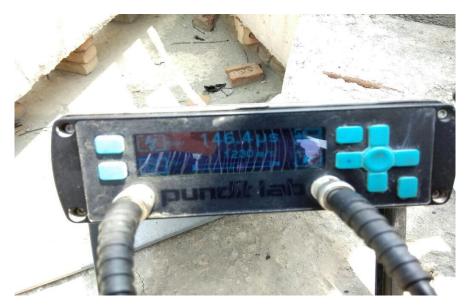
Figure 7 UPV test

Sr.no	Location	Avg RH value	UPV	Compressive
			m/s	Strength
				N/mm <sup>2</sup>
1.	Beam 1 (towards the	22,24,25.5,26,24,25=24.41	2244	16
	stairs) Point-1			
2.	Beam 1 (towards the	25,25.5,24.5,23,21,22=23.5	2465	15
	stairs) Point-2			
3.	Beam 2 (Tie beam) point-	19,17.5,16,21,18,18=18.25	1230-ID	Less than 10
	1			
4.	Beam 2 (Tie beam) point-	21,23,22,24,25,26=23.5	2156	15
	2			
5.	Beam 3 (Side beam	26,22,26,25,22.5,26=24.58	2474	16
	towards the road) point-1			
6.	Beam 3 (Side beam	20,22,24,23,21,21.5=21.91	2125	13
	towards the road) point-2			
7.	Beam 4 (near DG set)	23,19,18,25,26,26=22.83	2163	14
	point-1			
8.	Beam 4 (near DG set)	20,21,19,19,25,27=21.83	2223	13
	point-2			
9.	Column-1	21,18,19,20,21,21=20	1230-ID	10
10.	Column-2	22,21.5,21.5,22,21,22=21.61	1673-ID	13
11.	Column-3	21,19,19,25,24,24.5=22.03	1740-ID	13
