Design Optimisation and Manufacturing Analysis of Transmission Fork of Heavy Motor Vehicles

Abstract: During the process of Milling for v cut Slot minor Cracks are generated in fork Surface, which during induction hardening process converts in to deep cracks and can only be detected during the non-destructive testing like MPI (Magnetic Particle Inspection). This leads to higher rejection ratio and incur financial and material losses. The existing design of fork is heavy and not compact which leads to problems during assembly and leads to bending in rails. This necessitates a new design of fork which is compact and light weight. The second design is manufactured without v slot using standard manufacturing techniques which includes process flow diagrams and PFMEA.

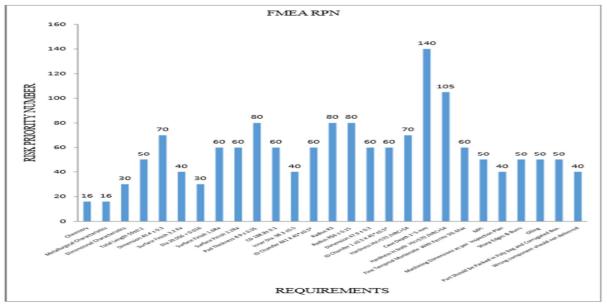
Fig. 3 Process Flow Diagram of 671 Fork

The analysis of the effective modes of process error is based on different parameters to determine the number of risk priorities obtained by the severity of the specifications, the appearance of errors and the detection of dimensions in different operations as shown in the Figure 3.

As should be obvious in the chart between the necessities and the quantity of hazard needs, the most extreme hazard in the fork is to keep up the profundity of the crate of 125 mm and accomplish the hardness in the acceptance procedure.

Risk priority number = severity x occurrence x detection
