Effect of Surface Textures on the Performance of Journal Bearings with Contaminated Oil

Vinay Kumar¹, D. P. Vakharia¹

¹Department of Mechanical Engineering, Sardar Vallabhbhai National Institute of Technology, 395007 Surat, Gujarat, India

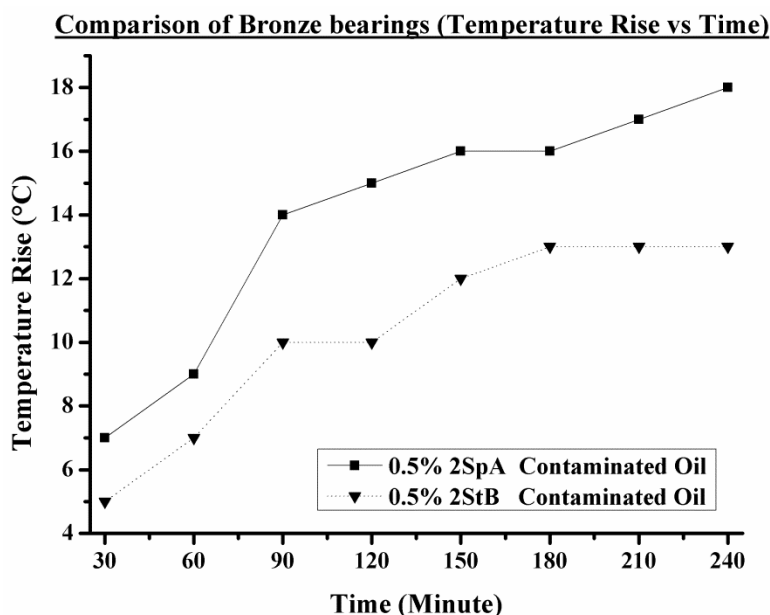
Fig. 5 Temperature of Phosphorous bronze bearings at 0.5% of contaminated oil

Comparison of the temperature of 2SpA and 2StB phosphor bearings as regards time under 0.5% of contaminated oil is shown in figure 5. Higher the temperature rise of 2SpA bearing has been noticed when comparing with 2StB bearings at 0.5% of contaminated oil. The temperature rise increases continuously up to 240 minutes of the test run in case of 2SpA bearing at 0.5% of contaminated oil. Only 3 °C of the temperature rise were marked on 2StB bearing between 90 to 240 minutes of test run.

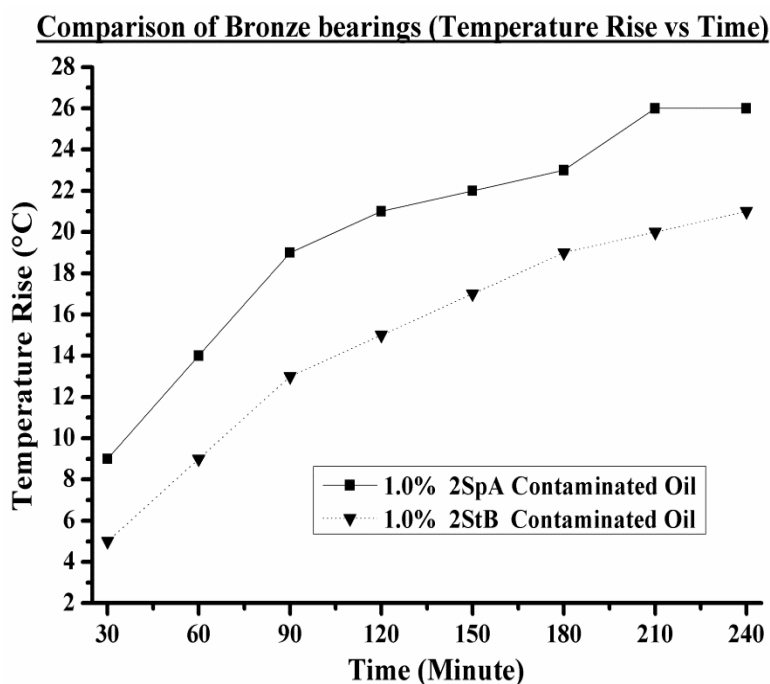
Comparison of the temperature of 2SpA and 2StB phosphor bearings with respect to time under 1.0% of contaminated oil is shown in figure 6. Higher the temperature rise of 2SpA bearing has been noticed when comparing with 2StB bearings with at 1.0% of contaminated oil. The temperature rise increases continuously up to 240 minutes of the test run in the case of 2SpA and 2StB bearing of 1.0% of contaminated oil.

Fig. 6 Temperature of Phosphorous bronze bearings at 1.0% of contaminated oil

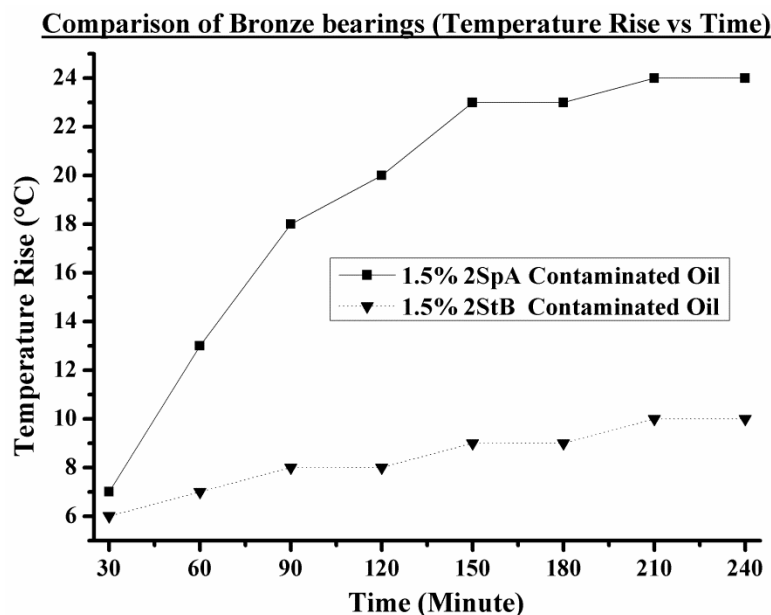
Fig. 7 Temperature of Phosphorous bronze bearings at 1.5% of contaminated oil

Comparison of the temperature of 2SpA and 2StB phosphor bearings with respect to time under 1.5% of contaminated oil is shown in figure 7. Higher the temperature rise of 2SpA bearing has been noticed when comparing with 2StB bearings with at 1.5% of contaminated oil. The temperature rise increases continuously up to 240 minutes of the test run in case of 2SpA bearing at 1.5% of contaminated oil. Only 4 °C of the temperature rise was marked on the 2StB bearing between 30 to 240 minutes of test run.

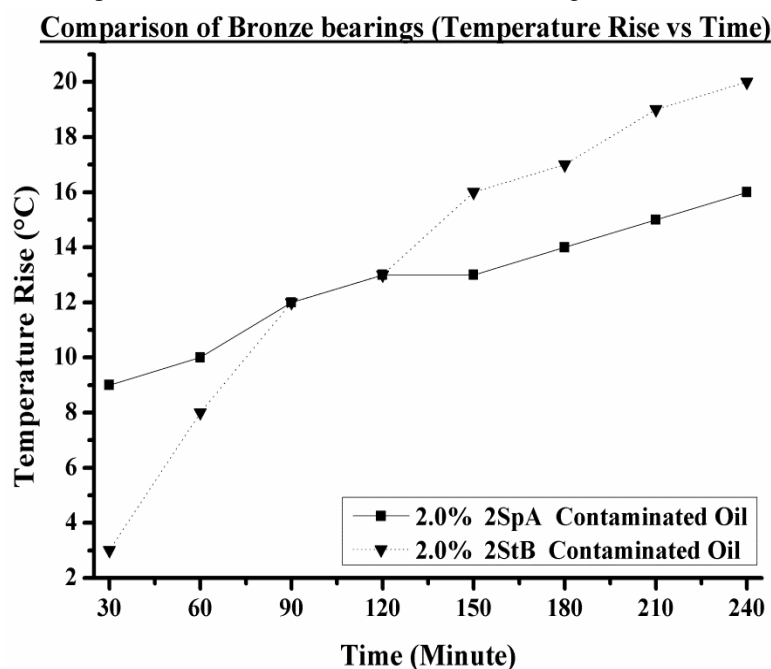
Fig. 8 Temperature of Phosphorous bronze bearings at 2.0% of contaminated oil

Comparison of the temperature of 2SpA and 2StB phosphor bearings with respect to time under 2.0% of contaminated oil is shown in figure 8. Higher the temperature rise of 2StB bearing has been noticed when comparing with 2SpA bearings with at 2.0% of contaminated oil. The temperature rise increases continuously up to 240 minutes of the test run in case of the 2SpA and 2StB bearing at 2.0% of contaminated oil.
