# Seismic Vulnerability Assessment of RC Buildings of Nagpur (North-East) using Rapid Visual Screening

**Abstract:** Earthquake phenomenon as a natural hazard is causing high levels of damages to the structures around the world. The damages and losses caused by recent earthquakes have increased. The damage and loss caused by recent earthquakes has increased. Most of the existing buildings in Nagpur (India) are designed to withstand gravity loads only without the provision of earthquakes. It is therefore necessary to study the vulnerability of reinforced concrete structures to avoid high risk. The north-east region of the city is surveyed through rapid visual screening methodology using two different screening forms. Two different forms are selected to choose better form for Indian context. The damage grade is assigned to the buildings from 1 to 5 as per the European Macroseismic Scale-1998 for both the methodology independently. According to the grading systems buildings are identified for the further detailed evaluation.

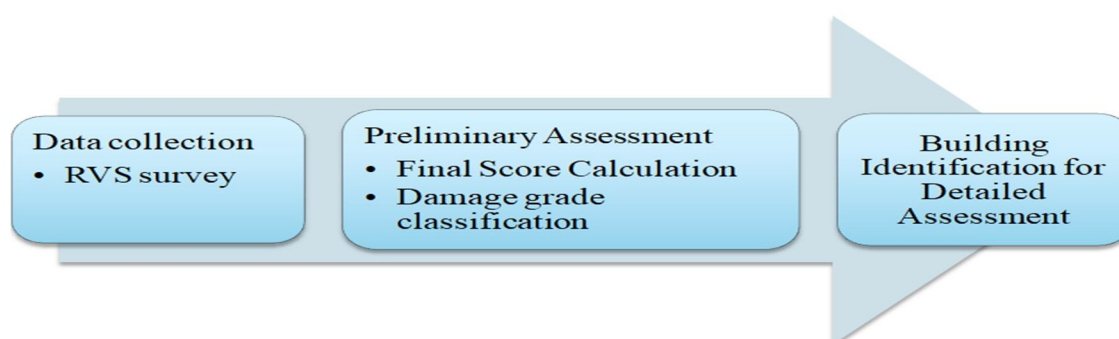
Fig. 1: Vulnerability Assessment Flow Chart

The methodology of the paper comprises of three major stages which are presented in flow chart below:

Steps of methodology are as follows:

- 1) Selection of area of region of the city for Rapid Visual Screening.
- 2) Selection of two RVS forms proposed by Ningthaujam and Nanda [1] and FEMA.
- 3) Conduction of the RVS survey for the selected area by the two forms.
- 4) Calculation of Final Score using survey data by both the forms.
- 5) Categorization of damage grade of RC buildings as per final scores.
- 6) Comparison between the two RVS forms.
- 7) Identification of buildings requiring detailed seismic investigation.

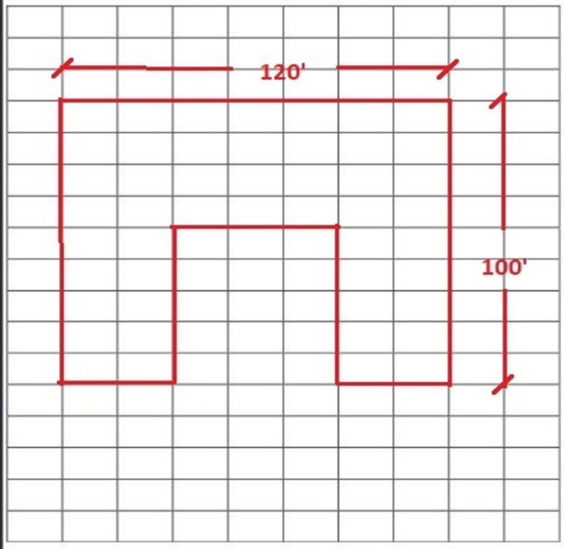
Fig. 3: RVS proposed by Ningthoujam and Nanda [1]

An educational building of G+1 is taken for the case study from the surveyed buildings. Scores are calculated based on the two methodologies as presented in Fig: 1 and Fig: 2. As per Ningthoujam and Nanda [1], the building will face grade 4 damage and need further detailed evaluation, whereas the school building will face grade 2 damage as per FEMA and need not further re-evaluation for the seismic event.

Building Name <b>Azad Nagar Urdu High School</b> Address <b>Farooque Nagar Teka Nagpur</b> Other Identifiers <b>---</b> GPS Co-ordinates (If available) <b>---</b> No. Stories <b>2</b> Year Built <b>1992</b> Total Floor Area (sq. Ft. /sq. m) <b>12000 sq.ft</b> Seismic zone <b>II</b> Surveyor <b>Shamshad Ali</b> Date <b>15/12/2019</b>				
<b>OCCUPANCY</b> Commercial <input type="checkbox"/> Residential <input type="checkbox"/> Educational <input checked="" type="checkbox"/> Occupancy number <b>400</b>		<b>SOIL TYPE</b> Type I Hard Type II Medium Type III <b>Soft</b> Age of the building: Age of building (In years) <b>27</b>				
<b>BASIC SCORE, MODIFIERS, AND FINAL SCORE, S</b>						
Seismic zone <b>Zone II</b> Basic scores <b>1.00</b>		<b>Zone III</b> <b>1.70</b>	<b>Zone IV</b> <b>2.00</b>			
<b>Zone V</b> <b>2.70</b>						
Basic score modifier	Substantial overhang	+0.41	+0.41	+0.41		
	Age of building : Increment per year <b>27x</b>	+0.02	+0.02	+0.02

Poor construction quality	+2.20	+2.20	+2.20		
	Moderate construction quality	+1.10	+1.10	+1.10		
	Poor Maintenance condition	+1.30	+1.30	+1.30		
	Moderate Maintenance condition	+0.65	+0.65	+0.65		
	Type of soil:					
	Soil type-I	-4.86	-4.86	-4.86		
Soil type-II	-2.43	-2.43	-2.43			
Soil type-III	0.00	0.00	0.00			
Number of stories: Increment per storey <b>2x</b>	+0.10	+0.10	+0.10	+0.10		
<b>FINAL SCORE, S= 2.39</b>						
Final score Assigned damage grade		<b>S&lt;1</b> Grade 1	<b>1≤S&lt;1.5</b> Grade 2	<b>1.5≤S&lt;2</b> Grade 3	<b>2≤S&lt;2.65</b> Grade 4	<b>2.65&lt;S</b> Grade 5
<b>RECOMMENDED ACTION FOR DIFFERENT DAMAGE GRADE:</b> Grade 1/2: Seismically safe but non-structural damage can be harmful to occupants so repairing work is recommended for the building Grade 3/4/5: Seismically not safe as structural damage will occur so further re-evaluation and retrofitting is recommended for the building				<b>Recommended action to be taken for the existing building:</b> <b>Further re-evaluation is recommended.</b>

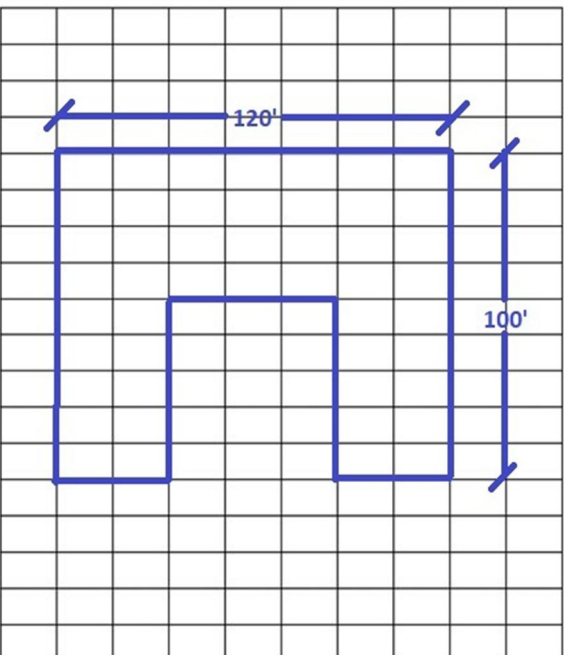
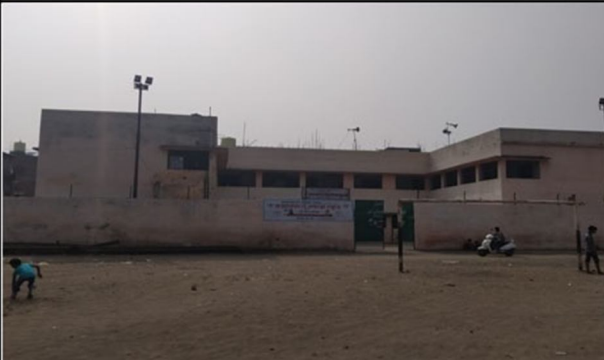
Fig. 4: RVS sheet by FEMA [9]

<p style="font-size: small;">Plan and Elevation Scale:</p>	<p>Address: <u>Farooque Nagar Teka</u>  <u>Nagpur</u> Pin <u>440017</u></p> <p>Other Identifiers <u>---</u></p> <p>GPS Co-ordinates (If available) <u>---</u></p> <p>No. Stories <u>2</u> Year Built <u>1992</u></p> <p>Surveyor <u>Shamshad Ali</u> Date <u>15/12/2019</u></p> <p>Total Floor Area(sq. Ft./sq. m) <u>12000 sq. ft</u></p> <p>Building Name <u>Azad Nagar Urdu High School</u></p> <p>Use <u>Educational</u></p>

OCCUPANCY										
Assembly Commercial Emer. Service	Govt. Historic Industrial	Office Residential <u>School</u>	Max. No. Of persons 0-10    11-100 <u>101-1000</u> 1000+	Type I    Type II <u>Type III</u> Hard    Medium    Soft	Chimneys Cladding	Parapets Others.				
BASIC SCORE, MODIFIERS, AND FINAL SCORE, S										
BUILDING TYPE	Wood	S1 (FRAME)	S2 (LM)	C1 (MRF)	C2 (SW)	C3 (INF)	RM1 (BAND+RD)	RM2 (BAND+FD)	URM3	URM4

Basic Score	6.0	4.6	4.6	<u>4.4</u>	4.8	4.4	4.6	4.8	4.6	3.6
Mid Rise (4 to 7 stories)	N/A	+0.2	N/A	+0.4	-0.2	-0.4	-0.2	-0.4	-0.6	-0.6
High Rise (>7 stories)	N/A	+1.0	N/A	+1.0	0.0	-0.4	N/A	N/A	N/A	N/A
Vertical Irregularity	-3.0	-2.0	N/A	-1.5	-2.0	-2.0	-1.5	-2.0	-1.5	-1.5
Plan Irregularity	-0.8	-0.8	-0.8	<u>-0.8</u>	-0.8	-0.8	-0.8	-0.8	-0.8	-0.8
Poor Condition	-0.5	-0.5	-0.5	-0.5	-0.5	-0.5	-0.5	-0.5	-0.5	-0.5
Code Detailing	N/A	+0.4	N/A	+0.6	+0.4	N/A	N/A	N/A	N/A	N/A
Soil Type II	-0.4	-0.8	-0.4	<u>-0.6</u>	-0.4	-0.4	-0.2	-0.4	-0.4	-0.4
Soil Type III	-0.8	-1.4	-1.0	<u>-1.4</u>	-0.8	-0.8	-0.8	-0.8	-0.8	-0.8
Liquefiable Soil	-2.0	-2.0	-2.0	-2.0	-2.0	-2.0	-1.6	-1.4	-1.4	-1.4
FINAL SCORE, S = 2.2										
Comments  <p style="color: blue;">As per the Score, further re-evaluation is not recommended as it is of more than the cut off score of 2.</p>										Further Evaluation Recommended  <div style="display: flex; justify-content: space-around;"> <span>YES</span> <span> NO</span> </div>

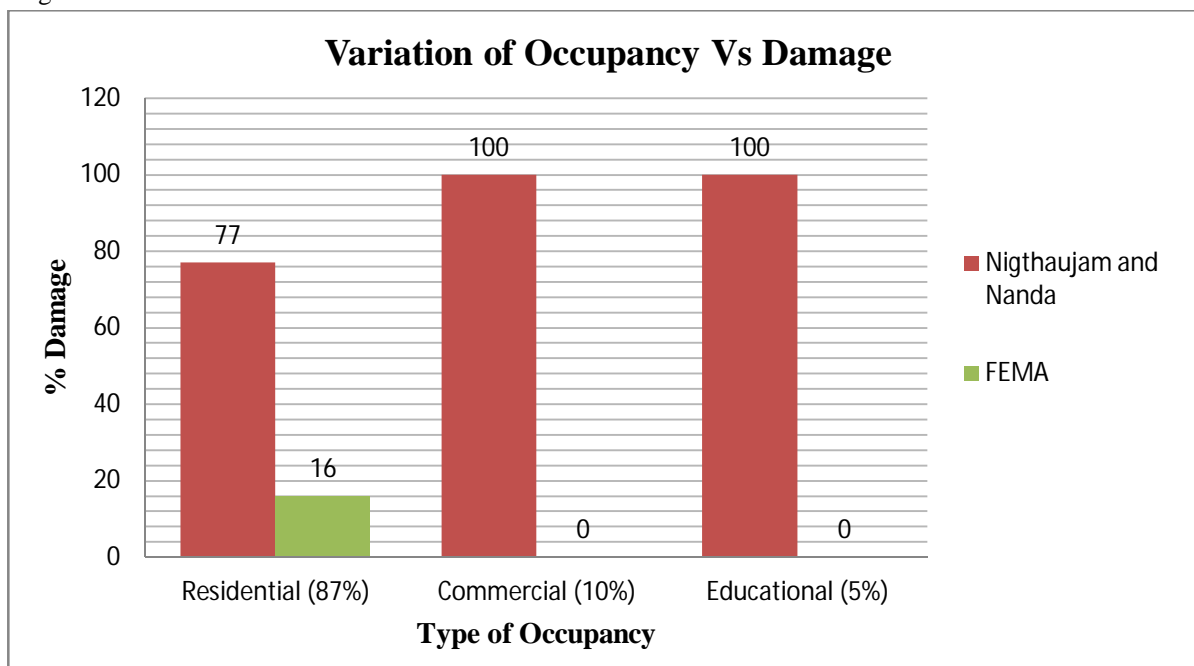
Fig. 5: Distribution of types of occupancy

The interpretation of the survey data has been represented in the form of bar charts. Figure 5 represents the variation in the occupancy type within the sample surveyed. 87% of the buildings are residential, 10% are commercial and 5% are the educational buildings. The vertical axis shows the % of damage calculated by both the methodologies that needs details evaluation (above grade 2). Forms proposed by Ningthaujam and Nanda shows high level of damage whereas FEMA shows only few residential buildings of getting damage.

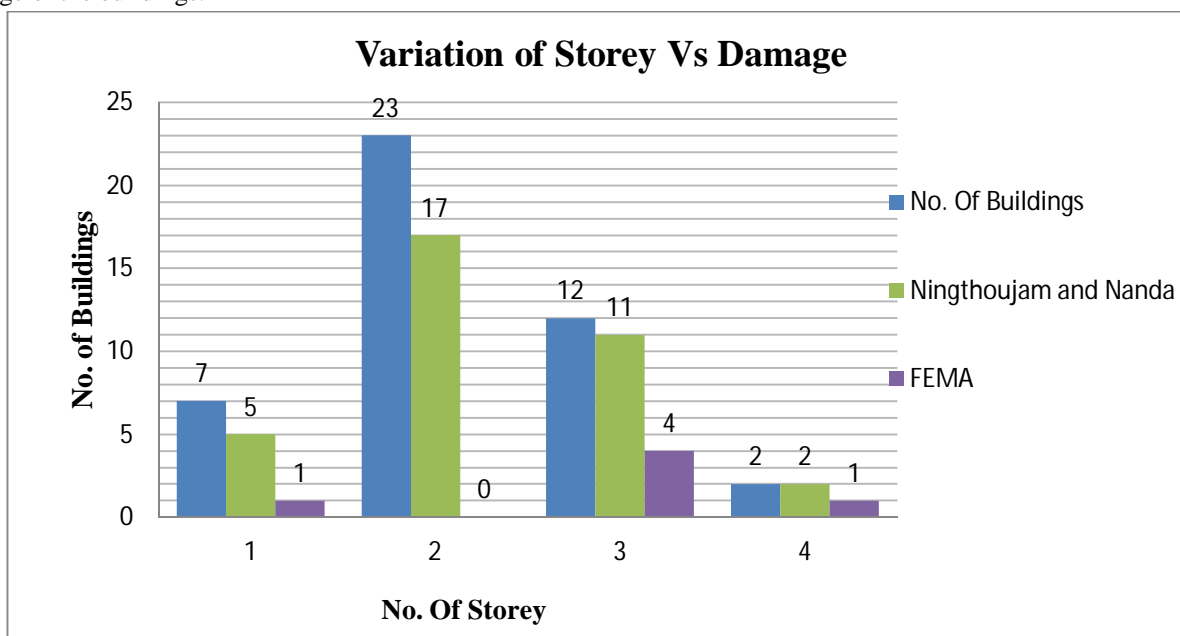
Fig. 6: Distribution of Storey of the buildings

Figure 6 represents the distribution of the storeys of the buildings surveyed. Maximum storey of the building is 4 within the vicinity and most of the buildings are of 2-3 storeys. Ningthaujam and Nanda, FEMA indicates the number of buildings getting the grade above 2 that emphasizes the heavy damage. Here also more damage prediction is made by the first form whereas FEMA shows very less damage of the buildings.

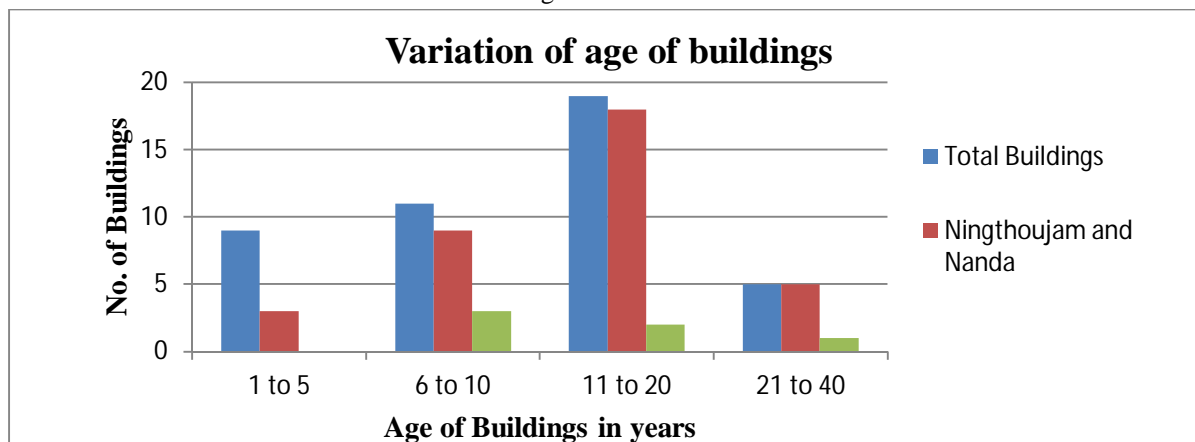
Fig. 7: Distribution of age of the buildings

Variation in the age of the RC buildings surveyed is represented in figure 7. In the selected region, most of the buildings are of 10 to 20 years and few of more than 20 years. In this chart, Ningthoujam and Nanda and FEMA indicate the number of buildings that require more detailed assessment as per the score calculated by the RVS forms. It can be seen that with increase of age of the buildings, damage also increases in the first case because the first form uses the age of building to calculate the RVS score, on the other hand FEMA recommended form doesn't contain the age in the calculation of score.

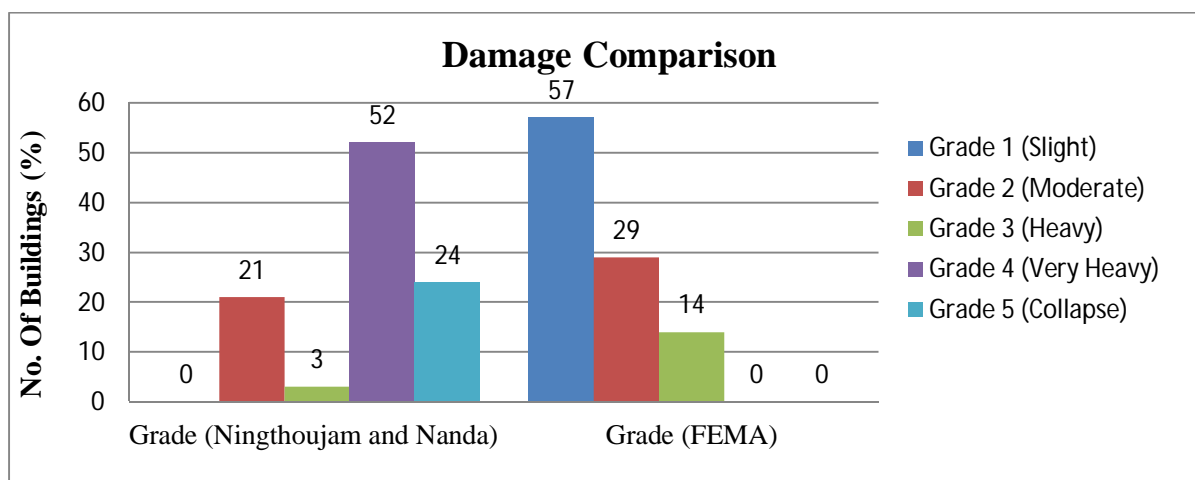
Fig. 8: Damage assigned by the two forms

The detailed comparison of all the grades calculated by the two methodologies within the selected area is represented in figure 8. It can be noted that only 21% (sum of grade 1 and grade 2) of buildings lie between slight to moderate damage calculated by Ningthoujam and Nanda whereas 86% of the buildings lie in the same range by FEMA. Ningthoujam and Nanda suggested screening form shows higher % of buildings fall under grade 4 and grade 5. FEMA recommended screening form illustrates only 14% of grade 3 damage of the buildings of none of grade 4 and grade 5.

- 79% of the total building surveyed needs further more detailed evaluation as per Ningthoujam and Nanda [1] and recommended for suitable retrofitting measures.
- The methodology proposed by the Ningthoujam and Nanda [1] was performed on zone V, the basic value and basic value modifiers are provided for other zones for soft soil condition that needs to be modified for rest of the zones to verify its accuracy for other zones. This screening form uses the age of building and number of storey to calculate the score that's why increase in both the parameters result in higher value of damage grade.

- C. Only 14% of the total buildings need more detailed evaluation as per FEMA code of screening. As this screening form uses the plan and vertical irregularity for estimating the score, most of the buildings surveyed within the vicinity likely to get less damage.
- D. About 24% of damage grade of the total screened buildings is matched by both the methodologies. For comparing the accuracy of the screening forms, the detailed software evaluation shall be conducted and an expert suggestion will also be helpful in this regard.
