Identification and Mitigation of Blackspots and Implementation of An Advanced Traffic Management System on NH-216A (A Spur of National Highway-16)

Maanyam Ramakrishna¹, Bandaru Ramesh²

¹M.Tech Student, Transportation Engineering, Department of Civil Engineering, Pydah College of Engineering, Kakinada, Andhra Pradesh

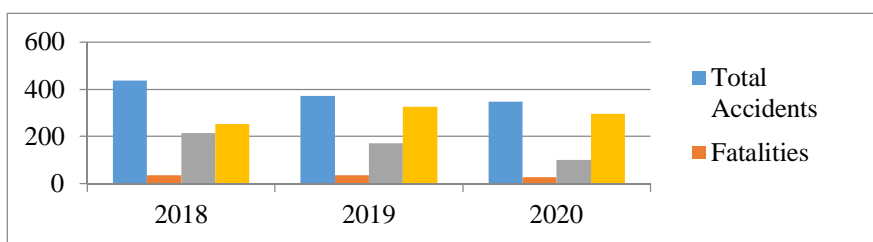
Fig. 3 Road Accidents on NH-16 for the section of Diwancheruvu to Siddantham

- 1) **Accident Data Collection:** The past 3 years (2018 To 2020) accident data is collected from the National Highways Authority of India for the section of Diwancheruvu to Siddantham section (from Km. 901+500 to Km. 950+542). The analysed accident data is represented in table 1:

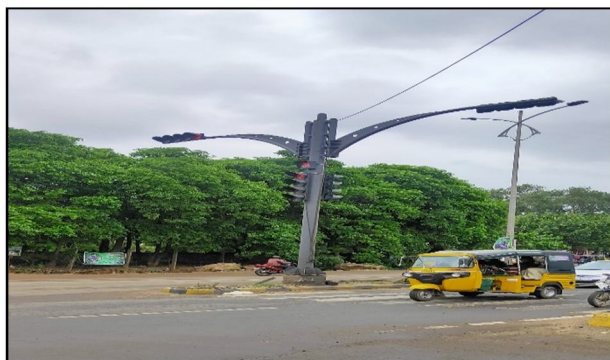
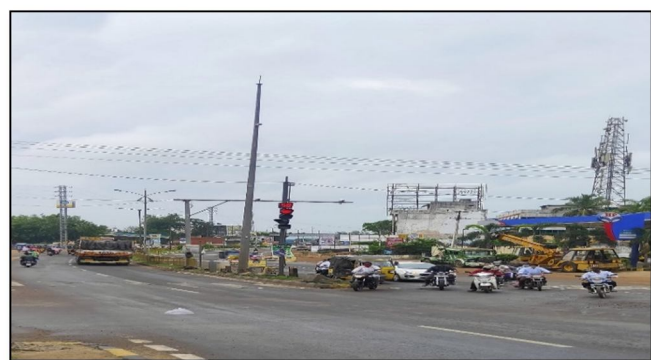
Fig. 4 Traffic Signal at Lalacheruvu Junction

Stretch	Average Delay Time	Reason for Delay
Diwancheruvu to Siddantham	192 Seconds	Traffic Signals at 1. Lalacheruvu Junction(62 Sec) 2. Morampudi Junction(130 Sec)
Siddantham to Diwancheuvu	188 Seconds	Traffic Signals at 1. Lalacheruvu Junction(62 Sec) 2. Morampudi Junction(126 Sec)

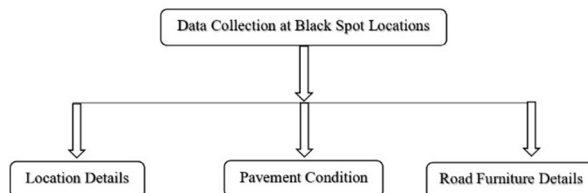
Fig. 6 Flowchart of Data Collection at Black Spot Location

The data collection at the black spot located in the present study is detailed in the below figure.

- 1) The data collection involves Location details Road Features, Median opening details, Approach Road conditions, Intersection details, and Pavement cross-sections.
- 2) Pavement condition involves Alligator cracking, Bleeding, Block cracking, Bumps and sags, Corrugations, Depressions, Edge cracking, Joint reflections, Lane/shoulder drop-off, Longitudinal, and transverse cracking, Potholes, Rutting, Shoving, Slippage cracking, Swelling, Ravelling.
- 3) Road Furniture condition involves the condition of Road Markings, Road Signs, Road Studs, Safety Barriers, Guard Posts, Traffic Delineators, and Highway Lighting.
