Identification and Mitigation of Blackspots and Implementation of An Advanced Traffic Management System on NH-216A (A Spur of National Highway-16)

Maanyam Ramakrishna¹, Bandaru Ramesh²

¹M.Tech Student, Transportation Engineering, Department of Civil Engineering, Pydah College of Engineering, Kakinada, Andhra Pradesh

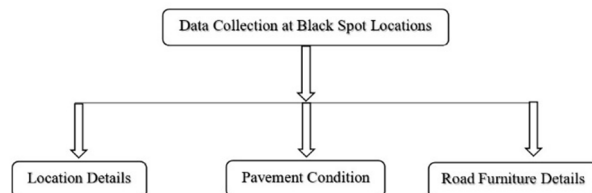
Fig. 6 Flowchart of Data Collection at Black Spot Location

The data collection at the black spot located in the present study is detailed in the below figure.

- 1) The data collection involves Location details Road Features, Median opening details, Approach Road conditions, Intersection details, and Pavement cross-sections.
- 2) Pavement condition involves Alligator cracking, Bleeding, Block cracking, Bumps and sags, Corrugations, Depressions, Edge cracking, Joint reflections, Lane/shoulder drop-off, Longitudinal, and transverse cracking, Potholes, Rutting, Shoving, Slippage cracking, Swelling, Ravelling.
- 3) Road Furniture condition involves the condition of Road Markings, Road Signs, Road Studs, Safety Barriers, Guard Posts, Traffic Delineators, and Highway Lighting.
