Identification and Mitigation of Blackspots and Implementation of An Advanced Traffic Management System on NH-216A (A Spur of National Highway-16)

Maanyam Ramakrishna¹, Bandaru Ramesh²

¹M.Tech Student, Transportation Engineering, Department of Civil Engineering, Pydah College of Engineering, Kakinada, Andhra Pradesh

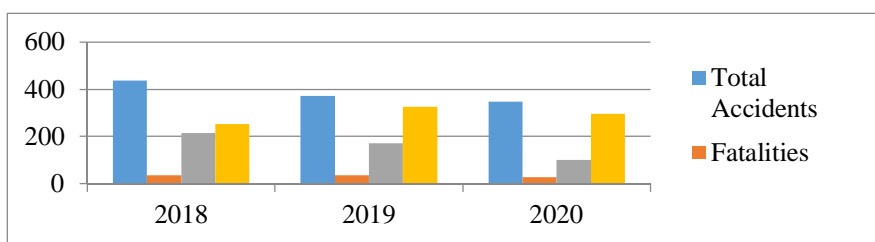
Fig. 3 Road Accidents on NH-16 for the section of Diwancheruvu to Siddantham

- 1) **Accident Data Collection:** The past 3 years (2018 To 2020) accident data is collected from the National Highways Authority of India for the section of Diwancheruvu to Siddantham section (from Km. 901+500 to Km. 950+542). The analysed accident data is represented in table 1:

Year	Total Accidents	Fatalities	Major Injured	Minor Injured
2018	438	36	215	254
2019	371	35	171	325
2020	348	27	101	295

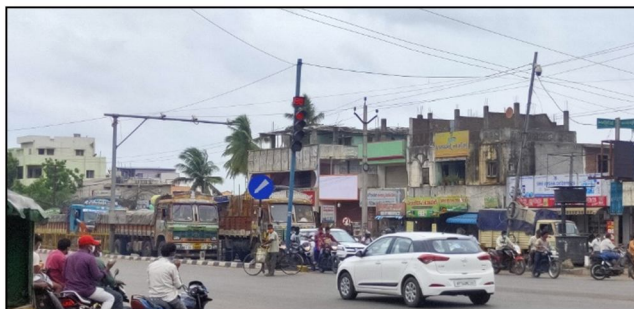
Fig. 4 Traffic Signal at Lalacheruvu Junction

Stretch	Average Delay Time	Reason for Delay
Diwancheruvu to Siddantham	192 Seconds	Traffic Signals at 1. Lalacheruvu Junction(62 Sec) 2. Morampudi Junction(130 Sec)
Siddantham to Diwancheuvu	188 Seconds	Traffic Signals at 1. Lalacheruvu Junction(62 Sec) 2. Morampudi Junction(126 Sec)

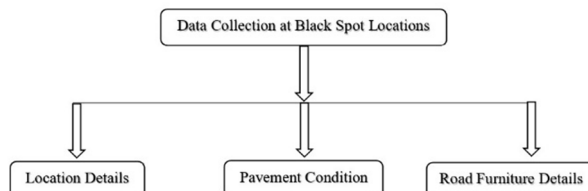
Fig. 6 Flowchart of Data Collection at Black Spot Location

The data collection at the black spot located in the present study is detailed in the below figure.

- 1) The data collection involves Location details Road Features, Median opening details, Approach Road conditions, Intersection details, and Pavement cross-sections.
- 2) Pavement condition involves Alligator cracking, Bleeding, Block cracking, Bumps and sags, Corrugations, Depressions, Edge cracking, Joint reflections, Lane/shoulder drop-off, Longitudinal, and transverse cracking, Potholes, Rutting, Shoving, Slippage cracking, Swelling, Ravelling.
- 3) Road Furniture condition involves the condition of Road Markings, Road Signs, Road Studs, Safety Barriers, Guard Posts, Traffic Delineators, and Highway Lighting.
