Identification and Mitigation of Blackspots and Implementation of An Advanced Traffic Management System on NH-216A (A Spur of National Highway-16)

Maanyam Ramakrishna¹, Bandaru Ramesh²

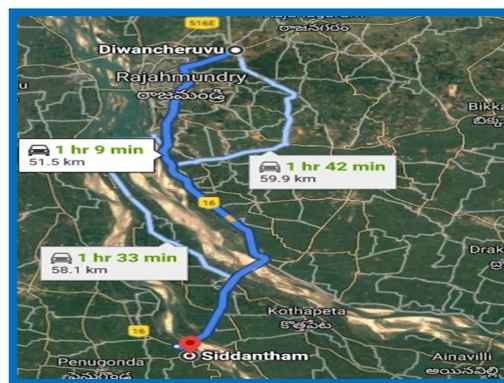
Fig. 2 Map of Study Stretch (Diwancheruvu to Siddantham)

The area which is selected for accident studies is 49 km long National Highway-216A (a spur road of National Highway-16) section between Diwancheruvu to Siddantham from Km. 901+500 to Km. 950+542, Andhra Pradesh.

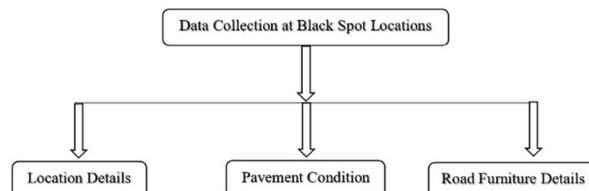
Fig. 6 Flowchart of Data Collection at Black Spot Location

The data collection at the black spot located in the present study is detailed in the below figure.

- 1) The data collection involves Location details Road Features, Median opening details, Approach Road conditions, Intersection details, and Pavement cross-sections.
- 2) Pavement condition involves Alligator cracking, Bleeding, Block cracking, Bumps and sags, Corrugations, Depressions, Edge cracking, Joint reflections, Lane/shoulder drop-off, Longitudinal, and transverse cracking, Potholes, Rutting, Shoving, Slippage cracking, Swelling, Ravelling.
- 3) Road Furniture condition involves the condition of Road Markings, Road Signs, Road Studs, Safety Barriers, Guard Posts, Traffic Delineators, and Highway Lighting.
