# Analysis and Providing Solutions for the Rectification of Black Spots On NH-27(OLD NH-28)

<sup>1</sup>PG Student, <sup>2,3</sup>Assistant Professor, Department of Civil Engineering, Galgotias University, Greater Noida (UP)

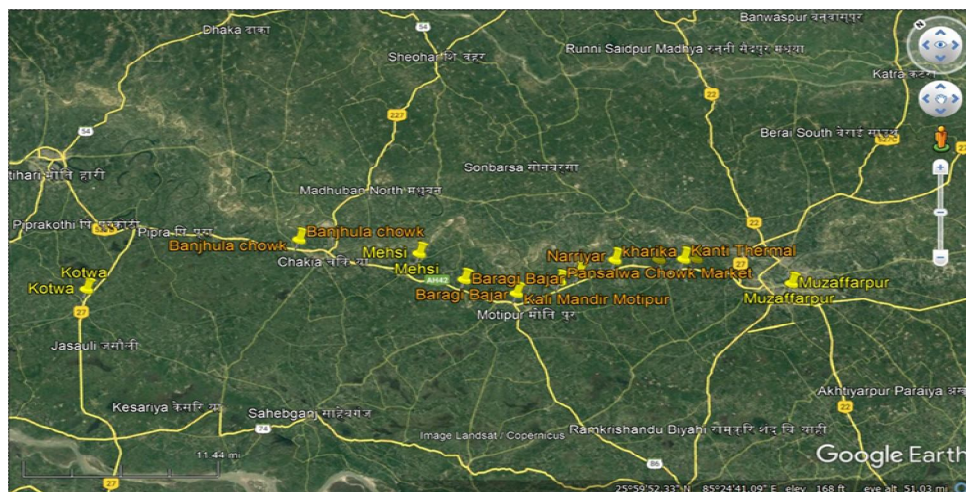
Figure I  
Project Study Stretch

Study area selected stretch of National Highway of Mehsi- Muzaffarpur Section from km 440.00 to km 520.00 (Total Length 80.00 Km) of NH-27 (old NH- 28) in the State of Bihar, India taken by google earth.

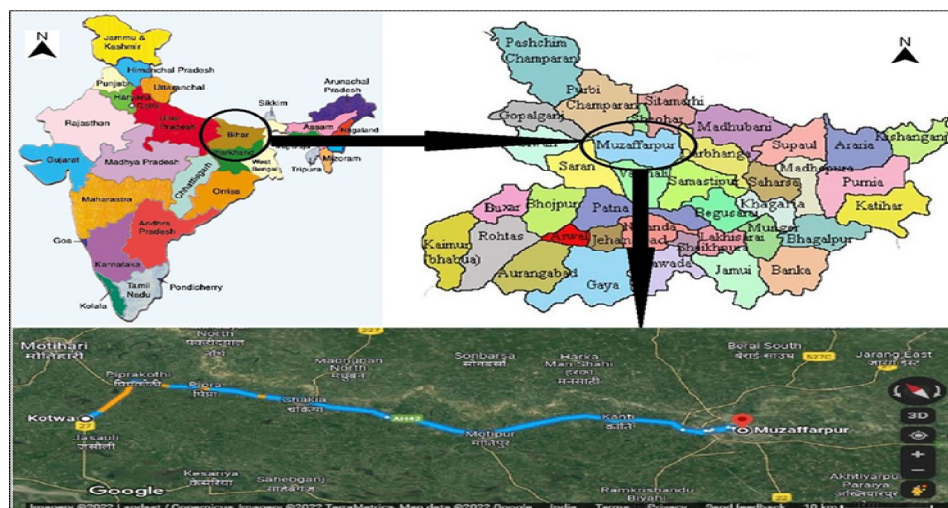
Figure II  
Key Plan Of Study Stretch

- 1) In this study the selected study stretch is located in state of Bihar, India i.e. From Kotwa to Muzaffarpur which is approx. 81.2 Km on NH-27 (old NH-28)

- 2) Study stretch as per chainage allotted by NHAI (National Highway Authority of India) is National Highways of Mehsi-Muzaffarpur Section from km 440.00 to km 520.00 (Total Length 80.00 Km) of NH-27 (old NH- 28) in the State of Bihar.

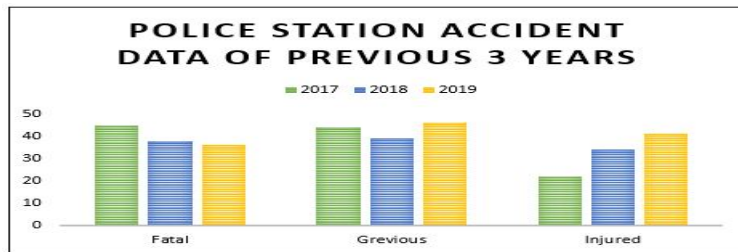
Figure IVII

Police Station Accident Data of previous 3 years

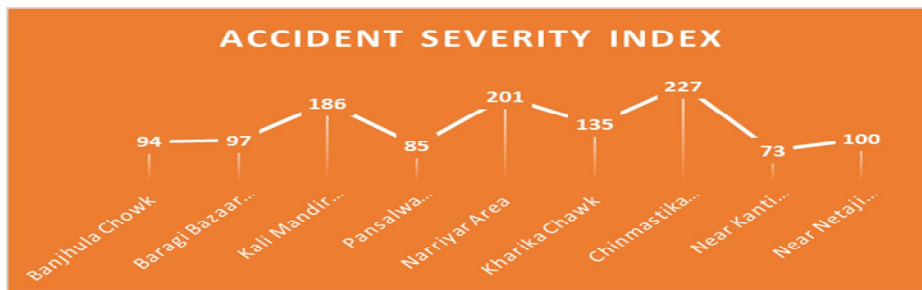
Figure VIV

ASI Of Different Black Spot On Nh-27

Based on ASI values the highest valued black spots further be taken for the rectification solution analysis i.e. Kali Mandir Motipur, Nariyar area & Chinmastika Mandir.

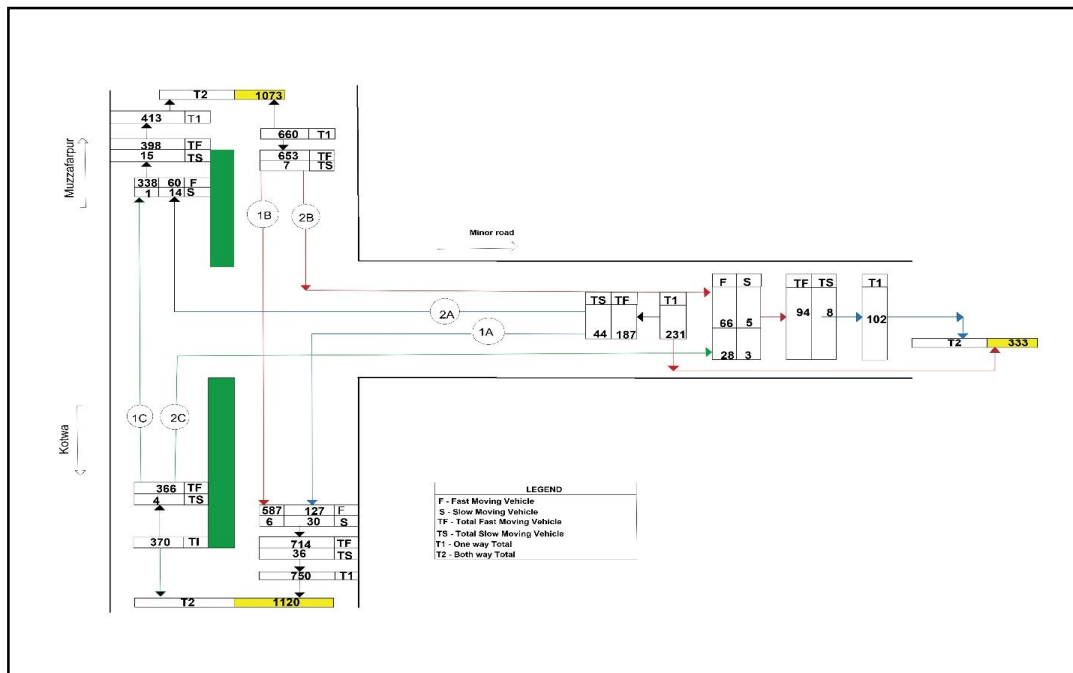
Figure V  
Traffic Flow Diagram of Kali Mandir

Kali Mandir Motipur at chainage 492.80

The intersection peak hour traffic (in number and in PCU) of Kali Mandir Motipur has been shown in table IV.

- a) It has been observed that parked trucks causing congestion to the vehicles on right side of carriage way while driving into the minor lane.
- b) There has been a disorientation in channelizing island diverting traffic to wrong side at channelizing area at the median opening.
- c) A VUP with span of 12.0m with vertical clearance of 5.5m.
- d) Provision of a Truck-lay bay with 20 truck parking capacity.
- e) Provision of intermediate lane, service road on both side of main carriageway.
- f) Development of Entry/Exit at the start/end of service road.
- g) Provision of signage as per IRC:67-2012.
- h) Provision of Lane marking as per IRC:35-2015.

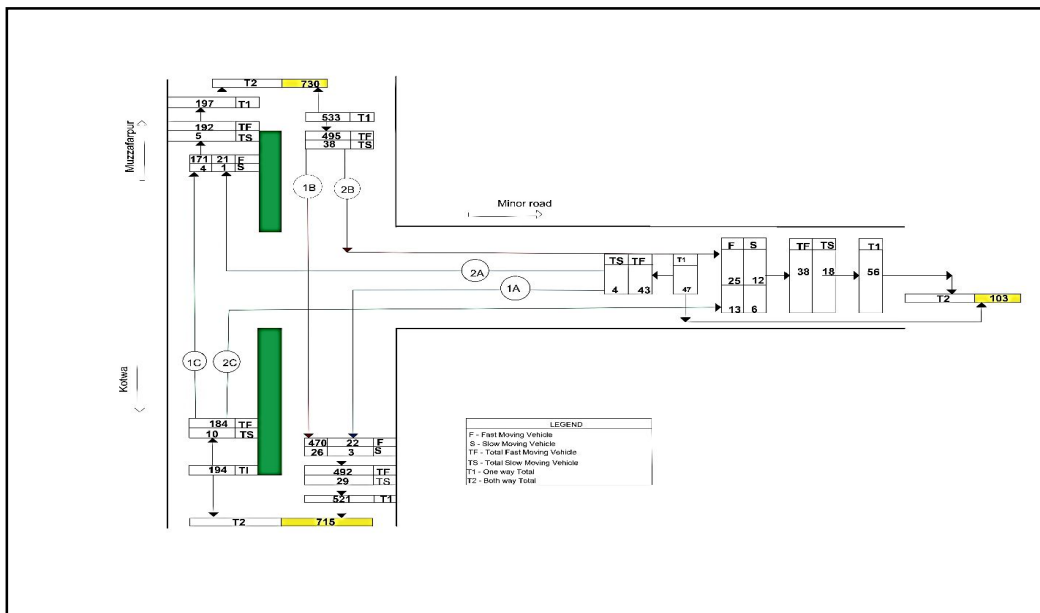
Figure VI  
Traffic Flow Diagram of Narriyar area

Narriyar area at chainage 499.30

The intersection peak hour traffic (in number and in PCU) of Narriyar area has been shown in table V.

- It has been observed that parked trucks causing congestion to the vehicles on right side of carriage way while driving into the minor lane.
- There has been a disorientation in channelizing island diverting traffic to wrong side at channelizing area at the median opening.

- c) A VUP with span of 12.0m with vertical clearance of 5.5m.
- d) Provision of a Truck-lay bay with 20 truck parking capacity.
- e) Provision of intermediate lane, service road on both side of main carriageway.
- f) Development of Entry/Exit at the start/end of service road.
- g) Provision of signage as per IRC:67-2012.
- h) Provision of Lane marking as per IRC:35-2015.

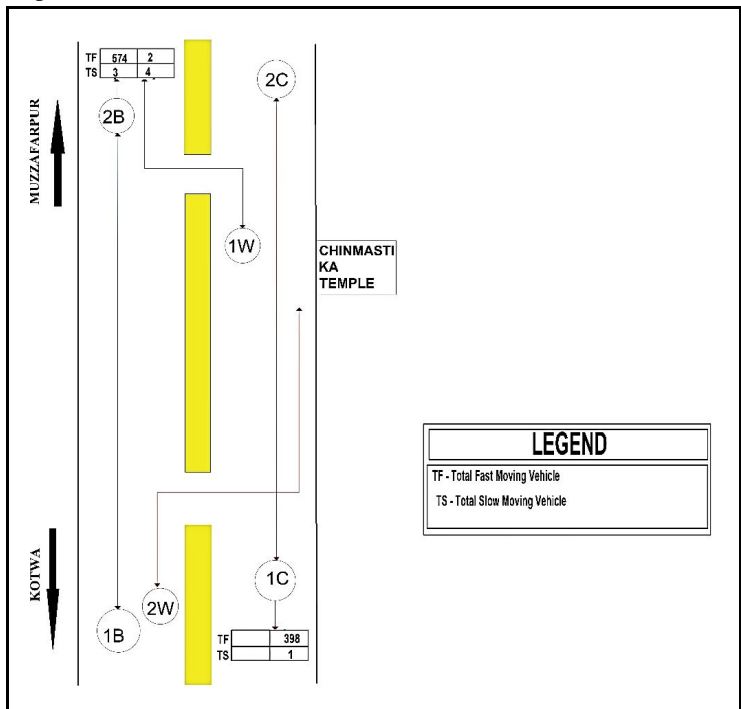
Figure VII  
Traffic Flow Diagram of Chinmastika Mandir

4) Chinmastika mandir at chainage 508.87

The intersection peak hour traffic (in number and in PCU) of Chinmastika Mandir has been shown in table VI.

- a) It is observed that median opening is placed 100m away from the temple, forcing vehicle users to take wrong route to the temple.
- b) It is observed that there is on-street parking available for the temple.
- c) A LVUP with span of 7.0m with vertical clearance of 4.0m.
- d) Provision of a Truck-lay bay with 20 truck parking capacity.
- e) Provision of intermediate lane, service road on both side of main carriageway.
- f) Development of Entry/Exit at the start/end of service road.
- g) Provision of signage as per IRC:67-2012.
- h) Provision of Lane marking as per IRC:35-2015.
