# Assessment of Water Quality in Chennai's Urban Lakes: Impacts of Urbanization and Encroachment

**Abstract:** This study assesses the 2019 water quality of five major lakes in Chennai—Ambattur, Korattur, Perungudi, Velachery, and Rettai Eri—highlighting significant contamination driven by urbanization and industrial activities. Water samples from these lakes were analyzed for key geo-chemical parameters, including calcium, magnesium, carbonates, bicarbonates, sulfates, sodium, chlorides, total dissolved solids (TDS), pH, electrical conductivity (EC), and potassium. The results revealed substantial contamination due to residential sewage and urban runoff. For instance, Velachery Lake exhibited the most significant contamination, with only 24.78% of its original area remaining and 75.22% encroached upon. The other lakes also showed high levels of pollution, reflecting the severe impact of urban expansion on water quality. These findings emphasize the urgent need for comprehensive water management strategies and targeted interventions to mitigate pollution and restore the ecological balance of these lakes. Effective measures such as strict zoning law enforcement, restoration project

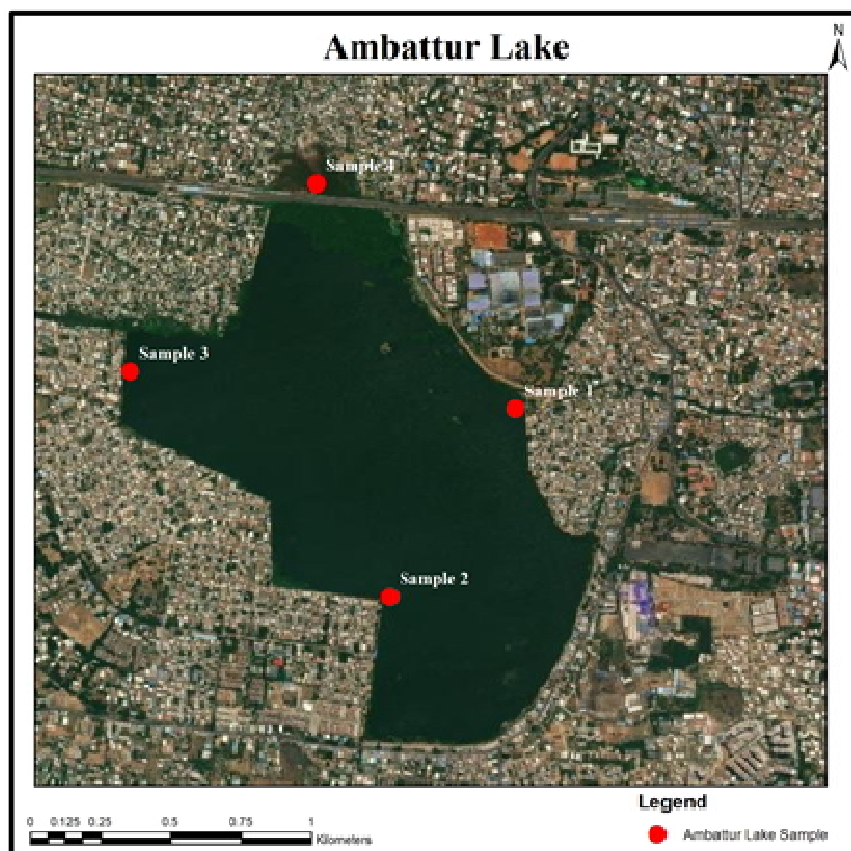
Figure.No.1 Ambattur Lake Water Quality sample

The water quality data for Ambattur Lake in 2019 highlights several key geo-chemical parameters, reflecting significant contamination primarily due to its location in a densely populated residential area. This lake receives direct sewage discharge from nearby homes, particularly affecting the northern part of the lake.

Calcium levels in Ambattur Lake range from 117.25 mg/L to 214.57 mg/L, while magnesium levels vary between 30.36 mg/L and 73.80 mg/L. These elevated levels suggest water hardness, often linked to urban runoff and sewage discharge. The carbonate levels range from 363 mg/L to 784 mg/L, and bicarbonates range from 282 mg/L to 455 mg/L. These high levels indicate substantial buffering capacity but also point to potential pollution from residential sewage.

Sulfate levels in the lake vary between 82.11 mg/L and 144.66 mg/L. Elevated sulfate levels can be associated with industrial discharges and the decomposition of organic matter from sewage. Sodium levels range from 219 mg/L to 327 mg/L, while chloride levels span from 236.23 mg/L to 800.53 mg/L. High concentrations of these ions are typical indicators of urban sewage contamination and road runoff.

TDS levels in Ambattur Lake range from 1242 mg/L to 2159 mg/L. These high values reflect significant contamination from sewage and urban runoff, impacting water quality. The pH of the lake ranges from 7.30 to 8.60, indicating slightly alkaline conditions, consistent with the presence of bicarbonates and carbonates in the water. EC values range from 1856.90  $\mu\text{S}/\text{cm}$  to 3387.50  $\mu\text{S}/\text{cm}$ . High electrical conductivity suggests a high ionic concentration in the lake water, indicating substantial contamination.

The northern part of Ambattur Lake is particularly contaminated, as evidenced by Sample 4 data: calcium at 214.57 mg/L, magnesium at 73.80 mg/L, carbonates ( $\text{CaCO}_3$ ) at 784 mg/L, bicarbonates ( $\text{HCO}_3$ ) at 455 mg/L, sulfate at 144.66 mg/L, sodium at 327 mg/L, chloride at 800.53 mg/L, TDS at 2159 mg/L, pH at 8.60, and electrical conductivity at 3387.50  $\mu\text{S}/\text{cm}$ . These elevated levels indicate severe contamination, likely from direct sewage discharge and urban runoff.

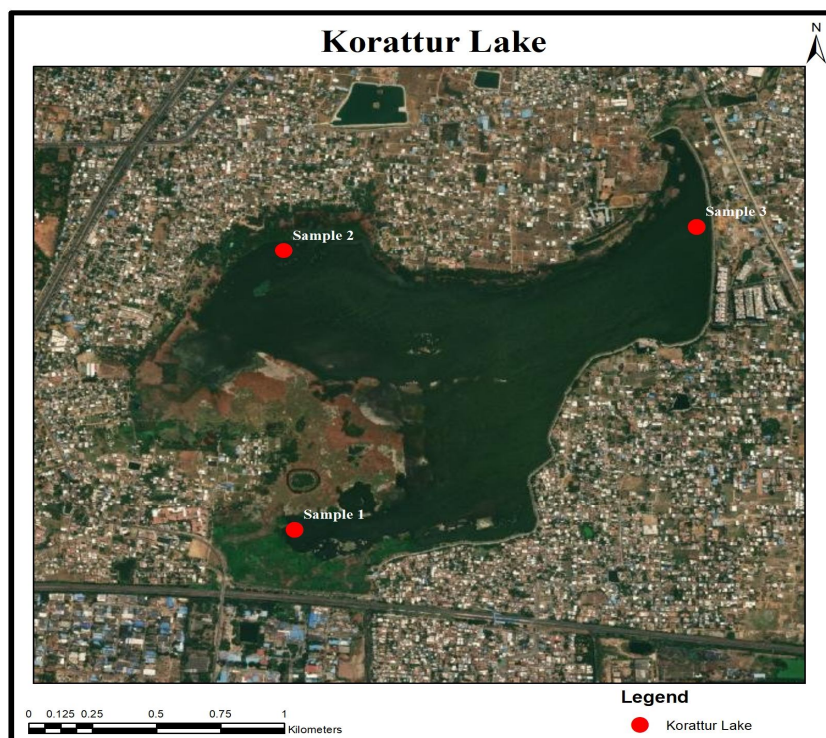
Figure.No.2 Korattur Lake Sample

The 2019 water quality data for Korattur Lake highlights several key geo-chemical parameters, reflecting significant contamination due to its location in a densely populated residential area. The direct connection of residential sewage to the lake exacerbates the pollution levels. Calcium levels in Korattur Lake range from 156.6 mg/L in Sample 1 to 247.23 mg/L in Sample 3. These elevated levels indicate significant hardness, likely resulting from the influx of residential sewage and urban runoff.

Magnesium concentrations vary from 31.69 mg/L in Sample 1 to 55.6 mg/L in Sample 3. Similar to calcium, high magnesium levels contribute to water hardness and indicate pollution from urban sources. Calcium carbonate levels range from 381.9 mg/L in Sample 1 to 458.9 mg/L in Sample 2, while bicarbonate levels are fairly consistent, ranging from 293.3 mg/L to 303.3 mg/L. These high levels suggest substantial buffering capacity but also highlight potential pollution from residential sewage. Sulfate levels range from 86.078 mg/L in Sample 1 to 115.198 mg/L in Sample 2. Elevated sulfate levels can be associated with the breakdown of organic matter from sewage and possibly industrial discharges. Sodium levels range from 220 mg/L in Sample 3 to 280 mg/L in Sample 2, while chloride concentrations vary from 243.29 mg/L in Sample 1 to 361.112 mg/L in Sample 2. High sodium and chloride levels are indicative of contamination from residential sewage and urban runoff.

TDS values vary significantly from 1340 mg/L in Sample 1 to 6050 mg/L in Sample 2. These high TDS levels reflect severe contamination, primarily from sewage and urban runoff, impacting the lake's overall water quality. The pH values range from 6.9 in Sample 2 to 7.73 in Sample 1. These values indicate slightly acidic to neutral conditions, consistent with the presence of various dissolved ions. EC values range from 1856.9  $\mu\text{S}/\text{cm}$  in Sample 1 to 8530  $\mu\text{S}/\text{cm}$  in Sample 2. High electrical conductivity directly indicates high ionic concentration in the lake water, suggesting significant contamination levels. The geo-chemical analysis of Korattur Lake for 2019 reveals substantial contamination primarily attributed to residential sewage inflow and urban runoff. Elevated levels of Total Dissolved Solids (TDS), sodium, chloride, and other key parameters underscore the urgent need for remedial actions to mitigate pollution sources and enhance water quality. Notably, Sample 2 stands out as the most contaminated, necessitating focused intervention to address the severe pollution in this part of the lake.

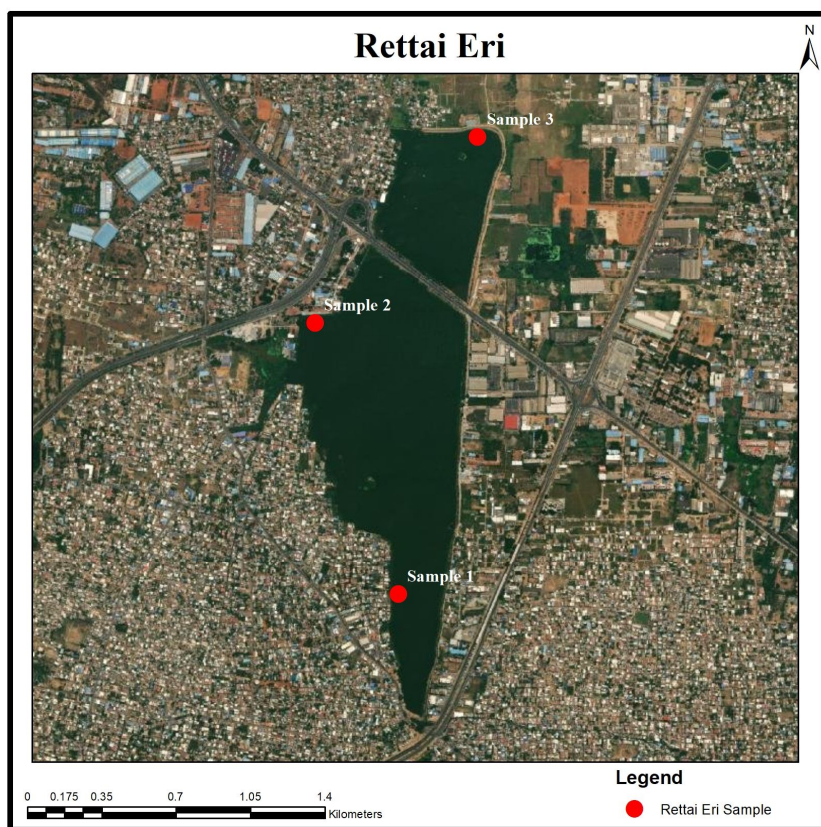
Figure.No.3 Rettai Eri Sample

The 2019 water quality data for Rettai Eri highlights several key geo-chemical parameters, reflecting significant contamination due to its location in a densely populated residential area and direct sewage inflow.

Calcium levels in Rettai Eri range from 142.95 mg/L in Sample 2 to 233.58 mg/L in Sample 3. These elevated levels suggest considerable hardness, likely due to residential sewage and urban runoff. Magnesium concentrations vary from 18.04 mg/L in Sample 2 to 41.95 mg/L in Sample 3. High magnesium levels, similar to calcium, contribute to water hardness and indicate pollution from urban sources. Calcium carbonate levels range from 368.25 mg/L in Sample 2 to 445.25 mg/L in Sample 1, while bicarbonate levels vary between 279.65 mg/L and 289.65 mg/L. These high levels suggest substantial buffering capacity but also highlight potential pollution from residential sewage.

Sulphate levels range from 72.428 mg/L in Sample 2 to 112.23 mg/L in Sample 1. Elevated sulfate levels can be associated with the breakdown of organic matter from sewage and possibly industrial discharges. Sodium levels range from 241.35 mg/L in Sample 2 to 452.21 mg/L in Sample 1, while chloride concentrations vary from 229.64 mg/L in Sample 2 to 347.462 mg/L in Sample 1. High sodium and chloride levels indicate contamination from residential sewage and urban runoff. TDS values significantly range from 906.11 mg/L in Sample 2 to 3325.22 mg/L in Sample 1. These high TDS levels reflect severe contamination, primarily from sewage and urban runoff, impacting the lake's overall water quality. The pH values range from 6.9 in Sample 1 to 7.96 in Sample 2. These readings indicate slightly acidic to neutral conditions, consistent with the presence of various dissolved ions. EC values range from 1087.33  $\mu\text{S/cm}$  in Sample 2 to 3990.26  $\mu\text{S/cm}$  in Sample 1. High electrical conductivity directly indicates high ionic concentration in the lake water, suggesting significant contamination levels.

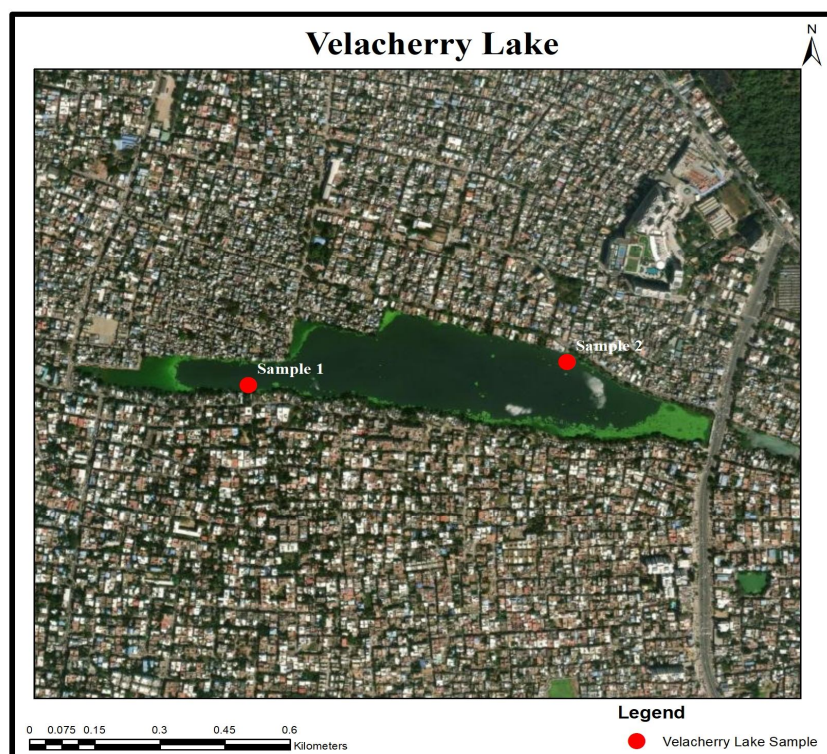
Figure. No. 4 Velachery Lake Sample

The 2019 water quality data for Velachery Lake, which spans 55 acres, reveals several key geo-chemical parameters indicative of significant contamination. Situated in a densely populated residential and commercial area, the lake faces substantial pollution pressures. Calcium levels are recorded at 136.59 mg/L in Sample 1 and 127.72 mg/L in Sample 2, indicating significant water hardness likely due to the influx of residential and commercial sewage, as well as urban runoff. Magnesium concentrations are 50.02 mg/L in Sample 1 and 53.93 mg/L in Sample 2, contributing to water hardness and signaling pollution from urban sources. Calcium carbonate levels are 332.92 mg/L in Sample 1 and 310.45 mg/L in Sample 2, while bicarbonate levels are 277.10 mg/L in Sample 1 and 274.59 mg/L in Sample 2. These high levels suggest substantial buffering capacity but also highlight potential pollution from residential sewage. Sulfate levels are 103.84 mg/L in Sample 1 and 102.16 mg/L in Sample 2, which can be linked to the breakdown of organic matter from sewage and possibly industrial discharges. Sodium levels are 331.80 mg/L in Sample 1 and 307.72 mg/L in Sample 2, while chloride concentrations are 369.84 mg/L in Sample 1 and 374.32 mg/L in Sample 2, indicating contamination from residential sewage and urban runoff. TDS values are 1747.18 mg/L in Sample 1 and 1431.57 mg/L in Sample 2, reflecting severe contamination primarily from sewage and urban runoff, impacting the lake's overall water quality. The pH values are 7.97 in Sample 1 and 8.18 in Sample 2, indicating slightly basic conditions consistent with the presence of various dissolved ions. EC values are 2220.81  $\mu\text{S}/\text{cm}$  in Sample 1 and 1866.91  $\mu\text{S}/\text{cm}$  in Sample 2, directly indicating high ionic concentration in the lake water and suggesting significant contamination levels. Potassium levels are 26 mg/L in Sample 1 and 22 mg/L in Sample 2, which also indicate contamination from urban sources. The elevated levels of calcium, magnesium, sodium, and chlorides, along with high TDS and EC values in both samples, indicate significant contamination, primarily from residential and commercial sewage and urban runoff. The particularly high readings of TDS (1747.18 mg/L in Sample 1) and EC (2220.81  $\mu\text{S}/\text{cm}$  in Sample 1) suggest localized areas of intense pollution. These hotspots are likely influenced by direct discharge points of sewage and runoff from nearby buildings. This underscores the urgent need for targeted interventions and comprehensive water management strategies to mitigate the contamination and protect the lake's ecosystem.

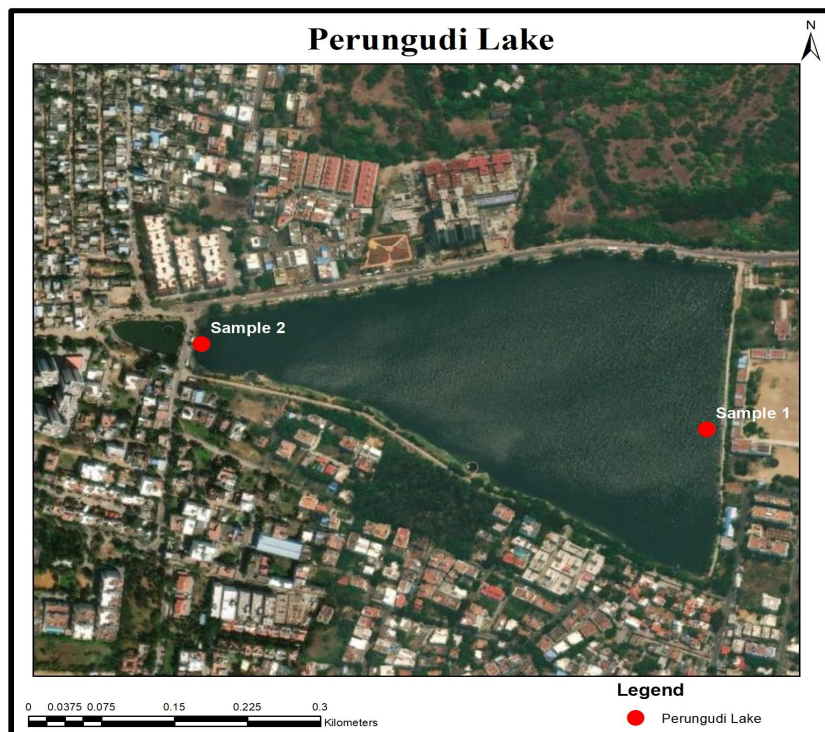
Figure.No.5 Perungudi Lake Sample

The 2019 water quality data for Perungudi Lake reveals several key geo-chemical parameters that indicate significant contamination due to its location in a highly residential and commercial area. Calcium levels are recorded at 136.59 mg/L in Sample 1 and 127.72 mg/L in Sample 2, indicating significant water hardness likely resulting from the influx of residential and commercial sewage and urban runoff. Magnesium concentrations are 50.02 mg/L in Sample 1 and 53.93 mg/L in Sample 2, contributing to water hardness and indicating pollution from urban sources. Calcium carbonate levels are 332.92 mg/L in Sample 1 and 310.45 mg/L in Sample 2, while bicarbonate levels are 277.10 mg/L in Sample 1 and 274.59 mg/L in Sample 2. These high levels suggest substantial buffering capacity but also highlight potential pollution from residential sewage. Sulfate levels are 103.84 mg/L in Sample 1 and 102.16 mg/L in Sample 2, which can be linked to the breakdown of organic matter from sewage and possibly industrial discharges. Sodium levels are 331.80 mg/L in Sample 1 and 307.72 mg/L in Sample 2, while chloride concentrations are 369.84 mg/L in Sample 1 and 374.32 mg/L in Sample 2, indicating contamination from residential sewage and urban runoff. TDS values are 1747.18 mg/L in Sample 1 and 1431.57 mg/L in Sample 2, reflecting severe contamination primarily from sewage and urban runoff, impacting the lake's overall water quality. The pH values are 7.97 in Sample 1 and 8.18 in Sample 2, indicating slightly basic conditions consistent with the presence of various dissolved ions. EC values are 2220.81  $\mu\text{S}/\text{cm}$  in Sample 1 and 1866.91  $\mu\text{S}/\text{cm}$  in Sample 2, directly indicating high ionic concentration in the lake water and suggesting significant contamination levels. Potassium levels are 26 mg/L in Sample 1 and 22 mg/L in Sample 2, further indicating contamination from urban sources.
