Assessment of Water Quality in Chennai's Urban Lakes: Impacts of Urbanization and Encroachment

Abstract: This study assesses the 2019 water quality of five major lakes in Chennai—Ambattur, Korattur, Perungudi, Velachery, and Rettai Eri—highlighting significant contamination driven by urbanization and industrial activities. Water samples from these lakes were analyzed for key geo-chemical parameters, including calcium, magnesium, carbonates, bicarbonates, sulfates, sodium, chlorides, total dissolved solids (TDS), pH, electrical conductivity (EC), and potassium. The results revealed substantial contamination due to residential sewage and urban runoff. For instance, Velachery Lake exhibited the most significant contamination, with only 24.78% of its original area remaining and 75.22% encroached upon. The other lakes also showed high levels of pollution, reflecting the severe impact of urban expansion on water quality. These findings emphasize the urgent need for comprehensive water management strategies and targeted interventions to mitigate pollution and restore the ecological balance of these lakes. Effective measures such as strict zoning law enforcement, restoration projects, pub

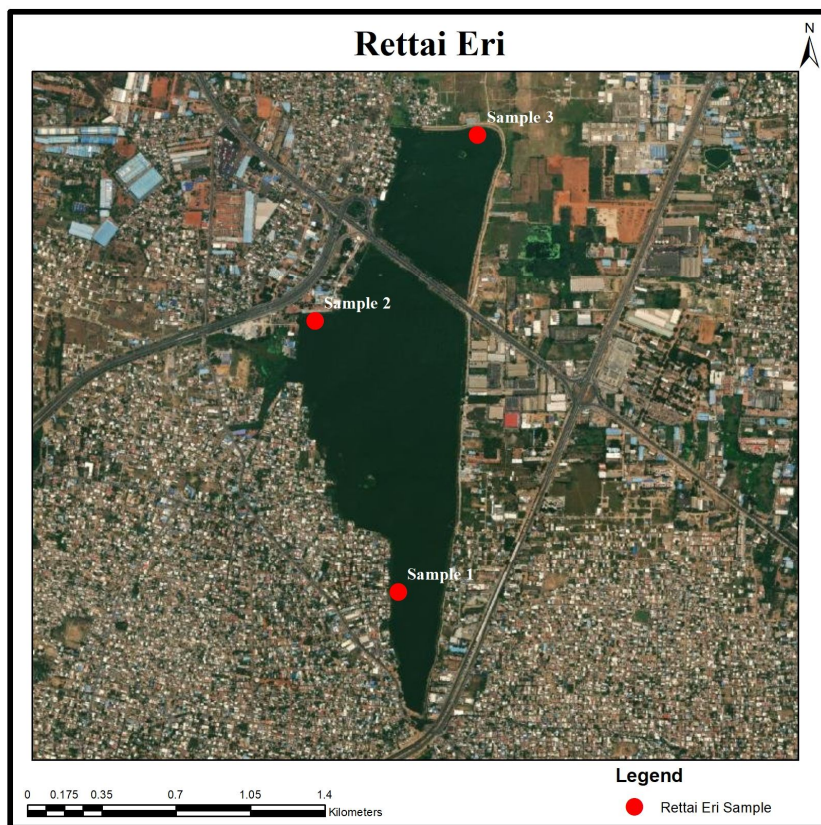
Figure.No.3 Rettai Eri Sample

The 2019 water quality data for Rettai Eri highlights several key geo-chemical parameters, reflecting significant contamination due to its location in a densely populated residential area and direct sewage inflow.

Calcium levels in Rettai Eri range from 142.95 mg/L in Sample 2 to 233.58 mg/L in Sample 3. These elevated levels suggest considerable hardness, likely due to residential sewage and urban runoff. Magnesium concentrations vary from 18.04 mg/L in Sample 2 to 41.95 mg/L in Sample 3. High magnesium levels, similar to calcium, contribute to water hardness and indicate pollution from urban sources. Calcium carbonate levels range from 368.25 mg/L in Sample 2 to 445.25 mg/L in Sample 1, while bicarbonate levels vary between 279.65 mg/L and 289.65 mg/L. These high levels suggest substantial buffering capacity but also highlight potential pollution from residential sewage.

Sulphate levels range from 72.428 mg/L in Sample 2 to 112.23 mg/L in Sample 1. Elevated sulfate levels can be associated with the breakdown of organic matter from sewage and possibly industrial discharges. Sodium levels range from 241.35 mg/L in Sample 2 to 452.21 mg/L in Sample 1, while chloride concentrations vary from 229.64 mg/L in Sample 2 to 347.462 mg/L in Sample 1. High sodium and chloride levels indicate contamination from residential sewage and urban runoff. TDS values significantly range from 906.11 mg/L in Sample 2 to 3325.22 mg/L in Sample 1. These high TDS levels reflect severe contamination, primarily from sewage and urban runoff, impacting the lake's overall water quality. The pH values range from 6.9 in Sample 1 to 7.96 in Sample 2. These readings indicate slightly acidic to neutral conditions, consistent with the presence of various dissolved ions. EC values range from 1087.33 $\mu\text{S/cm}$ in Sample 2 to 3990.26 $\mu\text{S/cm}$ in Sample 1. High electrical conductivity directly indicates high ionic concentration in the lake water, suggesting significant contamination levels.
