Assessment of Water Quality in Chennai's Urban Lakes: Impacts of Urbanization and Encroachment

Abstract: *This study assesses the 2019 water quality of five major lakes in Chennai—Ambattur, Korattur, Perungudi, Velachery, and Rettai Eri—highlighting significant contamination driven by urbanization and industrial activities. Water samples from these lakes were analyzed for key geo-chemical parameters, including calcium, magnesium, carbonates, bicarbonates, sulfates, sodium, chlorides, total dissolved solids (TDS), pH, electrical conductivity (EC), and potassium. The results revealed substantial contamination due to residential sewage and urban runoff. For instance, Velachery Lake exhibited the most significant contamination, with only 24.78% of its original area remaining and 75.22% encroached upon. The other lakes also showed high levels of pollution, reflecting the severe impact of urban expansion on water quality. These findings emphasize the urgent need for comprehensive water management strategies and targeted interventions to mitigate pollution and restore the ecological balance of these lakes. Effective measures such as strict zoning law enforcement, restoration projects, pu

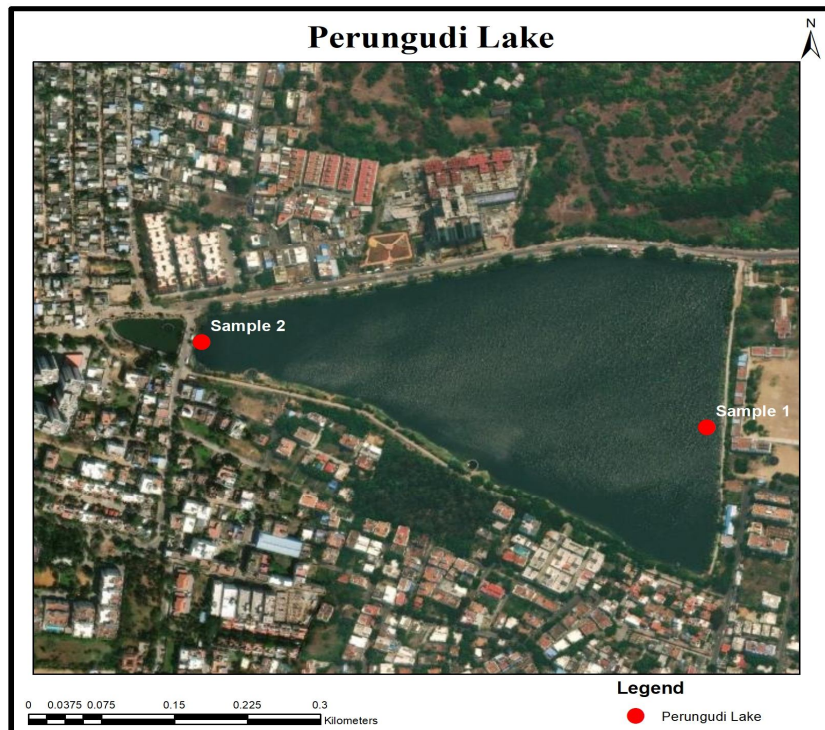
Figure.No.5 Perungudi Lake Sample

The 2019 water quality data for Perungudi Lake reveals several key geo-chemical parameters that indicate significant contamination due to its location in a highly residential and commercial area. Calcium levels are recorded at 136.59 mg/L in Sample 1 and 127.72 mg/L in Sample 2, indicating significant water hardness likely resulting from the influx of residential and commercial sewage and urban runoff. Magnesium concentrations are 50.02 mg/L in Sample 1 and 53.93 mg/L in Sample 2, contributing to water hardness and indicating pollution from urban sources. Calcium carbonate levels are 332.92 mg/L in Sample 1 and 310.45 mg/L in Sample 2, while bicarbonate levels are 277.10 mg/L in Sample 1 and 274.59 mg/L in Sample 2. These high levels suggest substantial buffering capacity but also highlight potential pollution from residential sewage. Sulfate levels are 103.84 mg/L in Sample 1 and 102.16 mg/L in Sample 2, which can be linked to the breakdown of organic matter from sewage and possibly industrial discharges. Sodium levels are 331.80 mg/L in Sample 1 and 307.72 mg/L in Sample 2, while chloride concentrations are 369.84 mg/L in Sample 1 and 374.32 mg/L in Sample 2, indicating contamination from residential sewage and urban runoff. TDS values are 1747.18 mg/L in Sample 1 and 1431.57 mg/L in Sample 2, reflecting severe contamination primarily from sewage and urban runoff, impacting the lake's overall water quality. The pH values are 7.97 in Sample 1 and 8.18 in Sample 2, indicating slightly basic conditions consistent with the presence of various dissolved ions. EC values are 2220.81 $\mu\text{S}/\text{cm}$ in Sample 1 and 1866.91 $\mu\text{S}/\text{cm}$ in Sample 2, directly indicating high ionic concentration in the lake water and suggesting significant contamination levels. Potassium levels are 26 mg/L in Sample 1 and 22 mg/L in Sample 2, further indicating contamination from urban sources.

In Korattur Lake, calcium and magnesium levels also indicate hardness from residential sewage, with elevated carbonates and bicarbonates suggesting pollution. Sodium and chloride levels, with high TDS and EC values, reflect severe contamination. Perungudi Lake shows similar contamination patterns with calcium, magnesium, sodium, and chloride levels indicating hardness and pollution from sewage and runoff. High TDS and EC values reflect severe contamination.
