Reliability Improvement of EP-UHR Belt Joint

Kaushal Kumar Singh¹, T. Thirumurugan², Himangshu S. Mandal³, N. Rajesh Kumar⁴

Tata Steel, Jamshedpur-831001, India

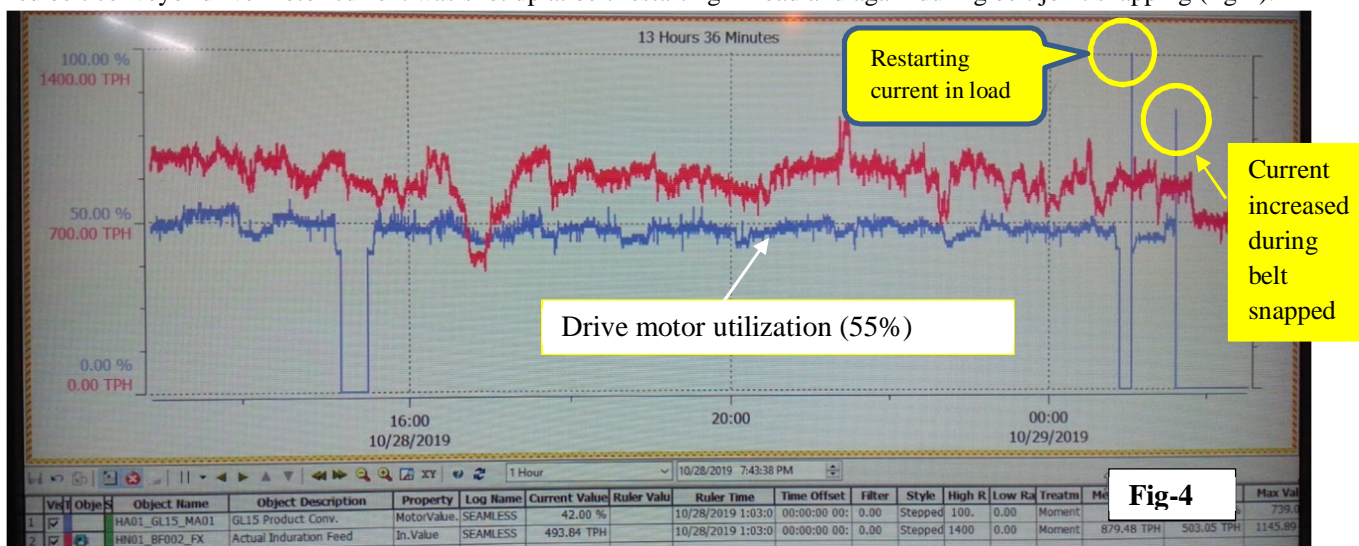
The failed belt conveyor drive motor current was shot up at belt restarting in load and again during belt joint snapping (fig-4).

Motor current spike before belt snapped: The belt was sensed high current during re-starting in load (fig-4). This might be the reason of pile formation at the receiving chute of conveyor.

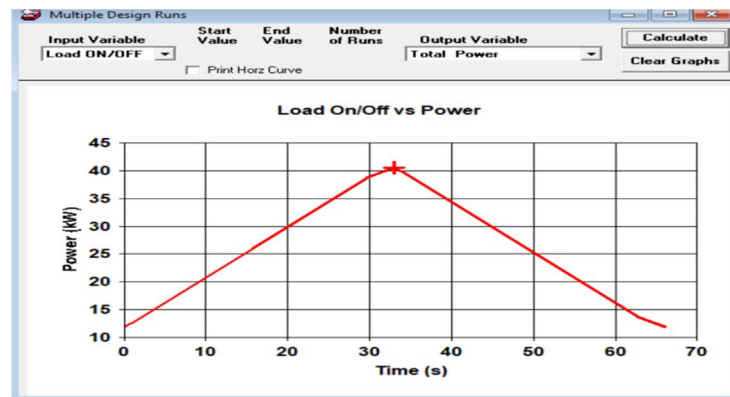
Table-2:

- 2) *High Belt Modulus*: As per supplier-DD belt data sheet, the failed belt was belt modulus 6300 KN/m (10 times of EP fabric belt rating). However further supplied belts have belt modulus 6490 KN/m as per supplier-DD. which is higher and might be affected the belt troughability. Hence belt rating should be selected as per CEMA standard.
- 3) *Belt Selection Error: High tensile strength*
 - o Drive motor max power consumption @ 55% = 41.60 kW (as per fig-4 & 5)
 - Maximum running TPH=1500 x 5.5/8 = 1031.25 ~1032 TPH
 - As per belt stat software, drive motor max power consumption is also 41 kW. Shown in table -2.

Available power 75 kW, hence no case of overload on motor.
