Condition Assessment Using None Destructive Tests at Montauk Bridge Deck

Samie Hamad¹, Wajdi Ammar², Salah Shaniba³

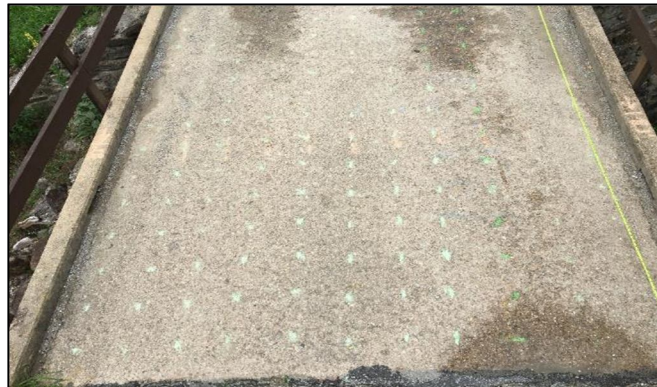
Visual inspection was performed on both the top and bottom of the bridge deck. Loose of concrete surface were recorded and marked on the bridge plan on most of the deck area (Figure 2). Grooves about 2-3 inches deep were in a different location on the bridge deck (Figure 3), and exposed steel bars were found in another location, showing evidence of corrosion (Figure 4). The visual data was used to create a map of the defects to compare it with the PSPA data and the GPR data (Figure 5).

Figure 2. Visual evidence of loss of concrete surface.

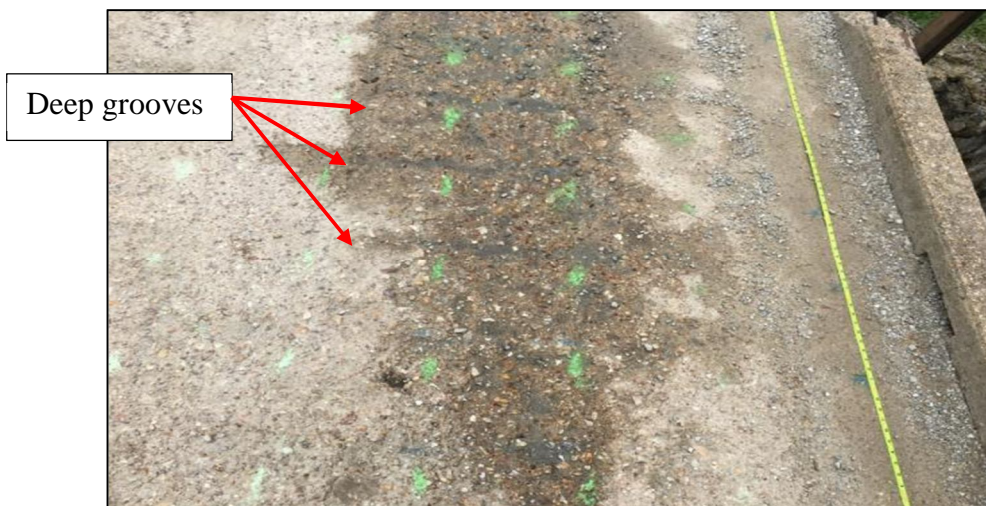
Figure 3. Visual evidence shows deep grooves. (Grooves about 3 inches deep cover over half of the bridge deck area)

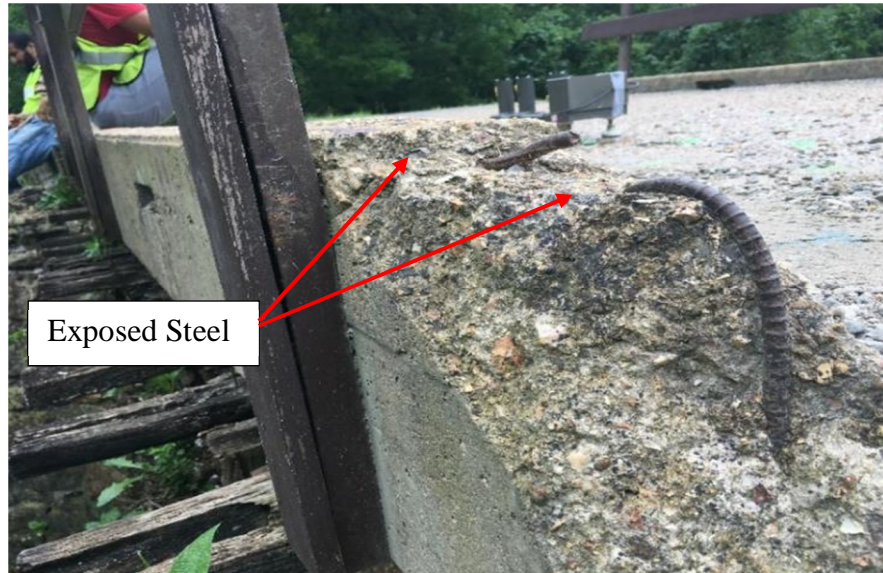
Figure 4. Visual evidence shows the exposed reinforcement steel bar. (In the picture is a corroded steel bars on the girder.)
