Condition Assessment Using None Destructive Tests at Montauk Bridge Deck

Samie Hamad¹, Wajdi Ammar², Salah Shaniba³

Abstract: Ground penetrating radar (GPR) and portable seismic property analyzer (PSPA), was used in concrete structures for monitoring, quantifying, and mapping the deterioration of bridge decks. The Montauk Bridge deck was assessed based on PSPA and GPR data. Based on the analysis of the PSPA data, it was determined that over 65% of bridge conditions were rated serious to poor condition with an average compressive strength of less than 2500 psi; less than 35% of bridge deck conditions were rated fair to good with an average compressive strength over 2500 psi. Based on GPR data, it was determined that 72% of the bridge deck was in serious to poor condition, and only 28% of the bridge deck was in fair to good condition. Additionally, the analyses of the ground penetrating radar data indicated possible rebar corrosion in places. For these reasons, it is recommended that the Montauk bridge's deck be completely replaced.

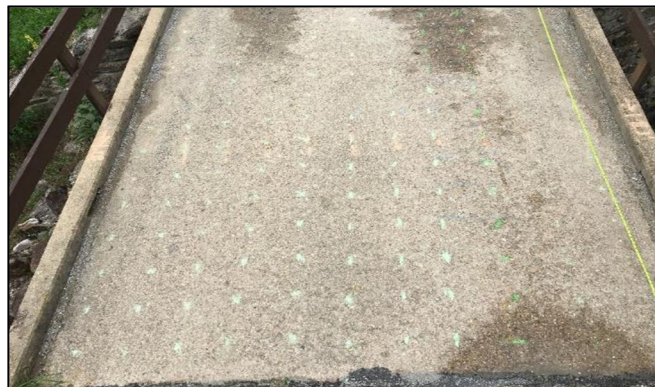
Figure 2. Visual evidence of loss of concrete surface.

Visual inspection was performed on both the top and bottom of the bridge deck. Loose of concrete surface were recorded and marked on the bridge plan on most of the deck area (Figure 2). Grooves about 2-3 inches deep were in a different location on the bridge deck (Figure 3), and exposed steel bars were found in another location, showing evidence of corrosion (Figure 4). The visual data was used to create a map of the defects to compare it with the PSPA data and the GPR data (Figure 5).
