# Condition Assessment Using None Destructive Tests at Montauk Bridge Deck

**Abstract:** Ground penetrating radar (GPR) and portable seismic property analyzer (PSPA), was used in concrete structures for monitoring, quantifying, and mapping the deterioration of bridge decks. The Montauk Bridge deck was assessed based on PSPA and GPR data. Based on the analysis of the PSPA data, it was determined that over 65% of bridge conditions were rated serious to poor condition with an average compressive strength of less than 2500 psi; less than 35% of bridge deck conditions were rated fair to good with an average compressive strength over 2500 psi. Based on GPR data, it was determined that 72% of the bridge deck was in serious to poor condition, and only 28% of the bridge deck was in fair to good condition. Additionally, the analyses of the ground penetrating radar data indicated possible rebar corrosion in places. For these reasons, it is recommended that the Montauk bridge's deck be completely replaced.

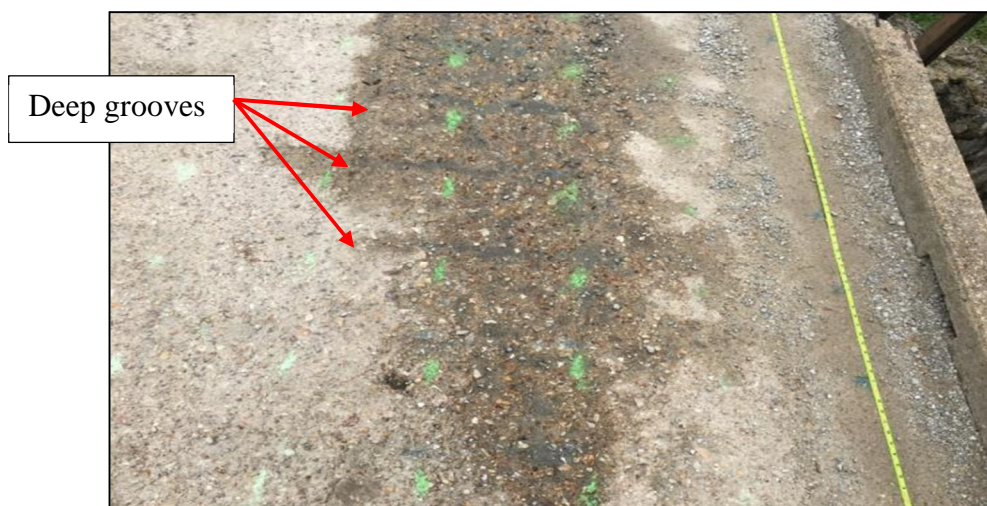
Figure 3. Visual evidence shows deep grooves. (Grooves about 3 inches deep cover over half of the bridge deck area)

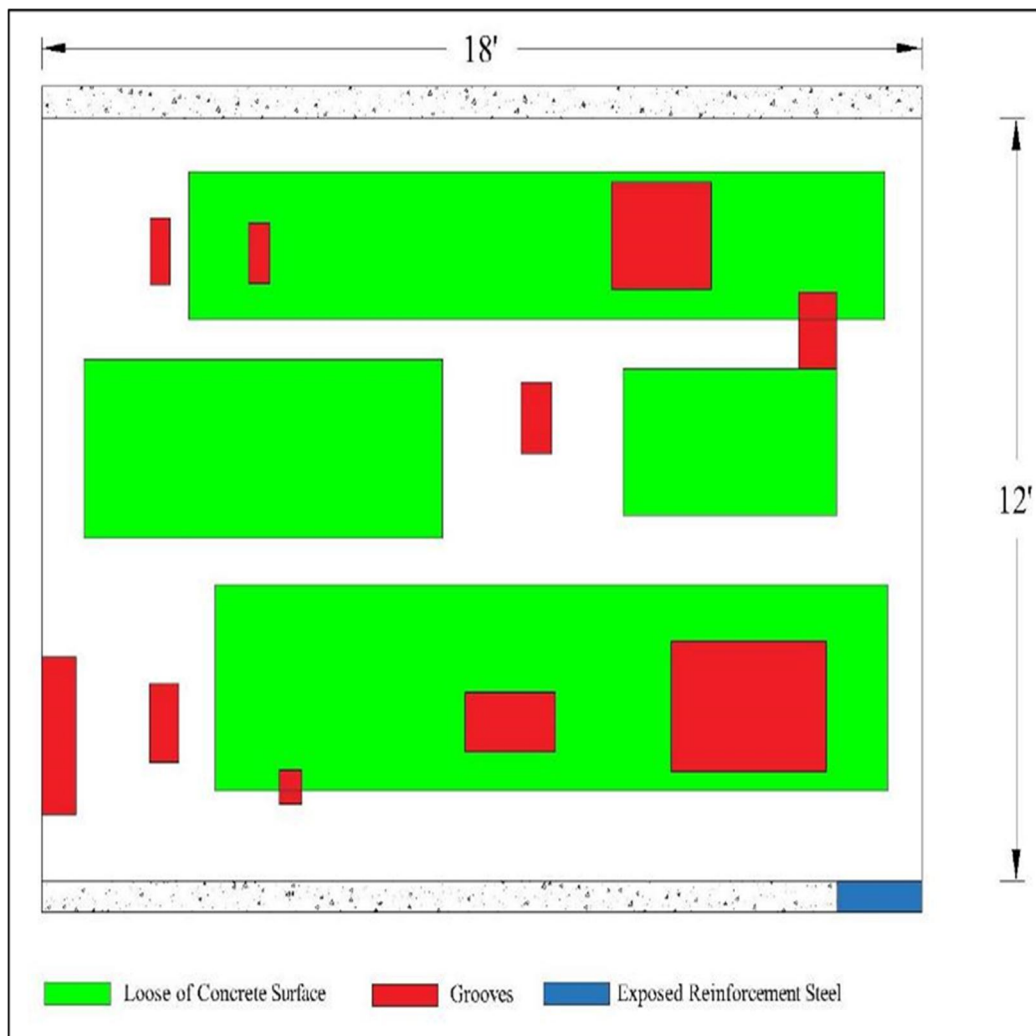
Figure 5. Detail map shows the type of the deterioration and its location on the bridge deck.

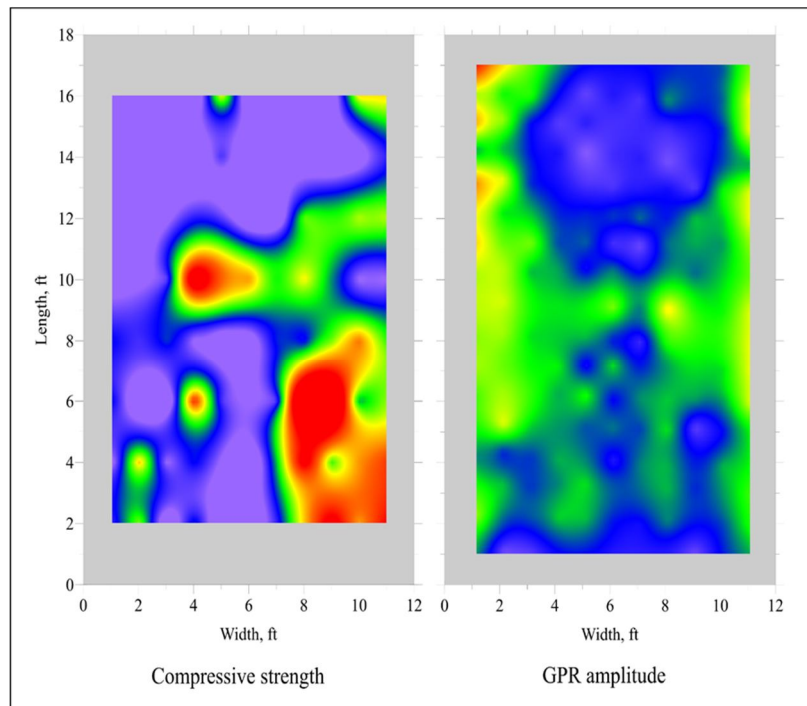
Figure 11. Compressive strength vs. GPR amplitude of the Montauk bridge deck.
