# Condition Assessment Using None Destructive Tests at Montauk Bridge Deck

**Abstract:** Ground penetrating radar (GPR) and portable seismic property analyzer (PSPA), was used in concrete structures for monitoring, quantifying, and mapping the deterioration of bridge decks. The Montauk Bridge deck was assessed based on PSPA and GPR data. Based on the analysis of the PSPA data, it was determined that over 65% of bridge conditions were rated serious to poor condition with an average compressive strength of less than 2500 psi; less than 35% of bridge deck conditions were rated fair to good with an average compressive strength over 2500 psi. Based on GPR data, it was determined that 72% of the bridge deck was in serious to poor condition, and only 28% of the bridge deck was in fair to good condition. Additionally, the analyses of the ground penetrating radar data indicated possible rebar corrosion in places. For these reasons, it is recommended that the Montauk bridge's deck be completely replaced.

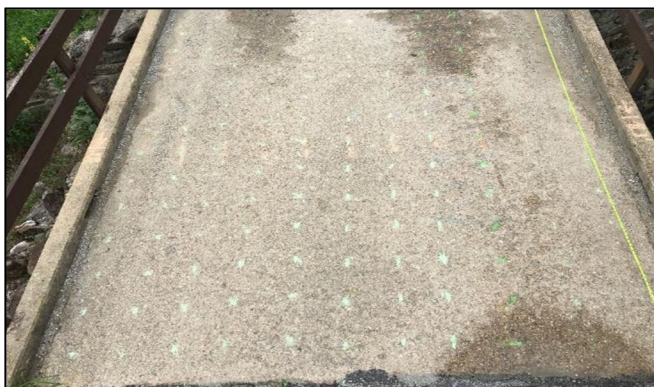
Figure 2. Visual evidence of loss of concrete surface.

Visual inspection was performed on both the top and bottom of the bridge deck. Loose of concrete surface were recorded and marked on the bridge plan on most of the deck area (Figure 2). Grooves about 2-3 inches deep were in a different location on the bridge deck (Figure 3), and exposed steel bars were found in another location, showing evidence of corrosion (Figure 4). The visual data was used to create a map of the defects to compare it with the PSPA data and the GPR data (Figure 5).

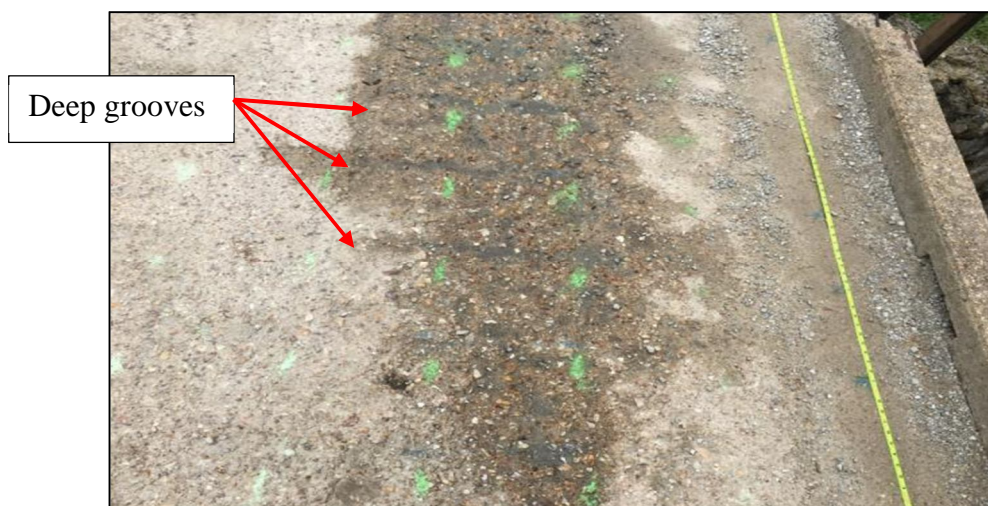
Figure 3. Visual evidence shows deep grooves. (Grooves about 3 inches deep cover over half of the bridge deck area)
