Condition Monitoring of Spur Gear Box based on Acoustic Emission Signal Analysis

Vikas. G. N¹, V. C. Chandra shekara², Madhusudana C. K³, Srinivasa. M. R⁴

^{1, 2, 3, 4}Department of Mechanical Engineering, PES College of Engineering, Mandya-571401

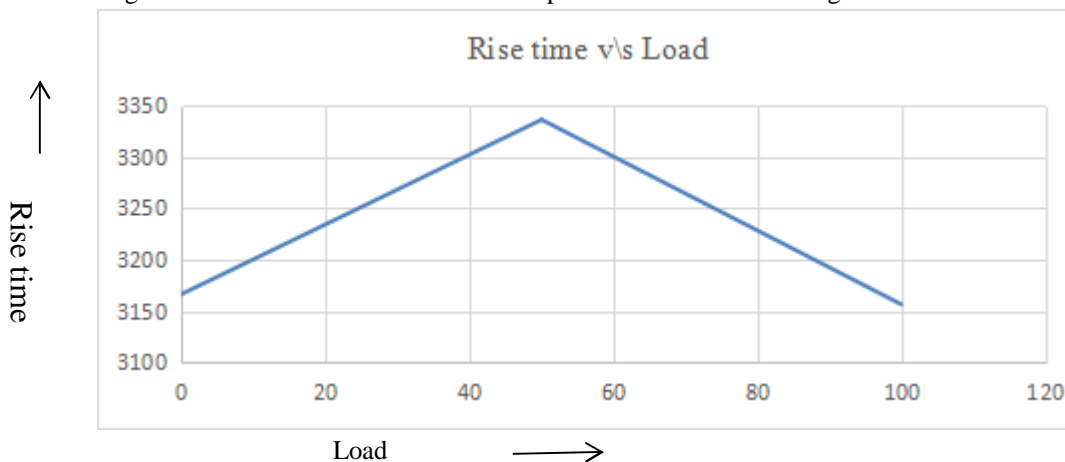
Figure 6:- Rise time versus load

The AE signal with a load of 50N have higher rise time about 3336.09 μ s and initially 3166.6 μ s for unloading condition as shown figure 6. This higher rise time is an indication of change in gear condition.
