# Effectiveness and Efficiency of the Existing Building in Seismic Zone-III: A Case Study of Hotel Kaashi Building in Ujire

**Abstract:** Building irregularities are an important concern when they are subjected to strong earthquakes. In structures, an abrupt change in the vertical or plan configuration tends to weaken the stability. It is necessary to study how irregular structures respond to lateral loads in order to prevent failure and reduce the risk of hazards. In this case study, a G+3 storey building is modeled using the existing beam and column cross sections. In addition, models with reduced cross sectional areas of 5%, 10%, and 15% were developed and static linear analysis was performed using Etabs software in accordance with IS1893 (Part-1):2016. The parameters considered in this study are storey displacement, storey drift, and base shear. The analytical results obtained are compared with those of the existing building model.

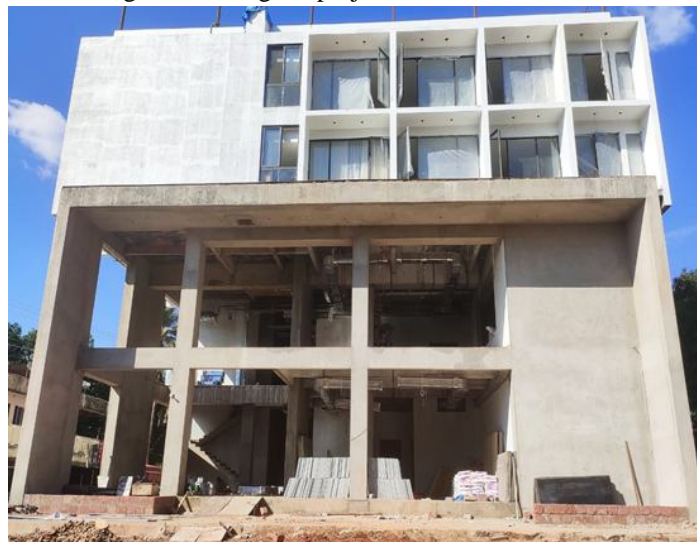
Fig. 1 Front view of Hotel Kaashi Building

This study examines a commercial complex building as shown in fig 1. The building is designed to withstand seismic loads in accordance with IS 1893 (Part 1): 2016. The building is in a Moderate Seismic Zone (Zone III) and is a G+3 structure, although the section sizes of the structure appear to be large, increasing the project's cost.

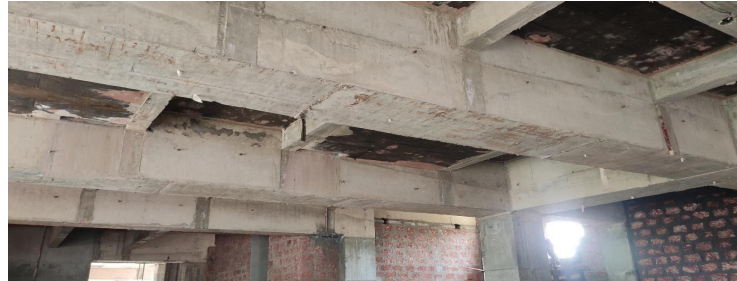
Fig. 2 Primary beams in Ground Floor

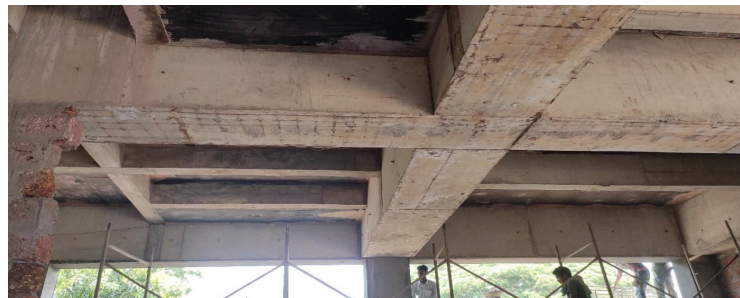
Fig. 3 Primary and Secondary beams in First Floor

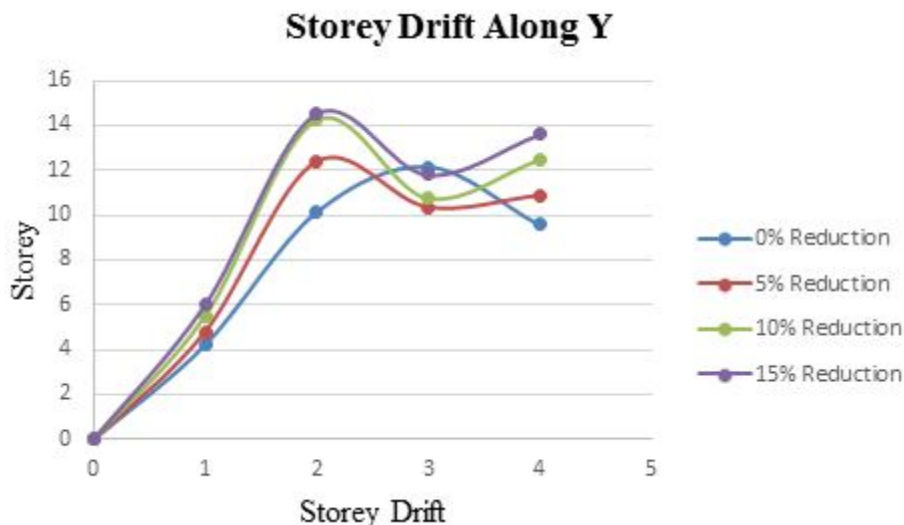
Fig. 7 Storey Drift of 0%, 5%, 10%, and 15% with 1.2 (DL + LL + EQY)

A storey drift was considered the point at which the junction of beam and column met. These points, where the maximum drifts occurred, were compared in this study. Storey drifts among G+3 storey building models are subjected to X and Y directions. Figs 6 and 7 indicate the plot of storey number versus storey drifts for earthquake loads.

- 1) Results show that storey drift and storey displacement increase with a decrease in cross-section from 0% to 10%
- 2) The second and third floors will not meet the storey drift requirements in EQY direction for a 15% reduction in cross section due to plan irregularity and stiffness irregularity.
- 3) Despite a drop in cross-section of 0% to 15%, the base shear only decreased by 2 to 3% respectively
- 4) All of the above results suggest that the existing building satisfies all the earthquake requirements with only a 10% reduction in cross sectional area due to its plan irregularity and stiffness irregularity
- 5) As a result, in light of the safety considerations, it is not advised to modify the specified cross-section sizes. In other words, the existing building details are adequate to satisfy the earthquake criteria as described in IS1893 (Part-1):2016
