Effectiveness and Efficiency of the Existing Building in Seismic Zone-III: A Case Study of Hotel Kaashi Building in Ujire

Vinay M R¹, Divyashree K S², M R Shivani³, Prathiksha J N⁴, Rakshitha G⁵

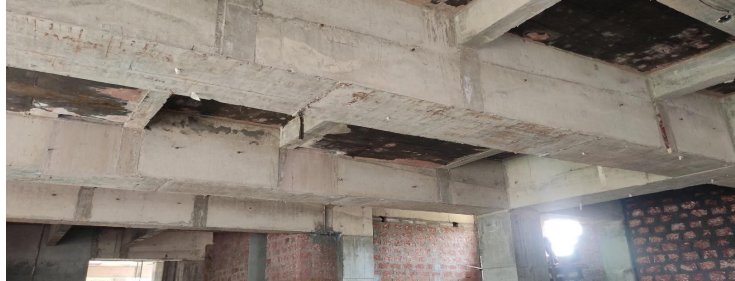
Fig. 2 Primary beams in Ground Floor

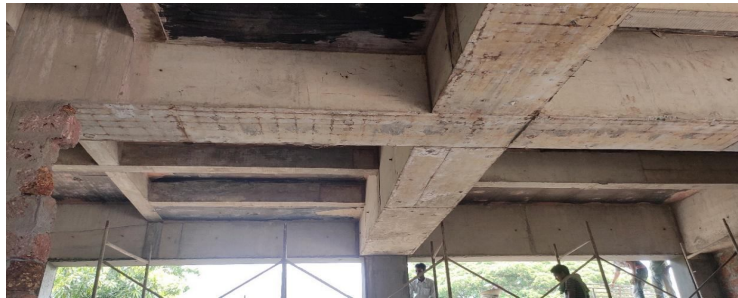
Fig. 3 Primary and Secondary beams in First Floor

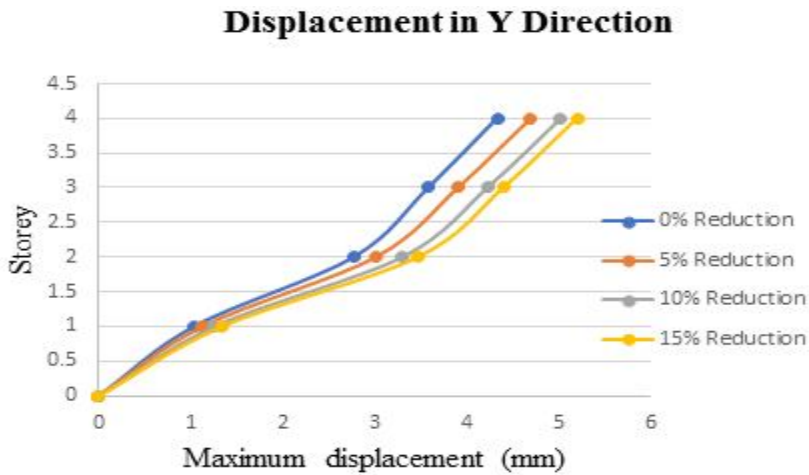
Fig. 9 Storey Displacement of 0%, 5%, 10%, & 15% in Y direction

A storey displacement was considered the point at which the maximum storey displacement occurred. Figs 8 and 9 indicate the plot of storey number versus storey displacement for earthquake loads.
