# Erosion and Dam Siltation in an Arzangarzan Earthen Dam in Budgam District of Jammu and Kashmir

**Abstract:** Many check dams were built in the Budgam district of Jammu and Kashmir during the 1970s, however after a few years, their entire infill was caused by significant siltation rates. This effort aimed to evaluate the mechanisms producing soil particles and their accumulation in the Arzangarzan dam. To measure the amount of sediments and the overall rate of erosion, a bathymetric survey was conducted.

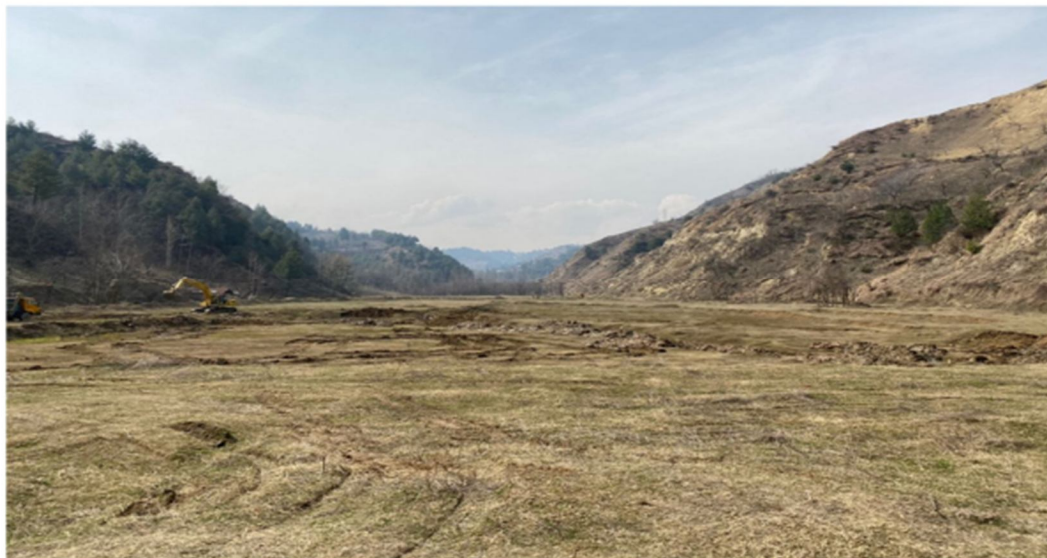
Location of the sediment profiles surveyed in the Arzengarzen dam
