Erosion and Dam Siltation in an Arzangarzan Earthen Dam in Budgam District of Jammu and Kashmir

Dr. Bashir Ahmad Pandit

Abstract: Many check dams were built in the Budgam district of Jammu and Kashmir during the 1970s, however after a few years, their entire infill was caused by significant siltation rates. This effort aimed to evaluate the mechanisms producing soil particles and their accumulation in the Arzangarzan dam. To measure the amount of sediments and the overall rate of erosion, a bathymetric survey was conducted.

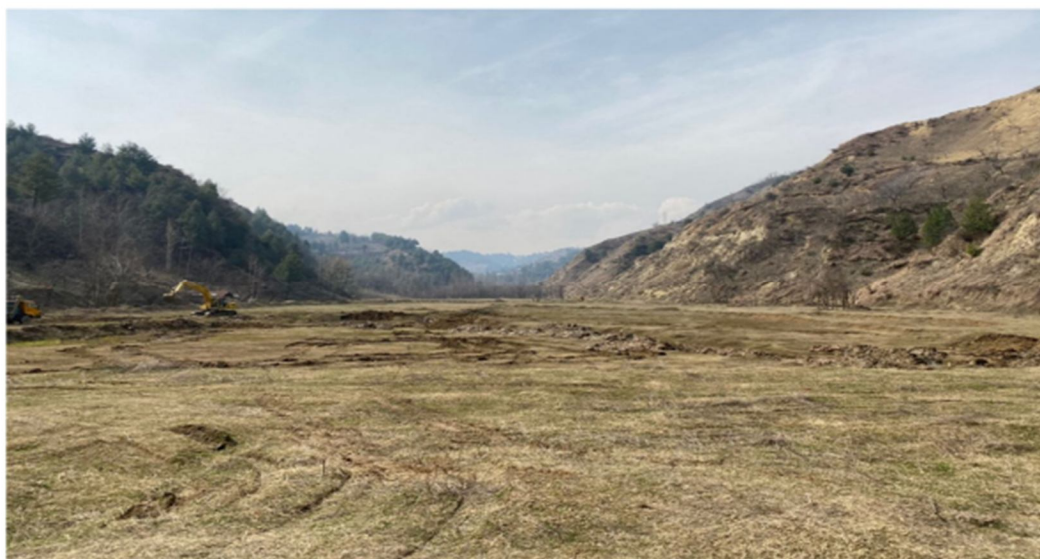
Location of the sediment profiles surveyed in the Arzengarzen dam
