Study on Identified Blackspots and Rectification Measures: A Case study

Surbhi Semwal¹, Er. Ajay. K. Duggal², Dr. Sanjay K. Sharma³

Abstract: *In this paper, the survey was conducted in the Sirmour district of Himachal Pradesh where National highway 72 (NEW NH-07) runs through the district and other state highways connecting the state to the rest of the country. However, due to the district's abrupt bends, cliffs, and narrow streets, it has experienced the large number of traffic accidents.*

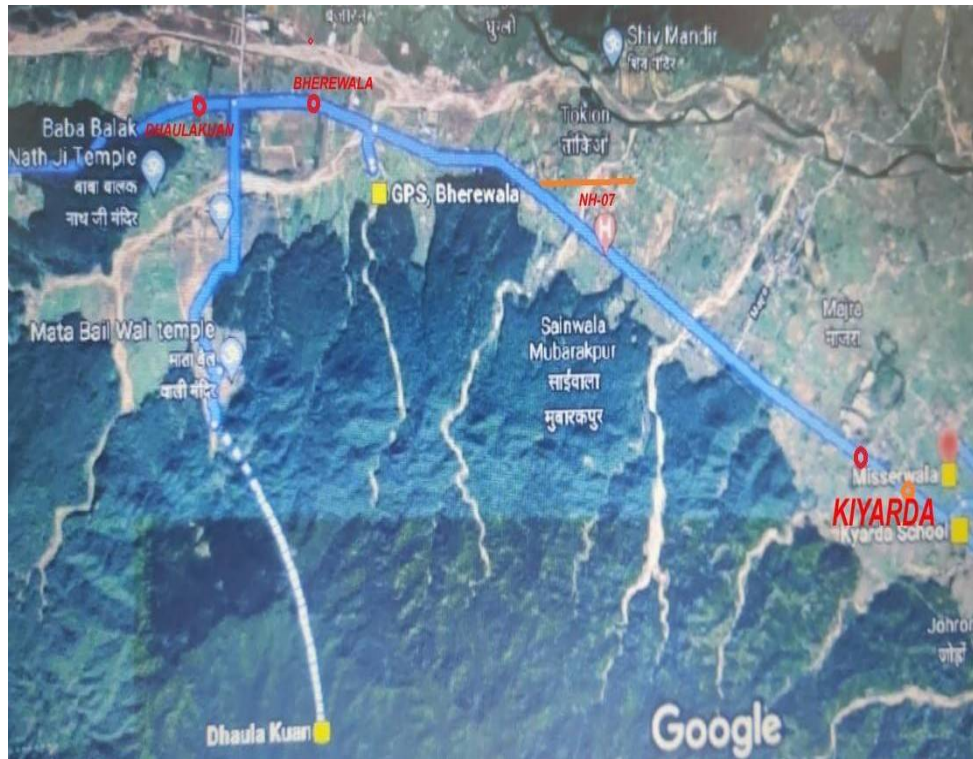
Figure 1: Image of identified black spots

The selected location for the case study of identified black spots was on the NH-07 and the study area lies between Dhaulakuan to Kyarda having a length of 9 km in plain area and having an average width of flexible pavement is 10m with paved shoulders. In the project area police authorities and P.W.D. department has already identified 4 nos. blackspots as shown in Fig,1

S. No.	Name of Blackspots on NH 07	Location	Blackspot ID	WASI
1	Dhaulakuan	83/300 to 83/800	HP-(02)-037	3.01
2	Bherewala	86/0 to 86/200	HP-(02)-096	3.24
3	Misserwala	90/300 to 90/520	HP-(02)-077	3.25
4	Kyarda	90/800 to 91/100	HP-(02)-022	2.98

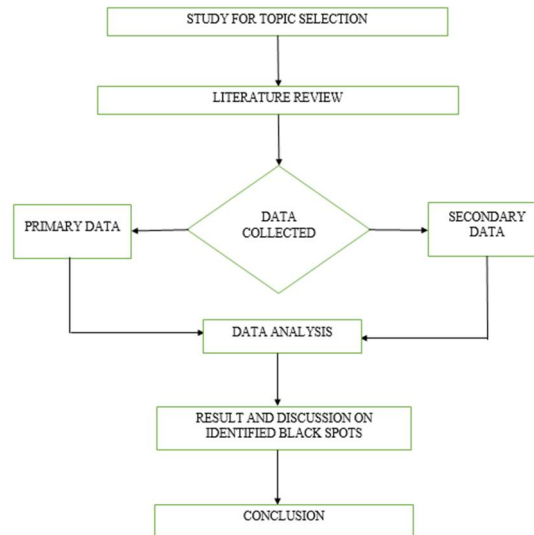
Figure 2: Work approach flow chart

- 1) A stretch of NH 72(New NH 07) was selected for the study.
- 2) Research papers were studied thoroughly for the knowledge of different methods and models used during the research and to get an idea about what data is to be collected. In this stage, primary data such as details of road inventory and secondary data such as accident data was collected from National Highway Division HPPWD Nahan, Himachal Pradesh.
- 3) Analysis of collected data has been done. Then, after the analysis and discussion done on the identified black spots, remedial measures were suggested for the identified black spots.
- 4) Lastly, interpretation of result and conclusion.

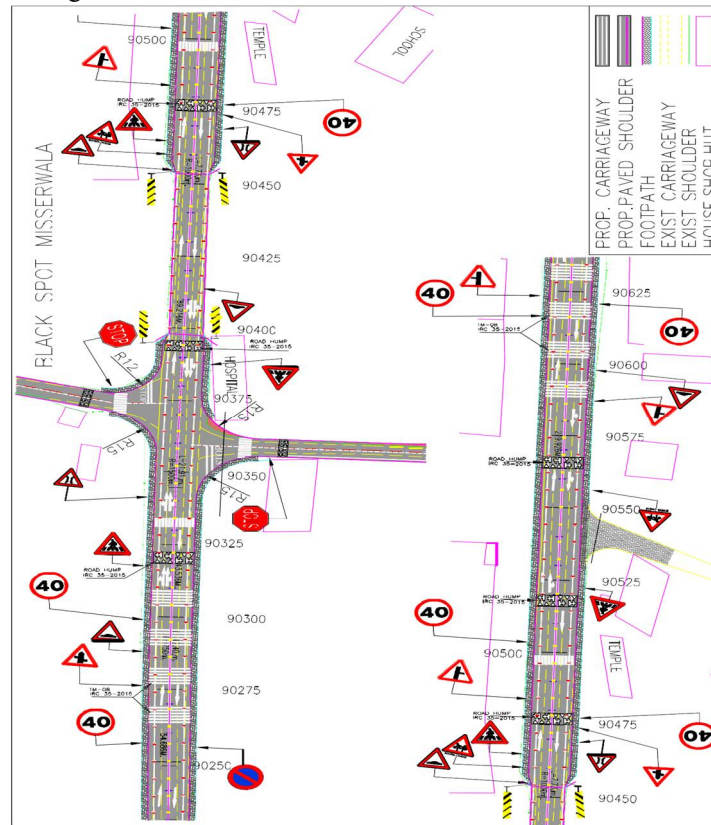
Figure 3: Drawing of blackspot Misserwala with remedial measures

After analyzing and evaluating the entire data it was concluded that *Misserwala* had high WASI value i.e., 3.25 hence it was more prone to road accidents and major reasons for accidents on blackspots were poor visibility, unclear intersections, carelessness of driver, over speeding, narrow bridge, absence of pedestrian path, absence of crash barriers, lack of road markings, sign boards and zebra crossing and so proper remedial measures from IRC codes and MORTH were suggested and implemented to reduce the road accidents.

Proper remedial measures from IRC codes and MORT&H specifications are hereby suggested to reduce the road mishaps as the road infrastructure is important for growth of Indian economy in present times. These are applicable for all the four sections.

- 1) Provide smooth paved shoulders.
- 2) Crossings both near intersections and mid-block, raised pedestrian crossing should be made mandatory in case of multilane road with heavy volume of vehicular traffic.

- 3) Crossing must be provided at all T-junctions.
- 4) "At grade" pedestrian minimum 3m wide pedestrian crossing and 2.5m wide cycle crossing must be provided at all road crossings.

- 5) Sign boards should be installed for psychological behavior of users which help in controlling rate of accidents.
- 6) Speed humps with adequate marking should be provided.

- 7) Provide mandatory and regulatory sign boards as per IRC:67-2012.
- 8) Double stop line should be provided at junction.
- 9) The reflective pavement markers (road studs) shall be provided to improve the visibility in night time and wet weather condition.

- 13) Installation of convex mirror and Providing rumble strips.

- 14) Advisory speed limits at sharp bends and provide regular speed limits.
- 15) Provide the guard rails.
- 16) Widening of lane and providing overtaking lanes which can improve traffic flow.
- 17) Footpath can also be provided at the bridge.
- 18) We can provide RCC crash barriers (M40) for all bridges in Highway to safeguard against errant vehicles. (IRC: 21 - 2000).
- 19) We can also install speed detecting devices.
