# Study on Identified Blackspots and Rectification Measures: A Case study

Surbhi Semwal<sup>1</sup>, Er. Ajay. K. Duggal<sup>2</sup>, Dr. Sanjay K. Sharma<sup>3</sup>

<sup>1</sup>ME Student, Civil Engineering Department, NITTTR Chandigarh

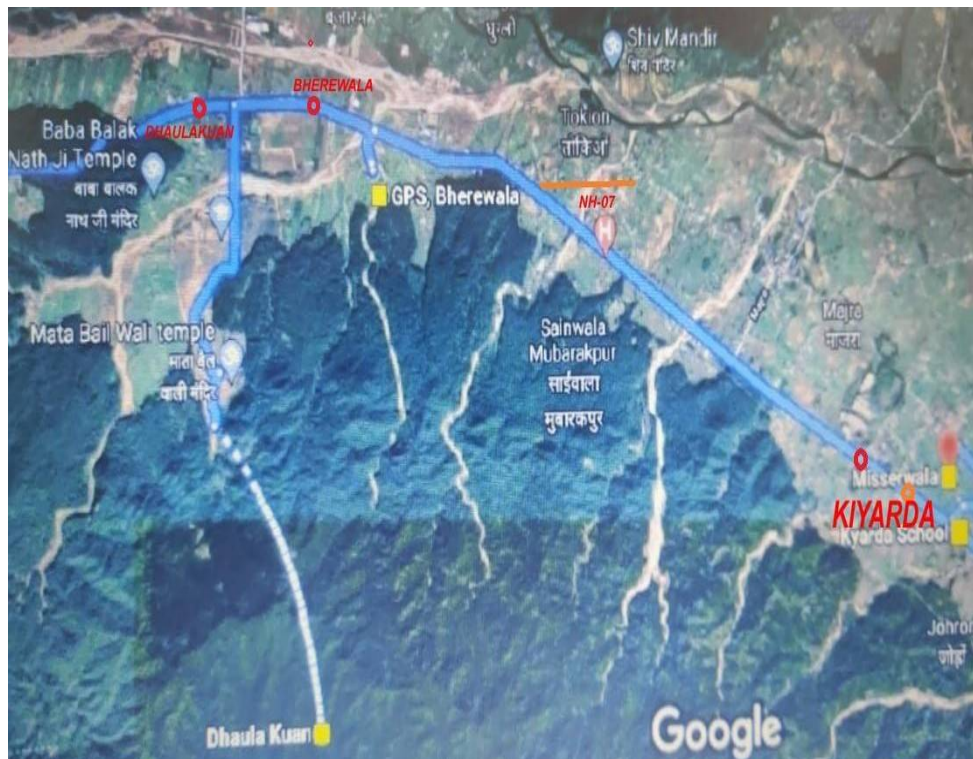
Figure 1: Image of identified black spots

The selected location for the case study of identified black spots was on the NH-07 and the study area lies between Dhaulakuan to Kyarda having a length of 9 km in plain area and having an average width of flexible pavement is 10m with paved shoulders. In the project area police authorities and P.W.D. department has already identified 4 nos. blackspots as shown in Fig,1

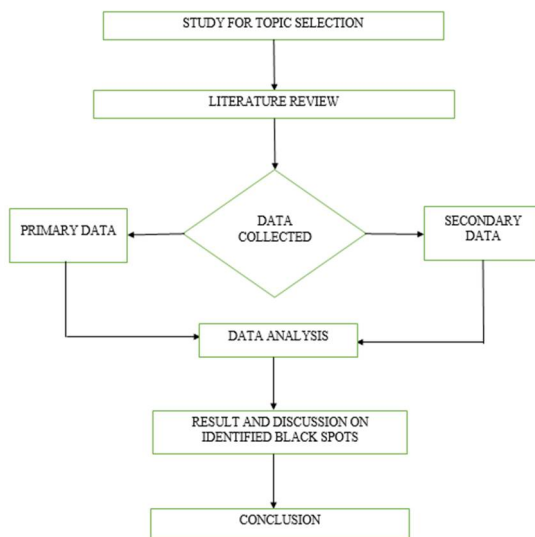
Figure 2: Work approach flow chart

The following steps was carried out for achieving the objectives of the research: -

- 1) A stretch of NH 72(New NH 07) was selected for the study.
- 2) Research papers were studied thoroughly for the knowledge of different methods and models used during the research and to get an idea about what data is to be collected. In this stage, primary data such as details of road inventory and secondary data such as accident data was collected from National Highway Division HPPWD Nahan, Himachal Pradesh.
- 3) Analysis of collected data has been done. Then, after the analysis and discussion done on the identified black spots, remedial measures were suggested for the identified black spots.
- 4) Lastly, interpretation of result and conclusion.
