# Study on Identified Blackspots and Rectification Measures: A Case study

**Abstract:** In this paper, the survey was conducted in the Sirmour district of Himachal Pradesh where National highway 72 (NEW NH-07) runs through the district and other state highways connecting the state to the rest of the country. However, due to the district's abrupt bends, cliffs, and narrow streets, it has experienced the large number of traffic accidents.

As a result, the study of the accident blackspots on this stretch is crucial for road safety. The study area lies between Dhaulakuan to Kyarda having a length of 9 km in the plain area has already identified 4 blackspots by police authorities and P.W.D. Department.

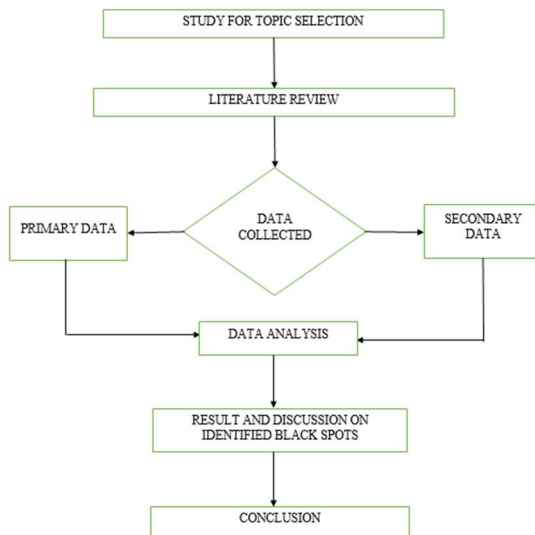
Figure 2: Work approach flow chart

The following steps was carried out for achieving the objectives of the research: -

- 1) A stretch of NH 72(New NH 07) was selected for the study.
- 2) Research papers were studied thoroughly for the knowledge of different methods and models used during the research and to get an idea about what data is to be collected. In this stage, primary data such as details of road inventory and secondary data such as accident data was collected from National Highway Division HPPWD Nahan, Himachal Pradesh.
- 3) Analysis of collected data has been done. Then, after the analysis and discussion done on the identified black spots, remedial measures were suggested for the identified black spots.
- 4) Lastly, interpretation of result and conclusion.
