Impact of Rapid Urbanization and Encroachment on the Major Lakes of Chennai: A Spatial Analysis

Imrana Banu F¹, Chandrasekar V², Shaik Mahamad³, Ravi Kumar P⁴

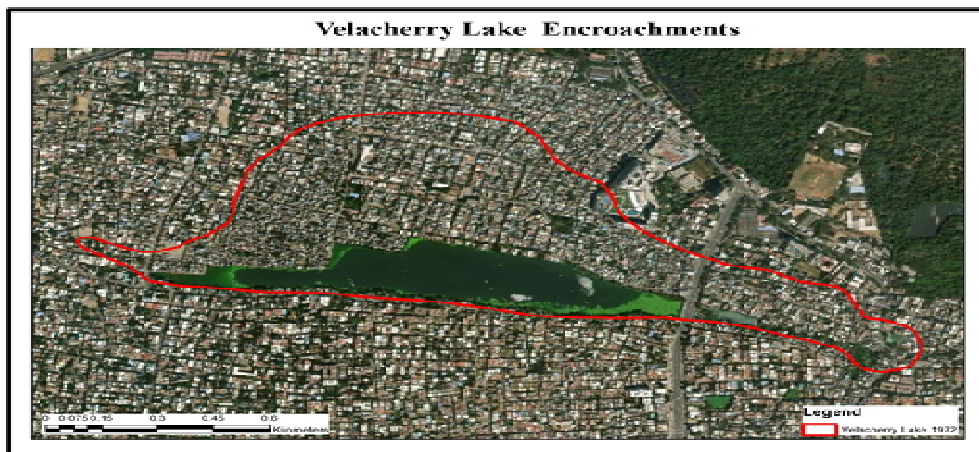
Figure. No. 2- Velacherry Lake Encroachments

The above image (Figure.No.2) interprets the encroachments of the lake. In 1972, Velacherry Lake encompassed an area of 89.31 hectares. However, by 2019, this area had drastically reduced to 22.13 hectares. The current water coverage now stands at 67.17 hectares. This means that only 24.78% of the lake's original area remains as water bodies, while a substantial 75.22% of the land has been encroached upon. This extensive encroachment highlights the severe impact of urbanization on Velacherry Lake, significantly diminishing its ecological and hydrological functions. The data underscores the critical need for effective management and restoration strategies to address the challenges posed by urban expansion and to preserve the lake's vital environmental roles.

Rettai Eri Lake decreased from 223.22 hectares to 136.15 hectares. Presently, 60.99% of the original lake area remains as water bodies, while 39.01% has been encroached upon. Velachery Lake is the most affected by urbanization, with only 24.78% of its original area remaining and 75.22% encroached upon. The findings from this study emphasize the critical need for effective urban planning and stringent regulatory measures to protect and restore these vital water bodies. The data-driven insights provided can inform policymakers and urban planners in devising strategies aimed at mitigating the adverse effects of encroachment and ensuring the sustainable management of Chennai's lake ecosystems. Continuous monitoring and proactive management are essential to preserve the ecological and hydrological functions of these lakes, thereby supporting the environmental health and resilience of the urban landscape.

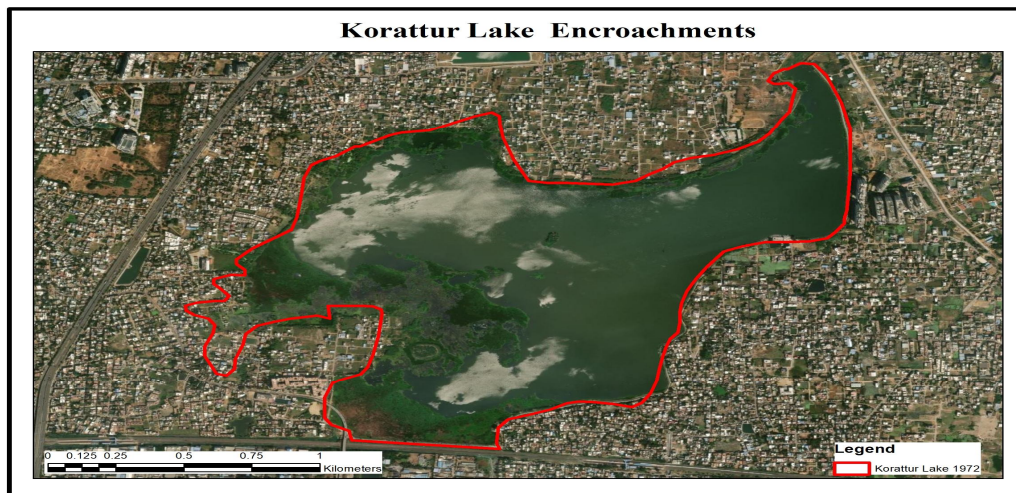
Figure.No.3 Korattur Lake Encroachments

In 1972, Korattur Lake (Figure. No 3) spanned an area of 244.31 hectares. By 2019, this area had slightly decreased to 233.93 hectares, with the current water coverage being 10.38 hectares. Notably, 95.75% of the original lake area remains intact, with only 4.25% of the land encroached upon. This minimal encroachment indicates that Korattur Lake is the least affected by urban development pressures among the lakes studied in Chennai. The data suggests effective conservation efforts or comparatively lower pressure from urban expansion, which has helped maintain the lake's ecological and hydrological functions. In 1972, Perungudi Lake (Figure. No. 4) encompassed an area of 16.03 hectares. By 2019, this area had decreased to 11.93 hectares, with the current water coverage standing at 4.10 hectares. Consequently, 74.41% of the original lake area remains as water bodies, while 25.59% has been encroached upon. This moderate level of encroachment suggests that, although urbanization has impacted the lake, a substantial portion remains relatively intact. The data highlights the need for ongoing conservation efforts to preserve and protect the remaining water bodies from further encroachment and to maintain the lake's ecological functions.
