Impact of Rapid Urbanization and Encroachment on the Major Lakes of Chennai: A Spatial Analysis

Abstract: *The rapid urbanization and encroachment in Chennai have significantly impacted five major lakes from 1972 to 2019. By overlaying historical lake boundaries from 1972 toposheets onto 2019 satellite images, substantial reductions in lake areas due to urban expansion are revealed. The lakes analyzed include Ambattur, Velachery, Korattur, Perungudi, and Rettai Eri. Velachery Lake is the most affected, retaining only 24.78% of its original area, with 75.22% encroached upon. Ambattur Lake has 60.27% of its area remaining, while 39.73% is encroached. Korattur Lake remains largely intact with 95.75% of its original area preserved and only 4.25% encroached. Perungudi Lake shows 74.41% remaining area and 25.59% encroachment. Rettai Eri Lake retains 60.99% of its original area with 39.01% encroached. These findings underscore the urgent need for effective urban planning and stringent regulatory measures to protect and restore these critical water bodies. The data-driven insights provided can inform policymakers and urban planners to devise strategies aimed at mitigating the adverse effe

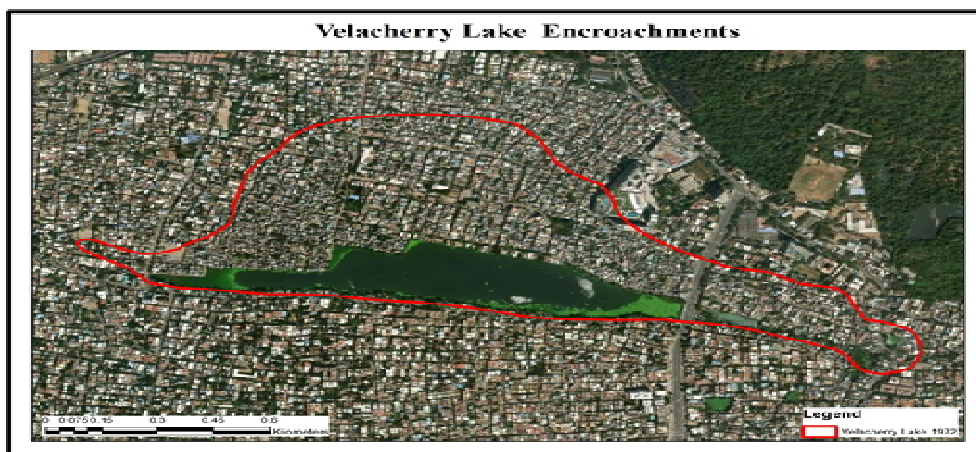
Figure. No. 2- Velacherry Lake Encroachments

The above image (Figure.No.2) interprets the encroachments of the lake. In 1972, Velacherry Lake encompassed an area of 89.31 hectares. However, by 2019, this area had drastically reduced to 22.13 hectares. The current water coverage now stands at 67.17 hectares. This means that only 24.78% of the lake's original area remains as water bodies, while a substantial 75.22% of the land has been encroached upon. This extensive encroachment highlights the severe impact of urbanization on Velacherry Lake, significantly diminishing its ecological and hydrological functions. The data underscores the critical need for effective management and restoration strategies to address the challenges posed by urban expansion and to preserve the lake's vital environmental roles.
