# Impact of Rapid Urbanization and Encroachment on the Major Lakes of Chennai: A Spatial Analysis

**Abstract:** *The rapid urbanization and encroachment in Chennai have significantly impacted five major lakes from 1972 to 2019. By overlaying historical lake boundaries from 1972 toposheets onto 2019 satellite images, substantial reductions in lake areas due to urban expansion are revealed. The lakes analyzed include Ambattur, Velachery, Korattur, Perungudi, and Rettai Eri. Velachery Lake is the most affected, retaining only 24.78% of its original area, with 75.22% encroached upon. Ambattur Lake has 60.27% of its area remaining, while 39.73% is encroached. Korattur Lake remains largely intact with 95.75% of its original area preserved and only 4.25% encroached. Perungudi Lake shows 74.41% remaining area and 25.59% encroachment. Rettai Eri Lake retains 60.99% of its original area with 39.01% encroached. These findings underscore the urgent need for effective urban planning and stringent regulatory measures to protect and restore these critical water bodies. The data-driven insights provided can inform policymakers and urban planners to devise strategies aimed at mitigating the advers

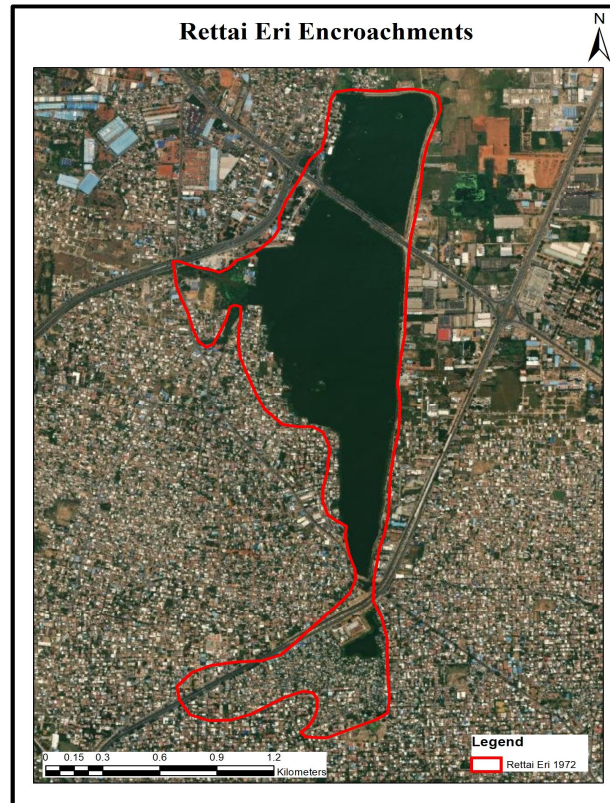
Figure.No.5 Rettai Eri Encroachments

In 1972, Rettai Eri Lake (Figure.No.5) covered an area of 223.22 hectares. By 2019, this area had reduced to 136.15 hectares, with the current water coverage recorded at 87.07 hectares. Consequently, 60.99% of the original lake area remains as water bodies, while 39.01% has been encroached upon. This substantial reduction in lake area highlights significant encroachment due to urbanization, reflecting the pressures of expanding urban development on natural water bodies. The data underscores the urgent need for effective urban planning and conservation measures to mitigate further encroachment and preserve the ecological integrity of Rettai Eri Lake.

Rettai Eri Lake decreased from 223.22 hectares to 136.15 hectares. Presently, 60.99% of the original lake area remains as water bodies, while 39.01% has been encroached upon. Velachery Lake is the most affected by urbanization, with only 24.78% of its original area remaining and 75.22% encroached upon. The findings from this study emphasize the critical need for effective urban planning and stringent regulatory measures to protect and restore these vital water bodies. The data-driven insights provided can inform policymakers and urban planners in devising strategies aimed at mitigating the adverse effects of encroachment and ensuring the sustainable management of Chennai's lake ecosystems. Continuous monitoring and proactive management are essential to preserve the ecological and hydrological functions of these lakes, thereby supporting the environmental health and resilience of the urban landscape.
