Infrastructure Planning for TOD Zone of Chikkabanawara of Sub-urban Station, Bengaluru

Mudavath Meghanath¹, Dr. Muhammad Danish²

¹MURP 4th Sem, Department of Architecture and Planning, NIT Patna.

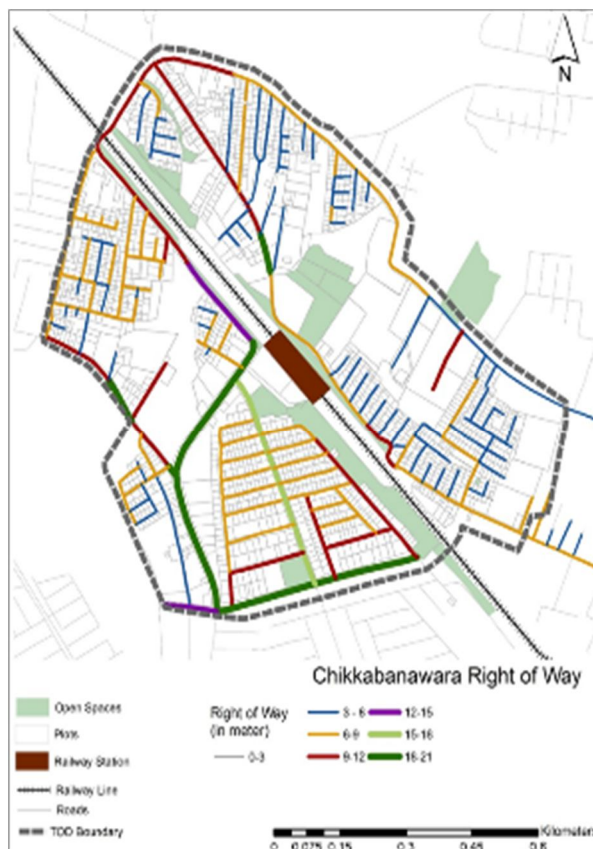
Figure 3: Chikkabanawara Right of Way map

The total length of the road network is 17.8km. The main roads have ROW in the range of 9-21m. The smaller ROWs of 3-6m width are majorly observed on the Northern side of the railway line. From the audit, it is evident that, around 33% of the total road network have ROW in the range of 6-9m.

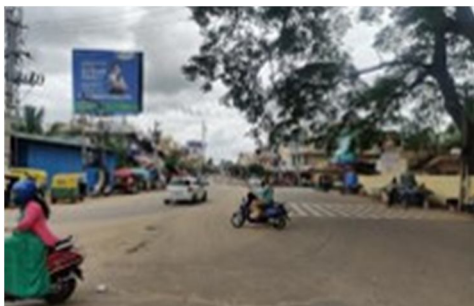
All the junctions are unsafe for pedestrians due to poor pedestrian crossing facilities. The zebra crossing in Satha Beedi junction is interrupted by the median. The foot over bridge present inside the Railway station is a connectivity between the southern and northern side of the railway line.

Figure 23: Santhe beedi discontinuous zebra crossing

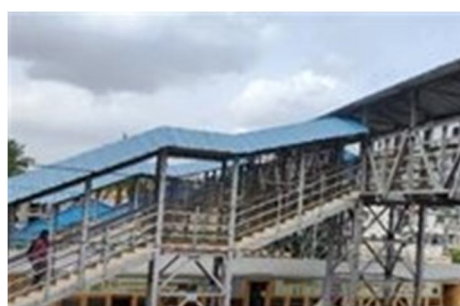
Figure 22: Foot over bridge in railway junction
