# Infrastructure Planning for TOD Zone of Chikkabanawara of Sub-urban Station, Bengaluru

Mudavath Meghanath<sup>1</sup>, Dr. Muhammad Danish<sup>2</sup>

<sup>1</sup>MURP 4<sup>th</sup> Sem, Department of Architecture and Planning, NIT Patna.

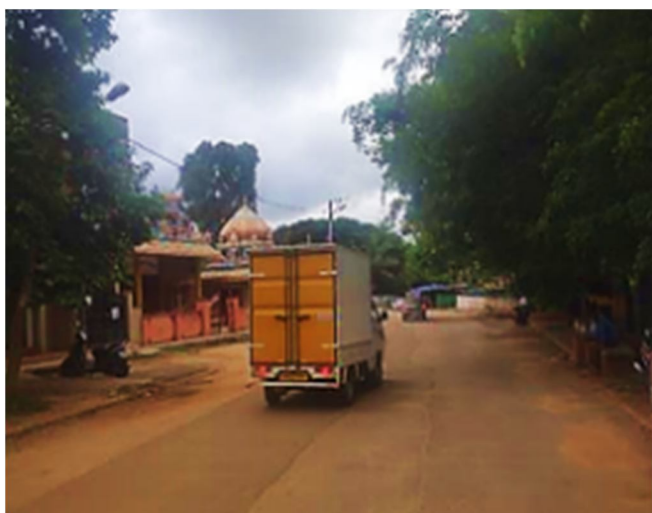
Figure 4: varying Right of Way width along the network

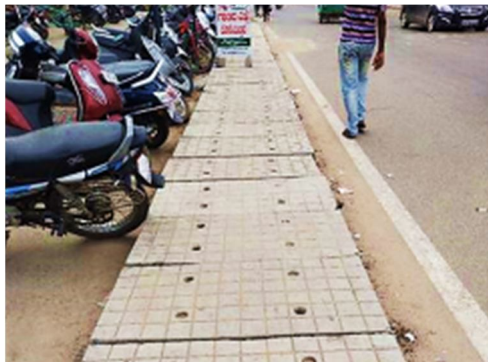
Figure 10:Drain covering as <1m footpath  
Source: Author

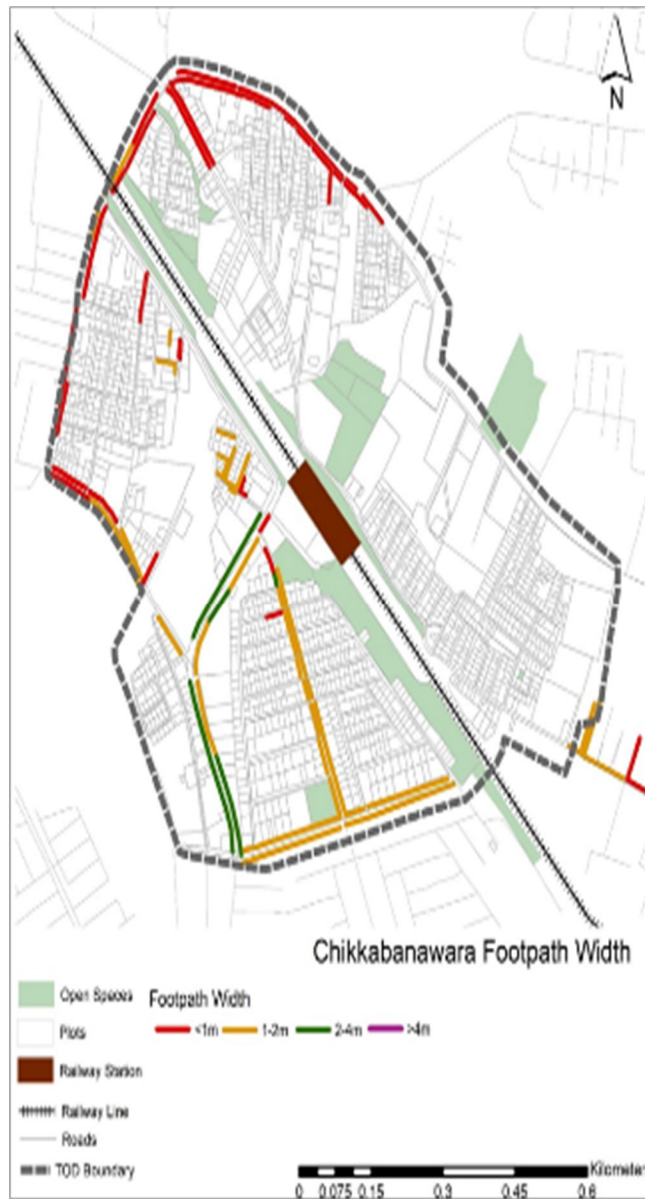
Figure 11:Chikkabanawara Footpath Width map  
Source: Author

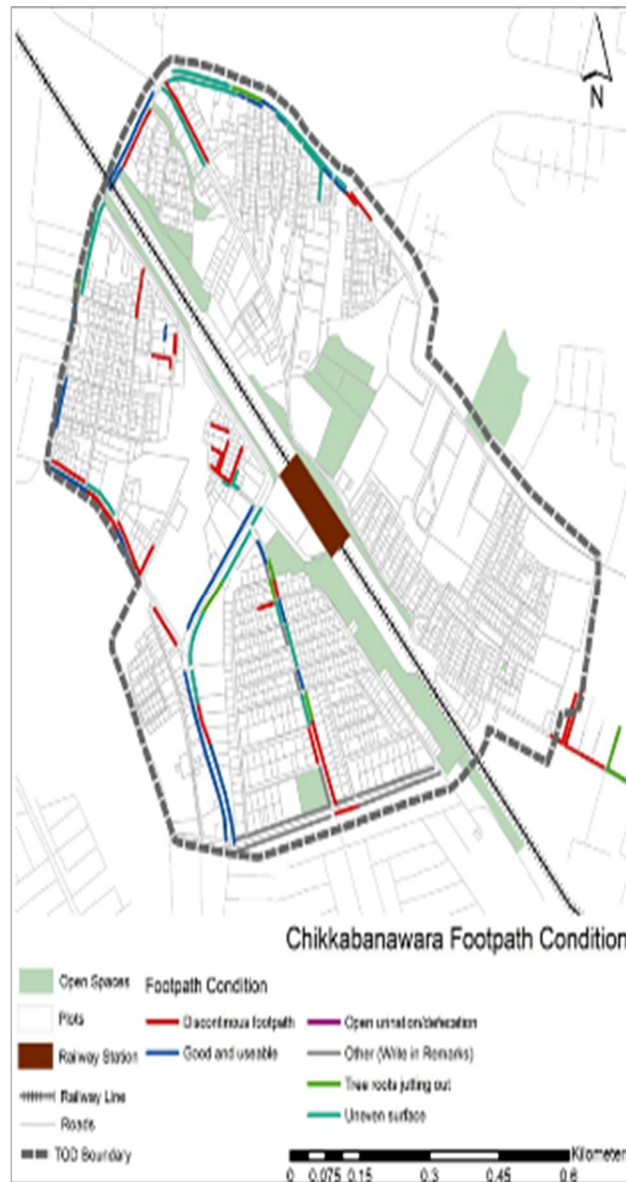
Figure 14: Chikkabanawara Footpath Condition map  
Source: Author

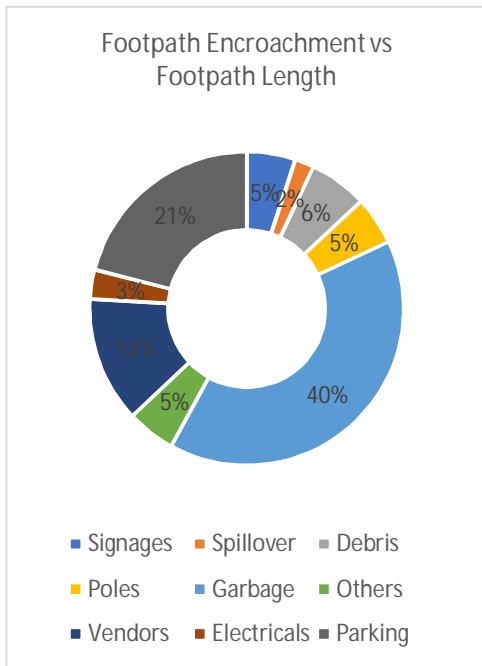
The total length of footpath encroachment is 1.21km, which is 25% of the total footpath length. Vehicular parking constitutes to 40% of the total footpath encroachment. A majority of the encroachments are on the Southern side of the Railway line.

Figure 16: Footpath Encroachment vs Length  
Source: Author

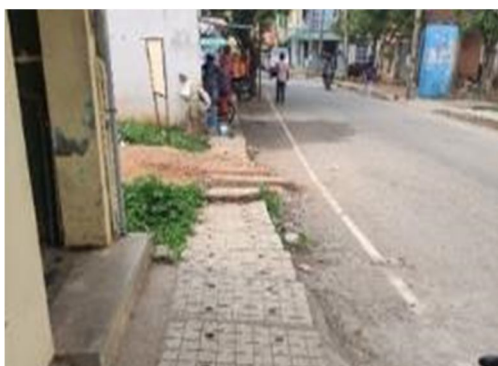
Figure 25: Discontinuous footpath

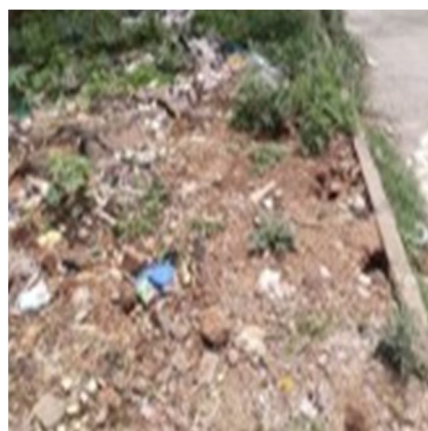
Figure 24: Garbage dump on footpaths

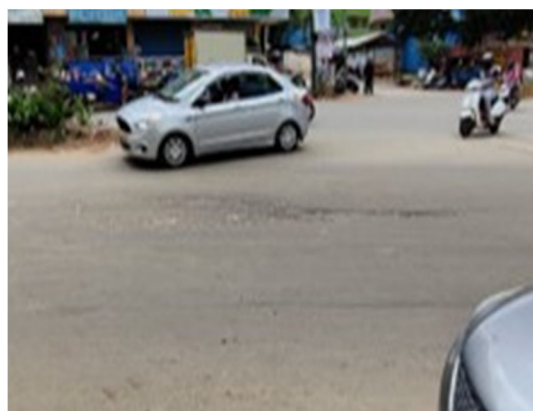
Figure 26: Incomplete Pedestrian Network

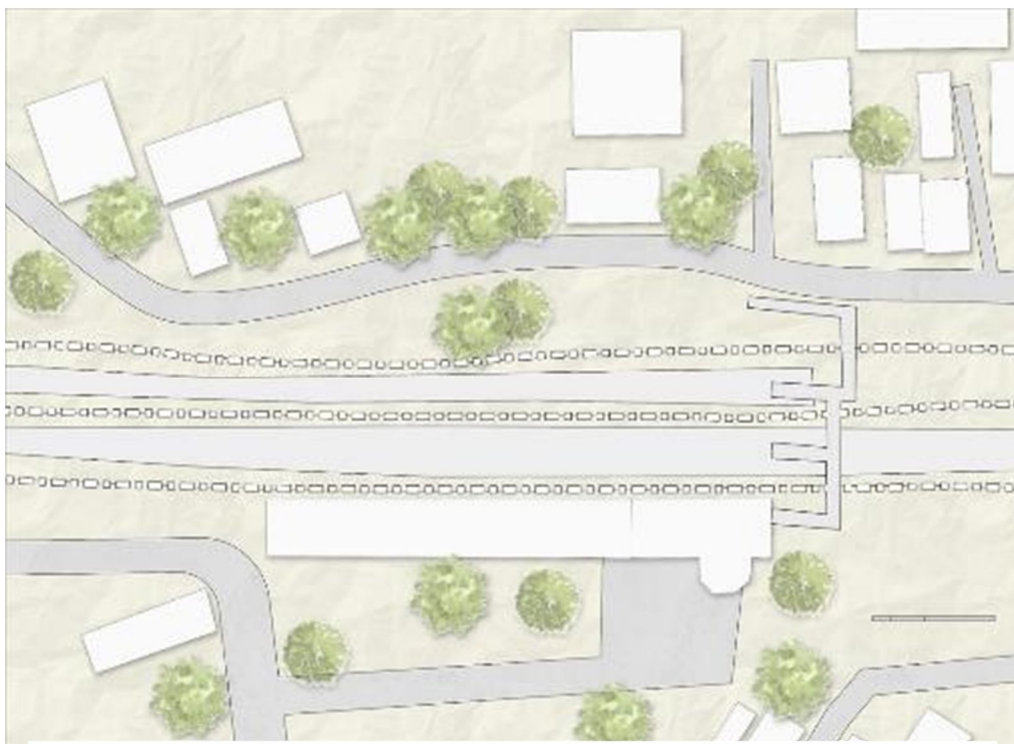
Figure 31:Chikkabanawara – Station Road Design (Existing Plan).

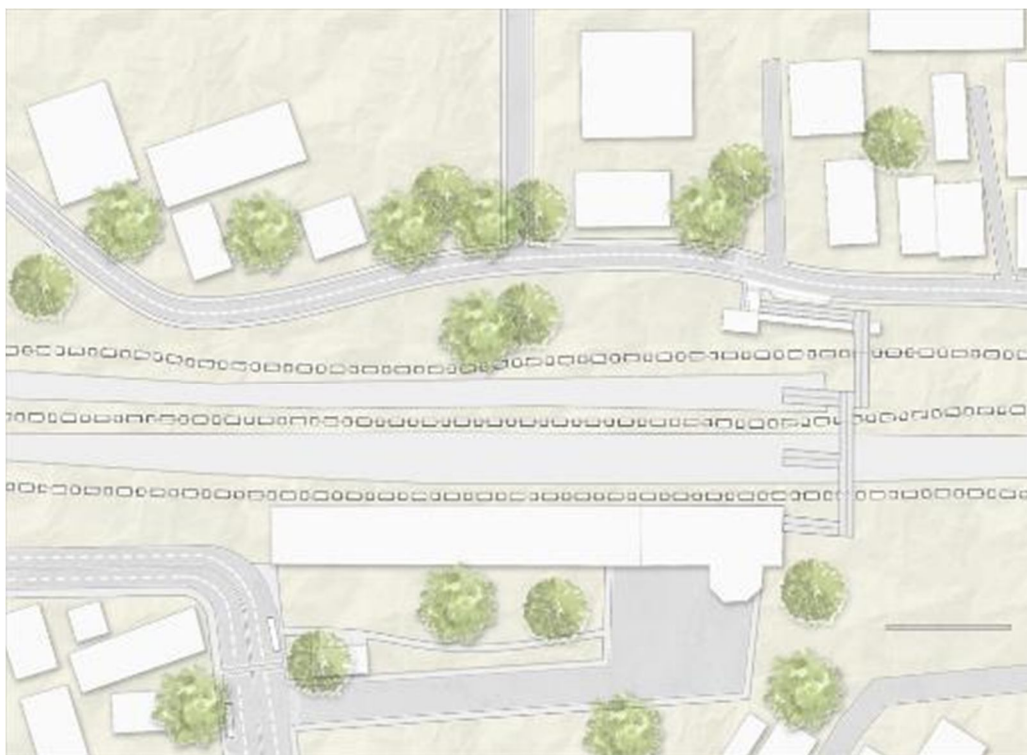
Figure 30:Chikkabanawara – Station Road Design (Proposed Plan).

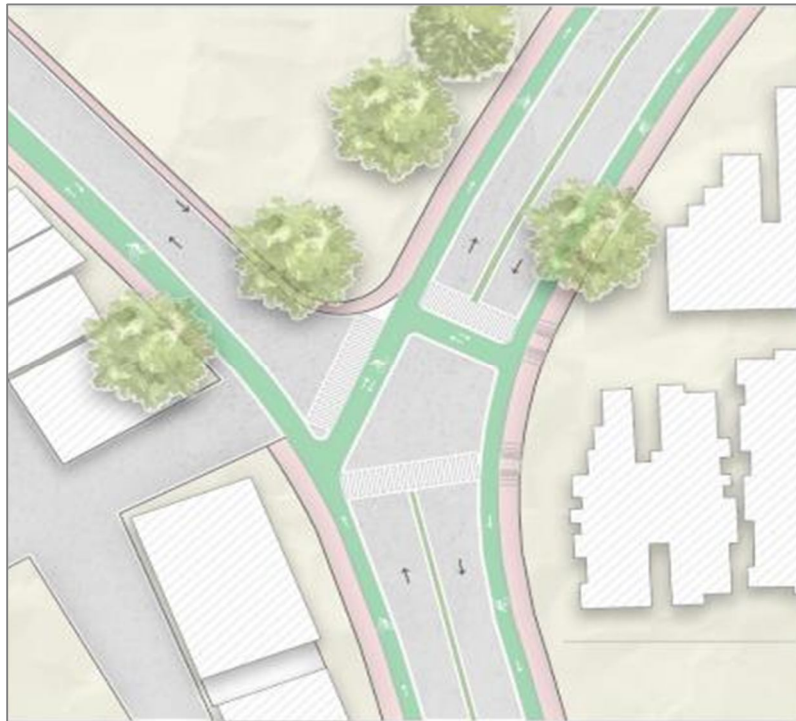
Figure 33: Proposed Janapriya Junction.  
Source: Author
