# Infrastructure Planning for TOD Zone of Chikkabanawara of Sub-urban Station, Bengaluru

Mudavath Meghanath<sup>1</sup>, Dr. Muhammad Danish<sup>2</sup>

<sup>1</sup>MURP 4<sup>th</sup> Sem, Department of Architecture and Planning, NIT Patna.

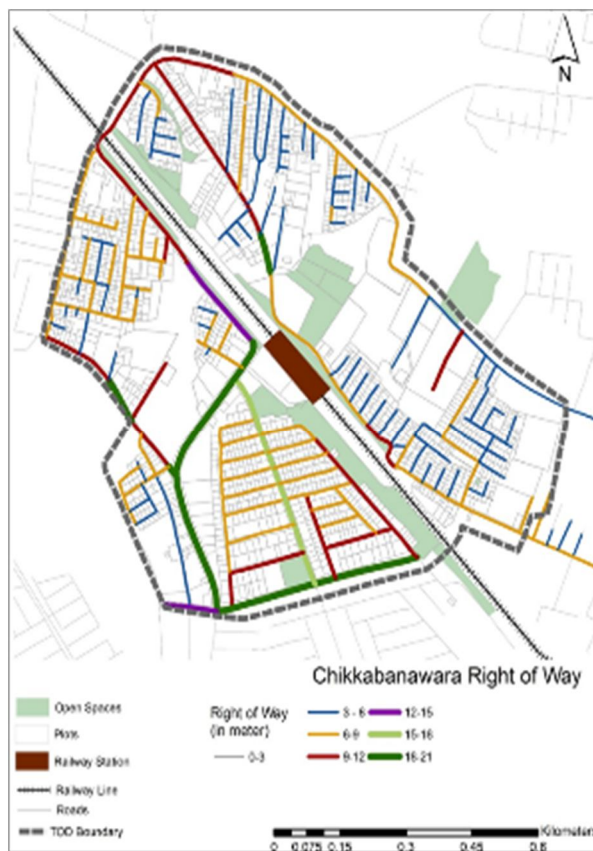
Figure 3: Chikkabanawara Right of Way map

The total length of the road network is 17.8km. The main roads have ROW in the range of 9-21m. The smaller ROWs of 3-6m width are majorly observed on the Northern side of the railway line. From the audit, it is evident that, around 33% of the total road network have ROW in the range of 6-9m.

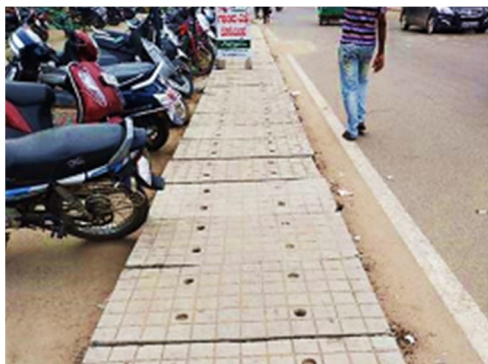
Figure 10:Drain covering as <1m footpath  
Source: Author

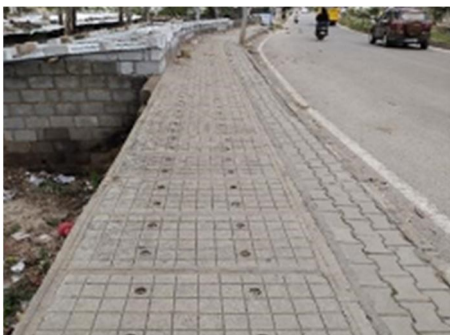
Figure 13: Good & Useable footpath Condition  
Source: Author

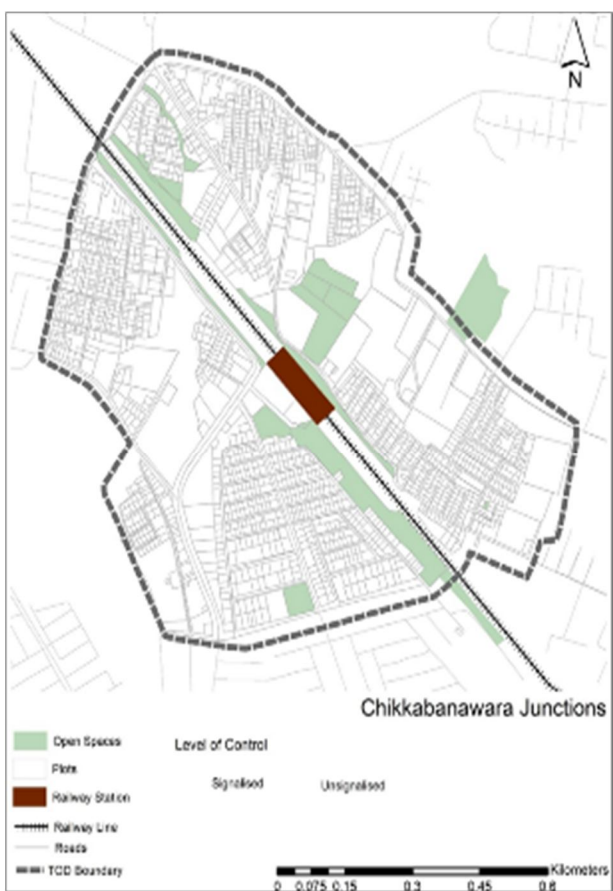
Figure 18: Chikkabanawara junction location map  
Source: Author

There are three major junctions in Chikkabanawara. The Sapthagiri junction in the south is a three-arm junction which also has a private road leading to Sapthagiri Medical College and hospital. Jana Priya junction is three-armed, one of which leads to the railway station and Sathe Beedi is a 5-armed junction. Although the Sapthagiri junction and Sathe Beedi junction are signaled, both of them are not functional.

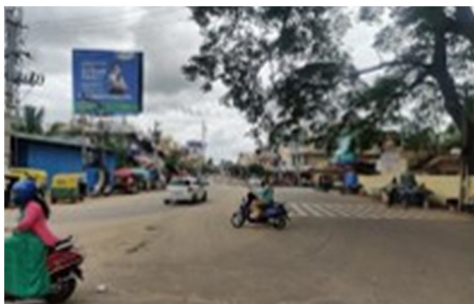
All the junctions are unsafe for pedestrians due to poor pedestrian crossing facilities. The zebra crossing in Sath Beedi junction is interrupted by the median. The foot over bridge present inside the Railway station is a connectivity between the southern and northern side of the railway line.

Figure 23: Santhe beedi discontinuous zebra crossing

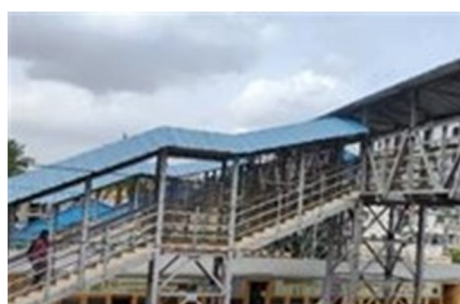
Figure 22: Foot over bridge in railway junction

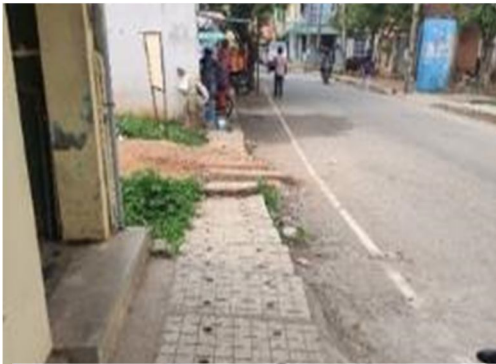
Figure 25: Discontinuous footpath  
Source: Author

With regard to road widths, a distinct hierarchy of streets is seen. Only 66% (14.5km of 21.9km) of the network's overall length is covered by footpaths. 70% of the footpaths—10.1 km of the 14.5 km—are encroached, with parking making up the majority. The pedestrian network, which includes walkways and crossings, is unfinished and disjointed, particularly at intersections. Poor facilities for pedestrians are indicated by the absence of amenities like public restrooms, trash cans, and benches. At bus stops, there is a lack of cover, signage, benches, and lighting.

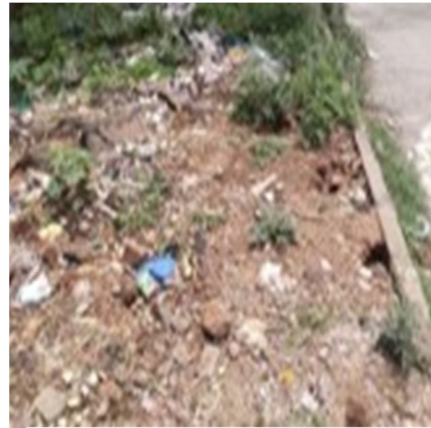
Figure 24: Garbage dump on footpaths  
Source: Author

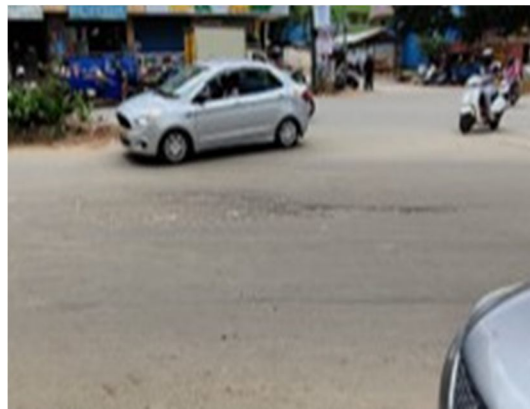
Figure 26: Incomplete Pedestrian Network  
Source: Author

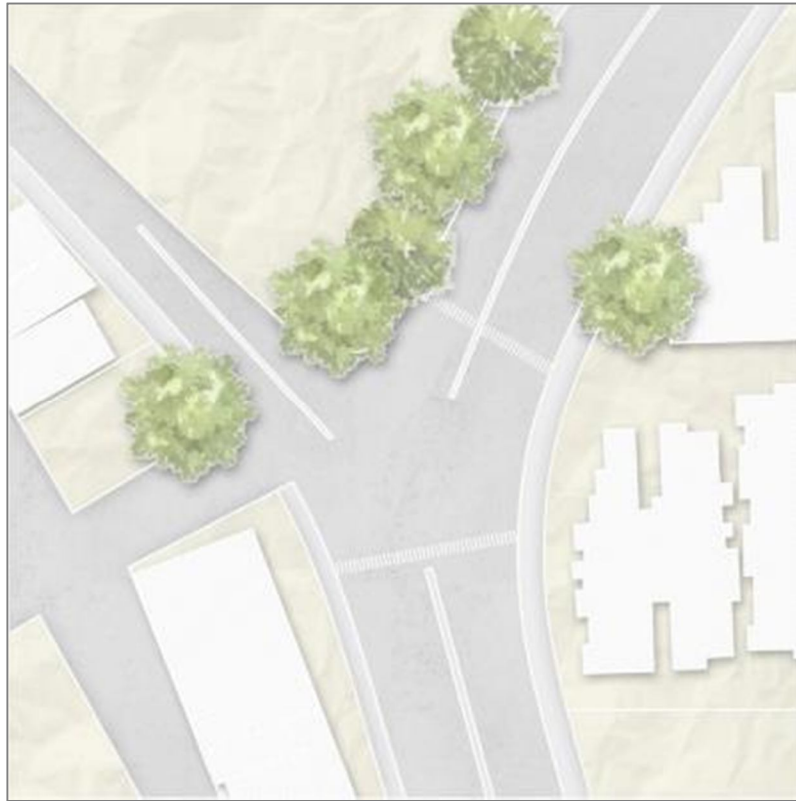
Figure 32: Existing Condition of Janapriya Junction.  
Source: Author
