Infrastructure Planning for TOD Zone of Chikkabanawara of Sub-urban Station, Bengaluru

Mudavath Meghanath¹, Dr. Muhammad Danish²

¹MURP 4th Sem, Department of Architecture and Planning, NIT Patna.

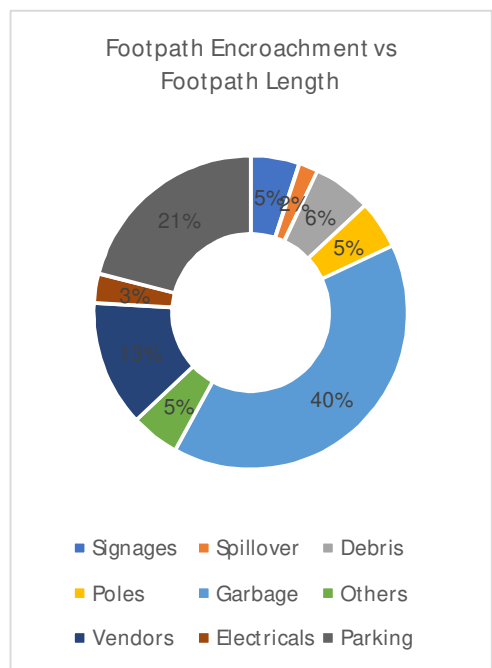
Figure 16:Footpath Encroachment vs Length
Source: Author

The total length of footpath encroachment is 1.21km, which is 25% of the total footpath length. Vehicular parking constitutes to 40% of the total footpath encroachment. A majority of the encroachments are on the Southern side of the Railway line.

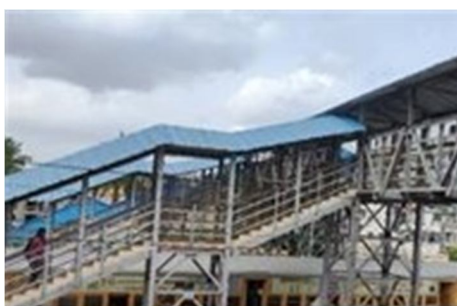
Figure 22: Foot over bridge in railway junction

All the junctions are unsafe for pedestrians due to poor pedestrian crossing facilities. The zebra crossing in Sath Beedi junction is interrupted by the median. The foot over bridge present inside the Railway station is a connectivity between the southern and northern side of the railway line.

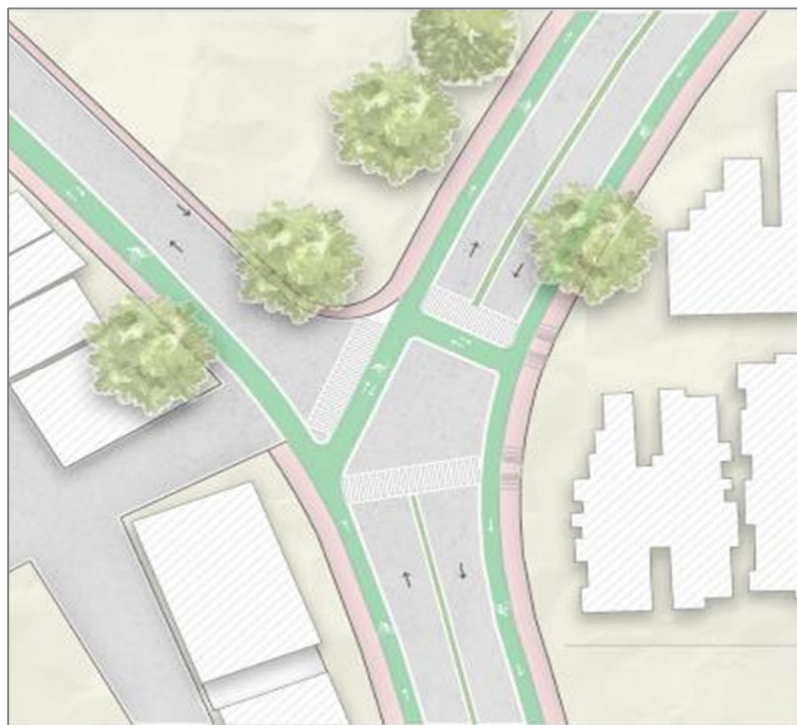
Figure 33: Proposed Janapriya Junction.
